City of Santa Fe Police Department

Public Safety Building Needs Assessment

06/19/2008 - 10/25/2012

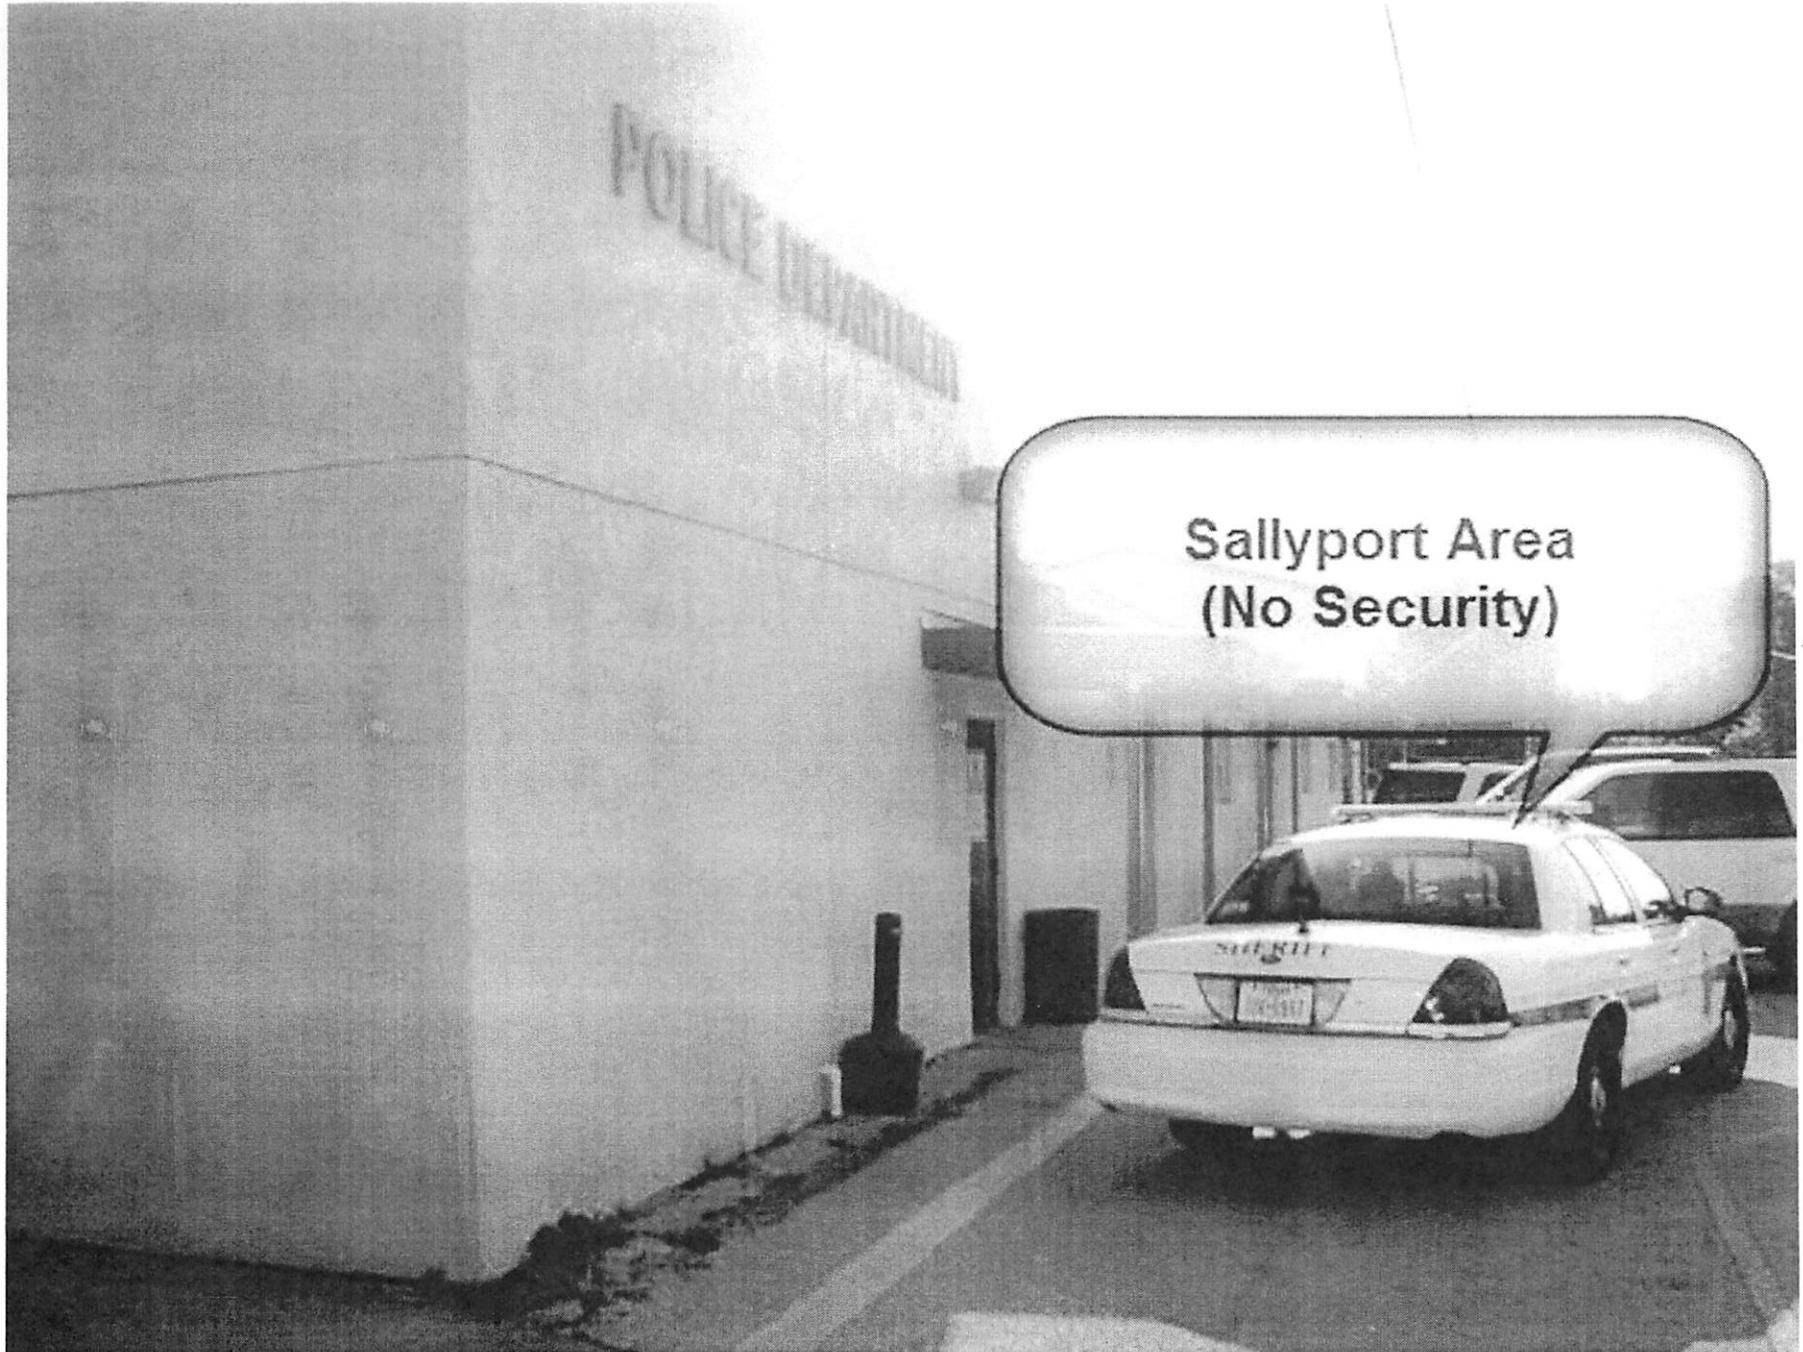
**Sallyport Area
(No Security)**

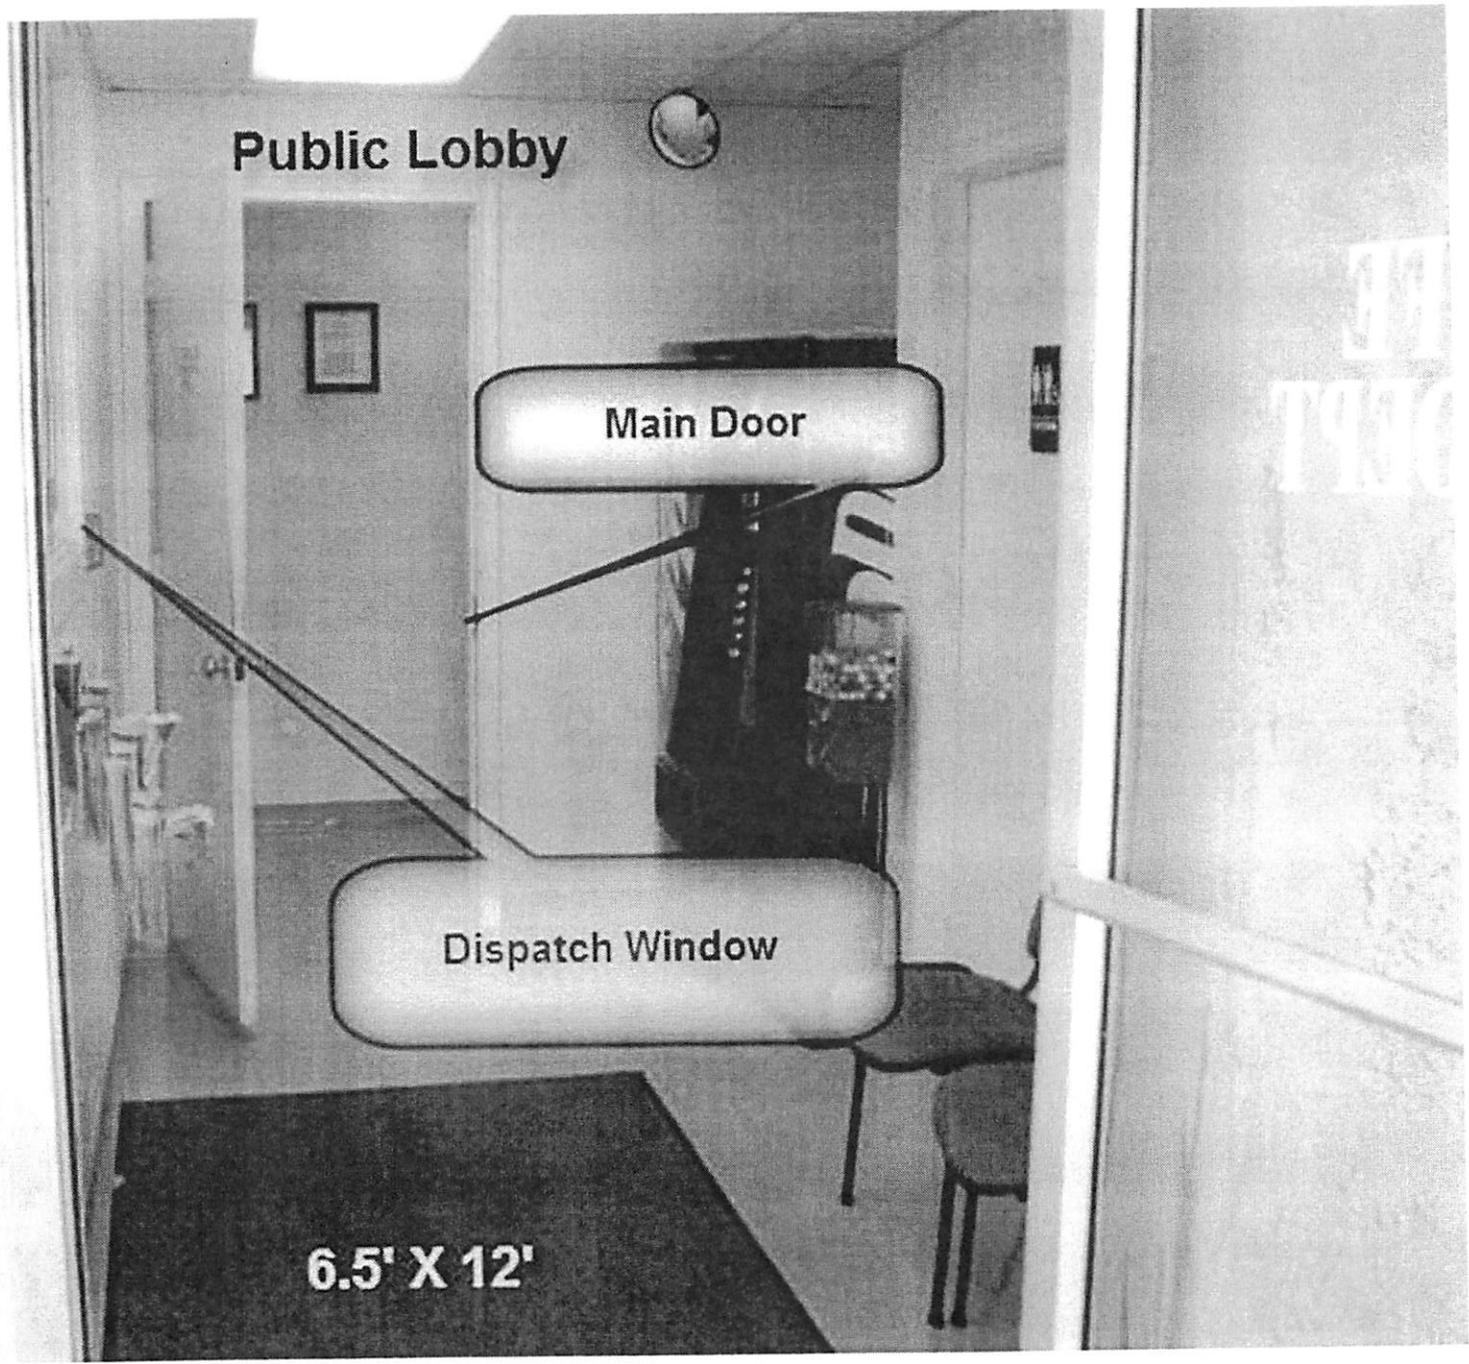
Public Lobby

- The public lobby does not provide adequate space to accommodate the visiting public. Our present lobby is too small and too crowded when we have multiple visitors. This is a definite public safety issue. The lobby also shares the climate control system with another part of the building. In the summer it is extremely cold and in the winter it is overpoweringly hot in the lobby. Lobby door is not secure, keeping unwanted threats from breaching the rest of the police department or the dispatch area.

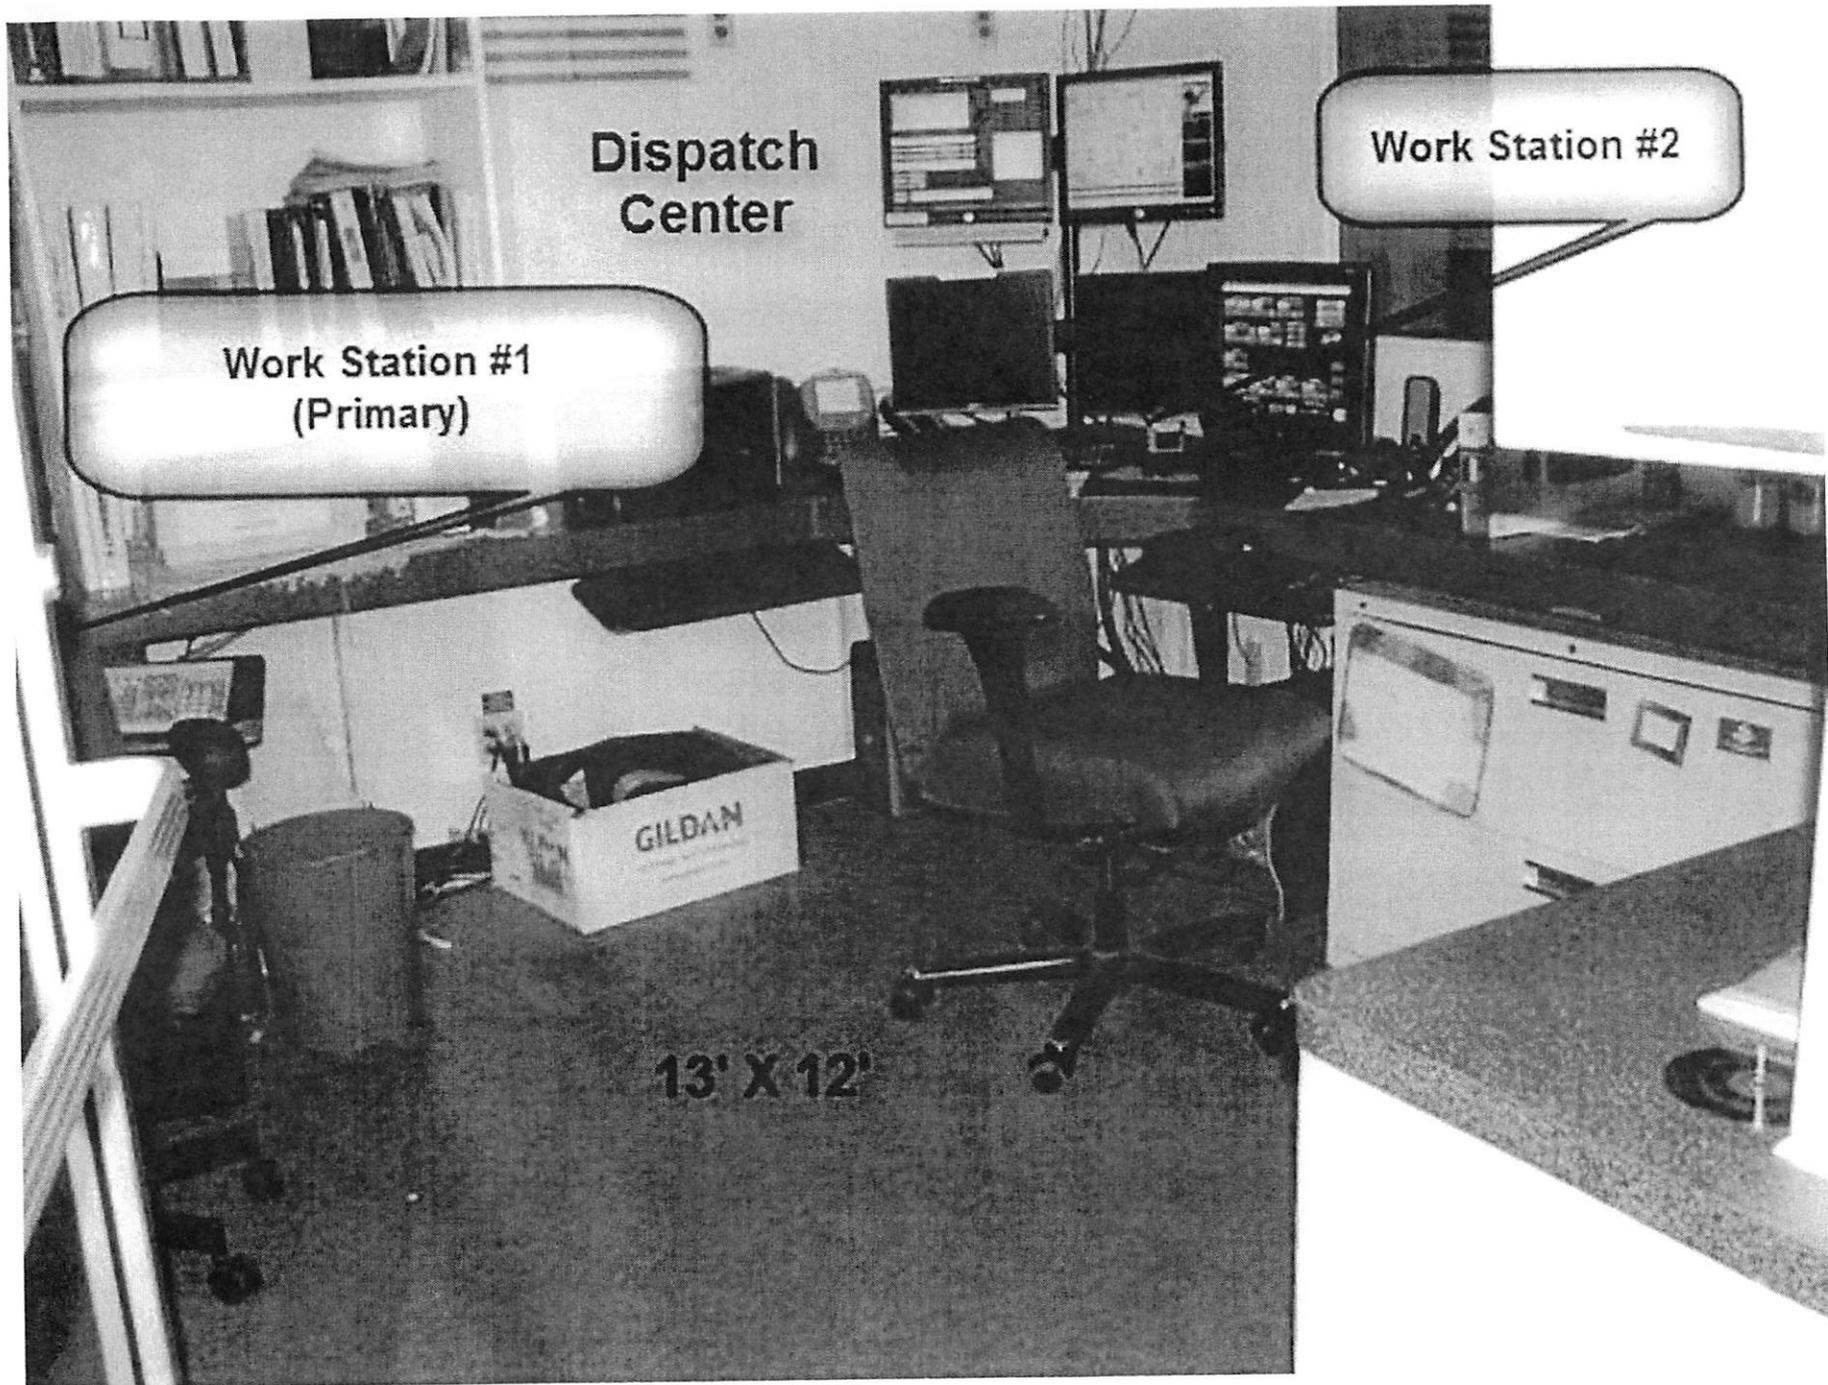
**Dispatch
Center**

- When the building was remodeled in 1999/2000, the dispatch center was set up for two dispatch positions. The design and space have proven to be inadequate. The dispatchers need a restroom adjacent to their workstation, presently they must go down the hall. This requires a patrolman to come in off of the street to relieve them. The dispatch window is made of thin Plexiglas, offering the dispatcher no security from an attack on the police station.

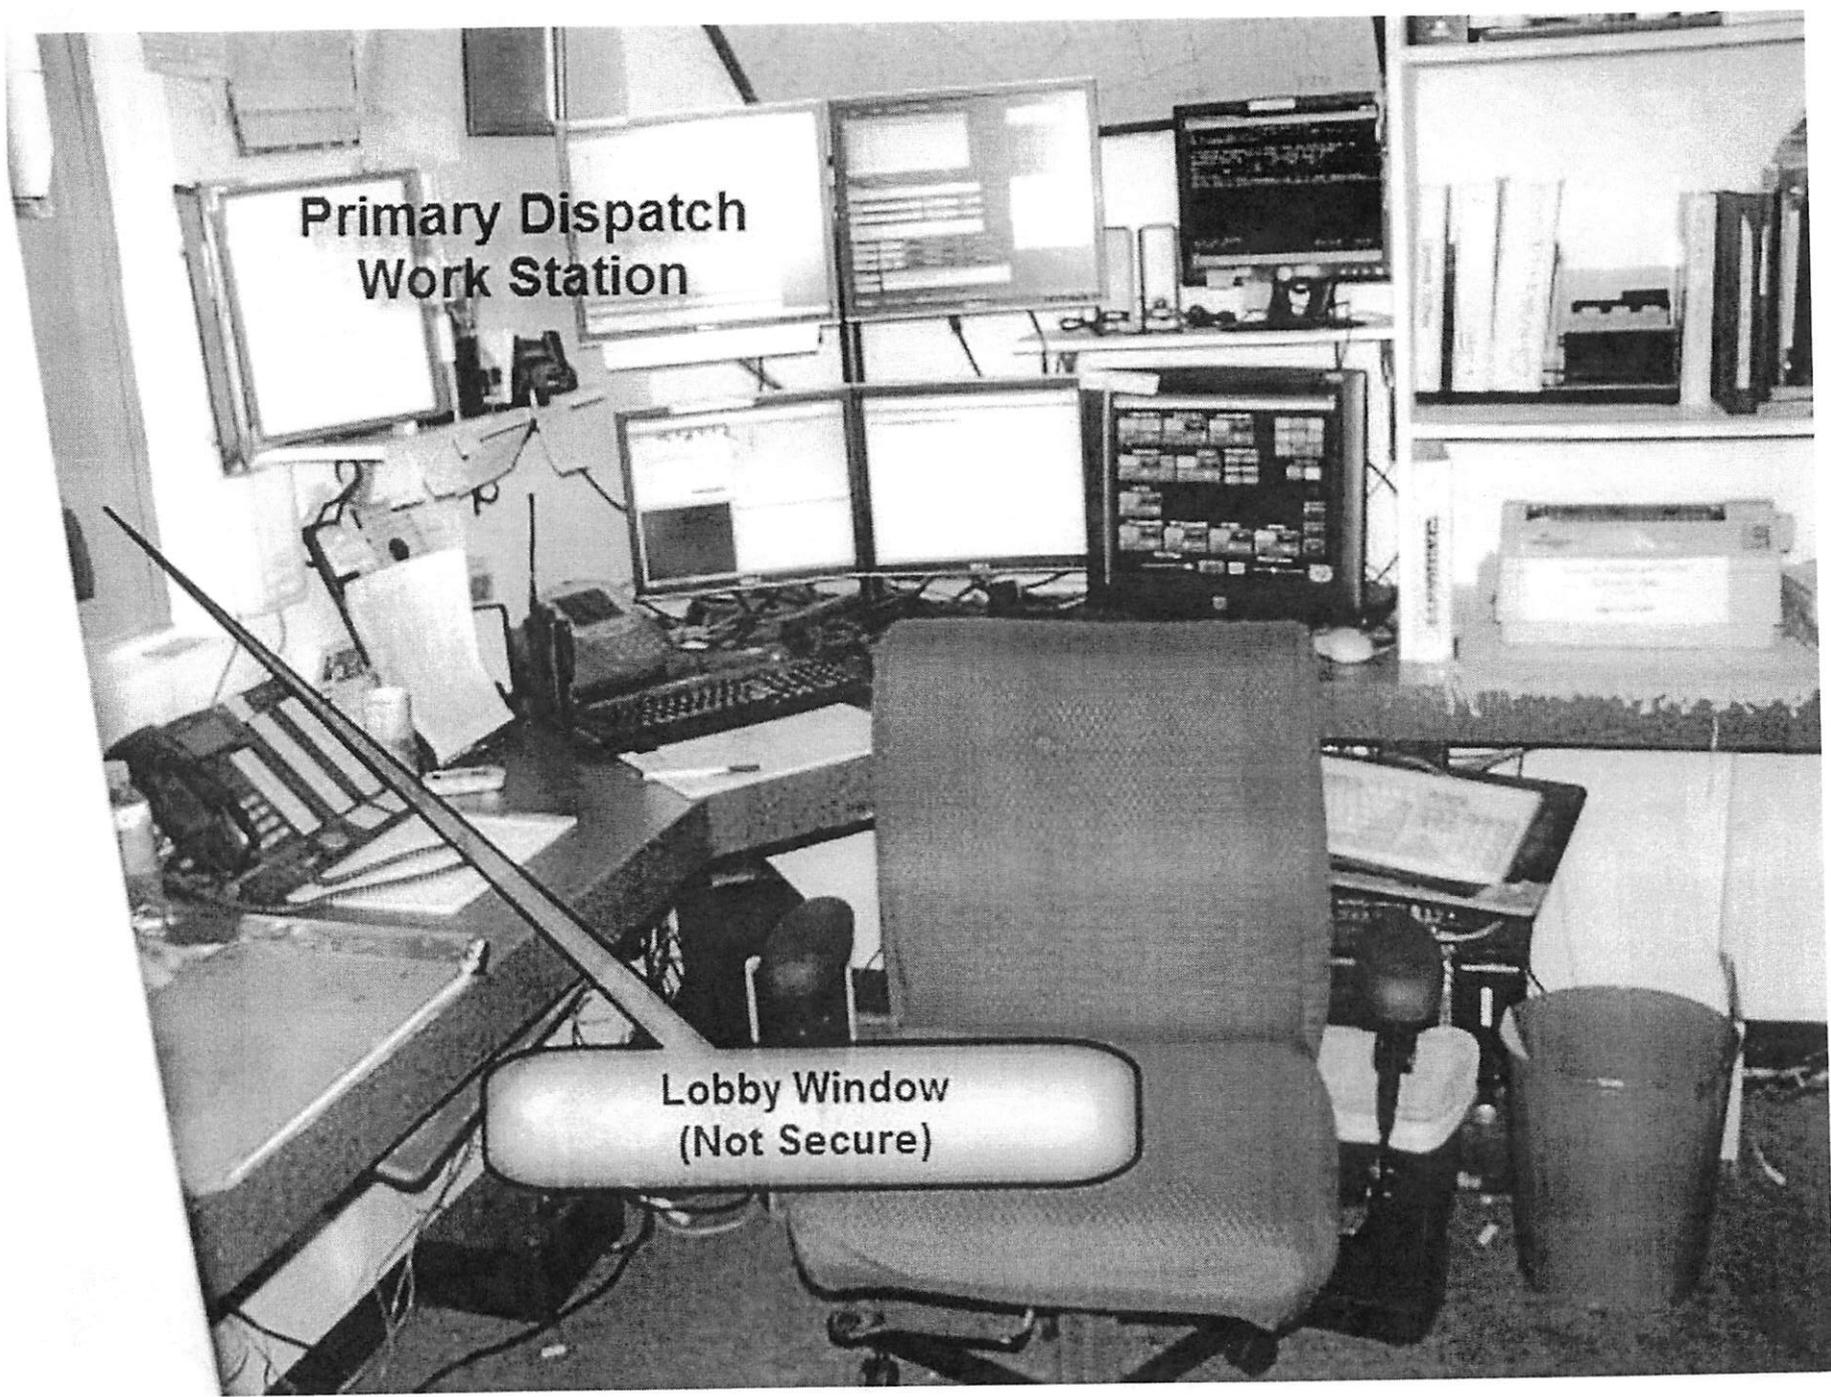
**Lobby Window
(Not Secure)**

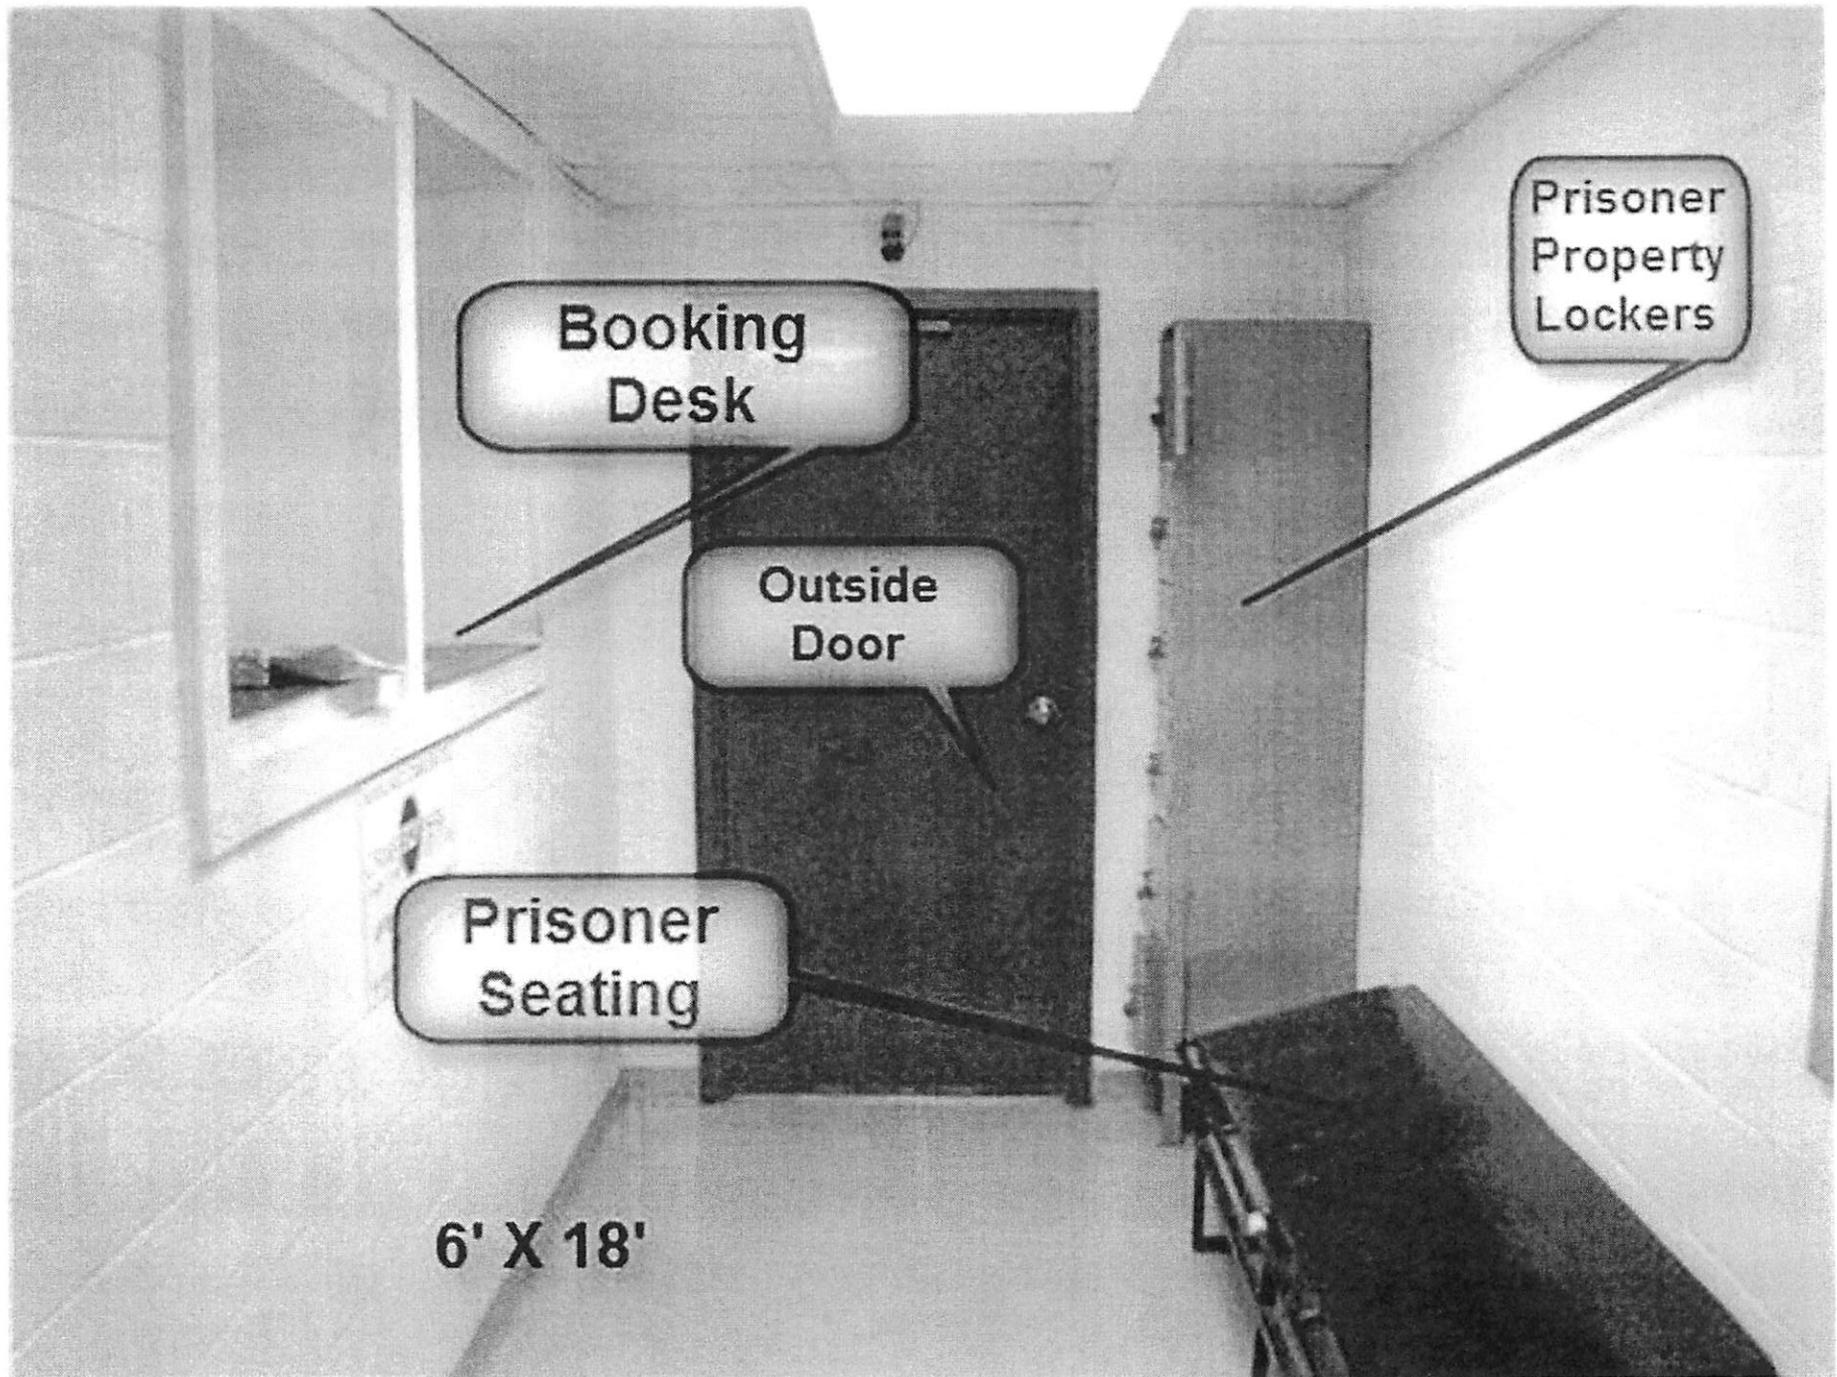
- Presently the booking area is too narrow and requires the officer to turn his back on the arrestee, which is a major officer safety issue. The gun locker is next to dispatch. The prisoner's property is secured in a simple metal locker, and there are often times more prisoners than lockers. This has proven to be a problem with property being mixed and property being misplaced. The fingerprint station is in between the door to the main building and the door to the jail, this is another officer safety issue, especially if there are multiple arrestees present. The booking entrance door from outside is accessible to the public and is not very secure.

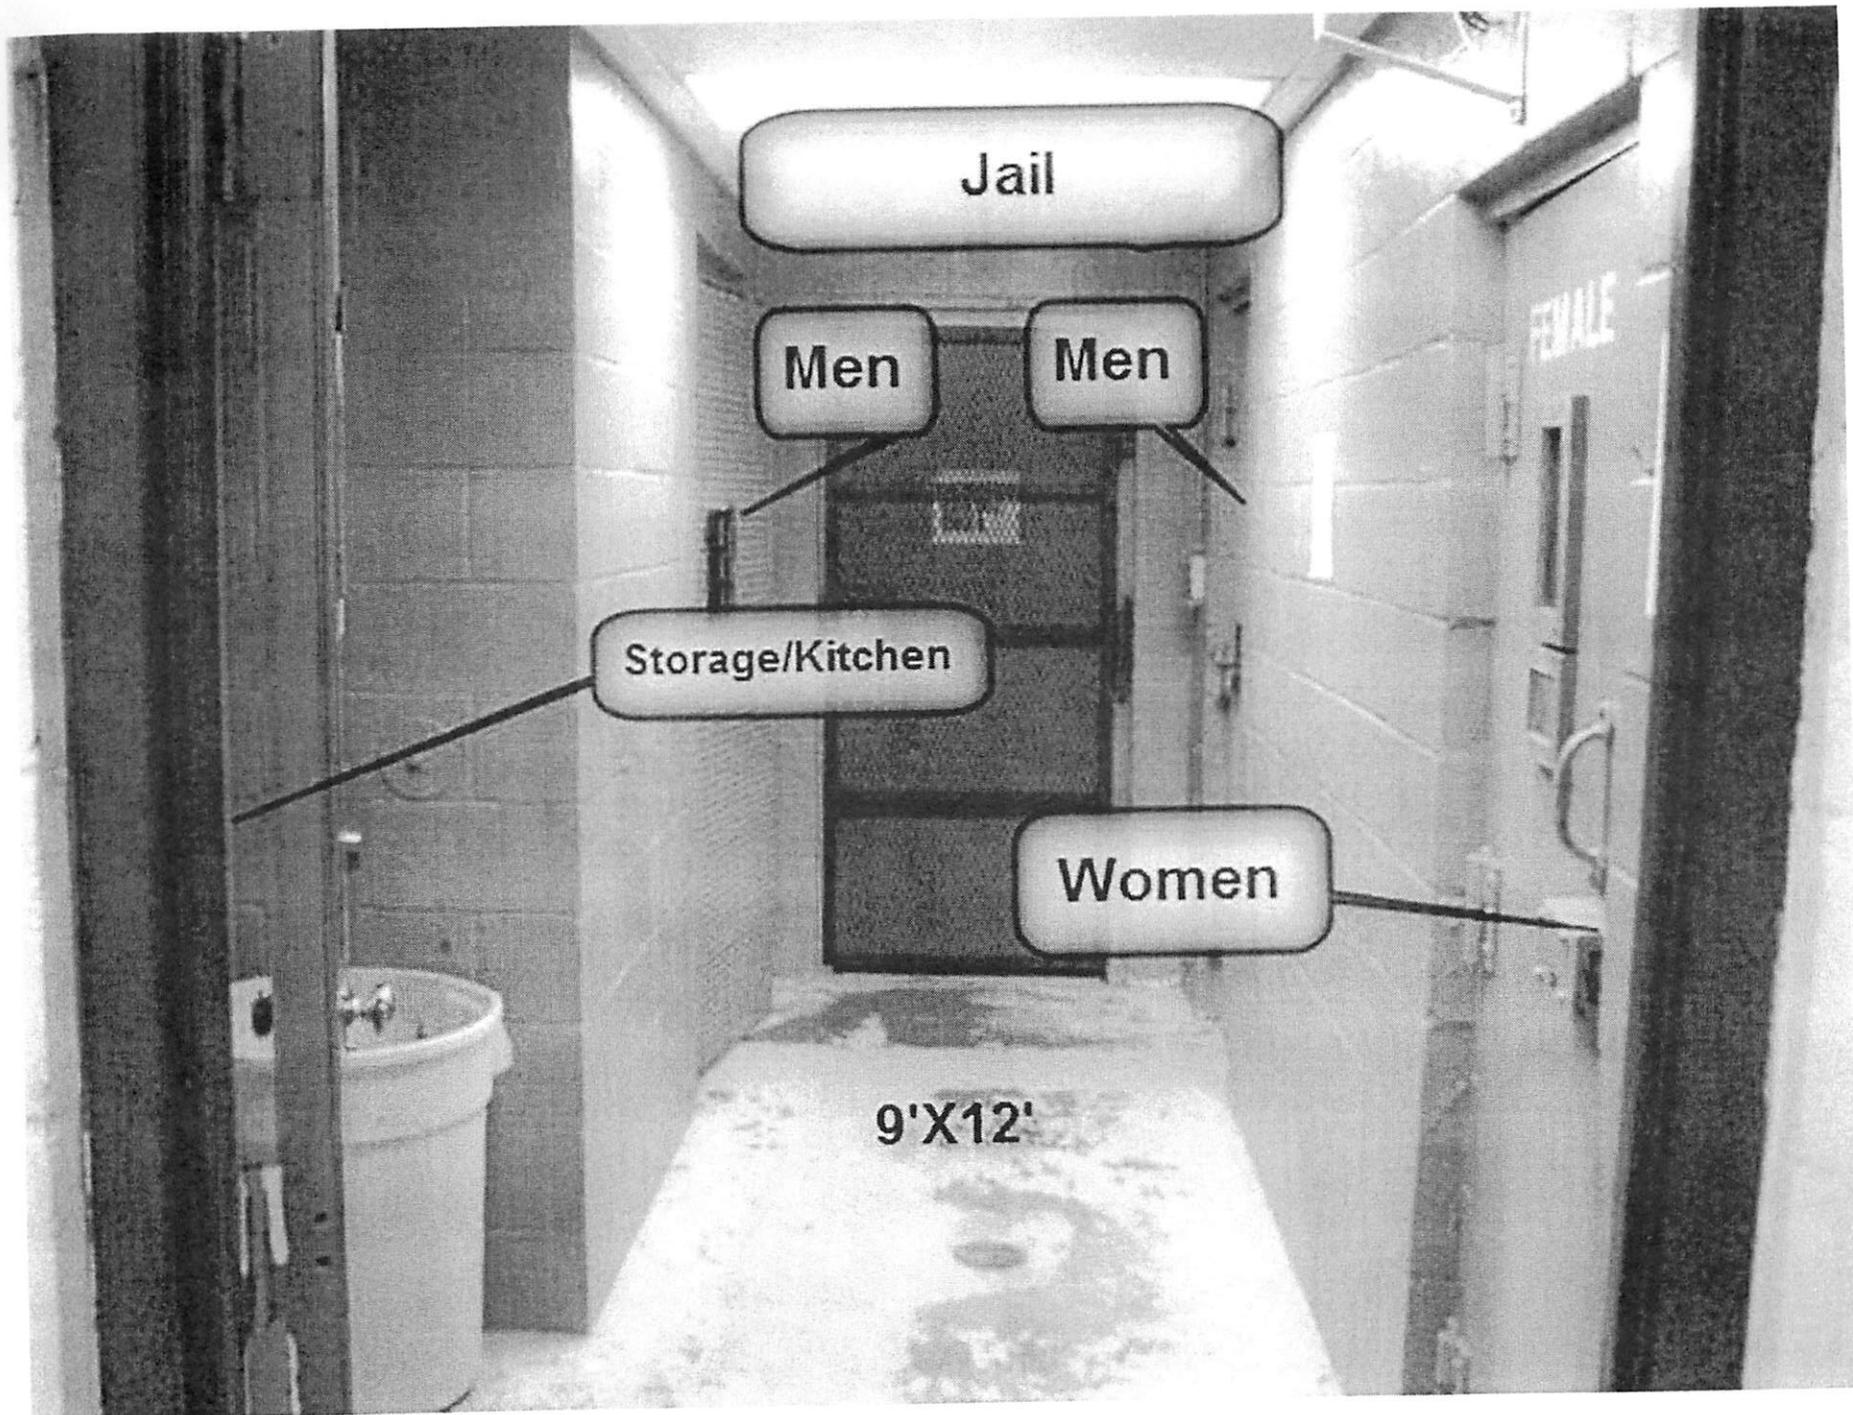
Jail

- Currently we have three jail cells, two male and one female. The cells are designed to accommodate two prisoners per cell. More often than not we have at least four people in each cell, requiring at least two per cell to be on the floor. The jail needs to be updated in its fixtures, jail access, lighting, bunks, and size. There is no juvenile cell. The storage area in the jail triples as the jail kitchen and has an evidence cold storage refrigerator in it.

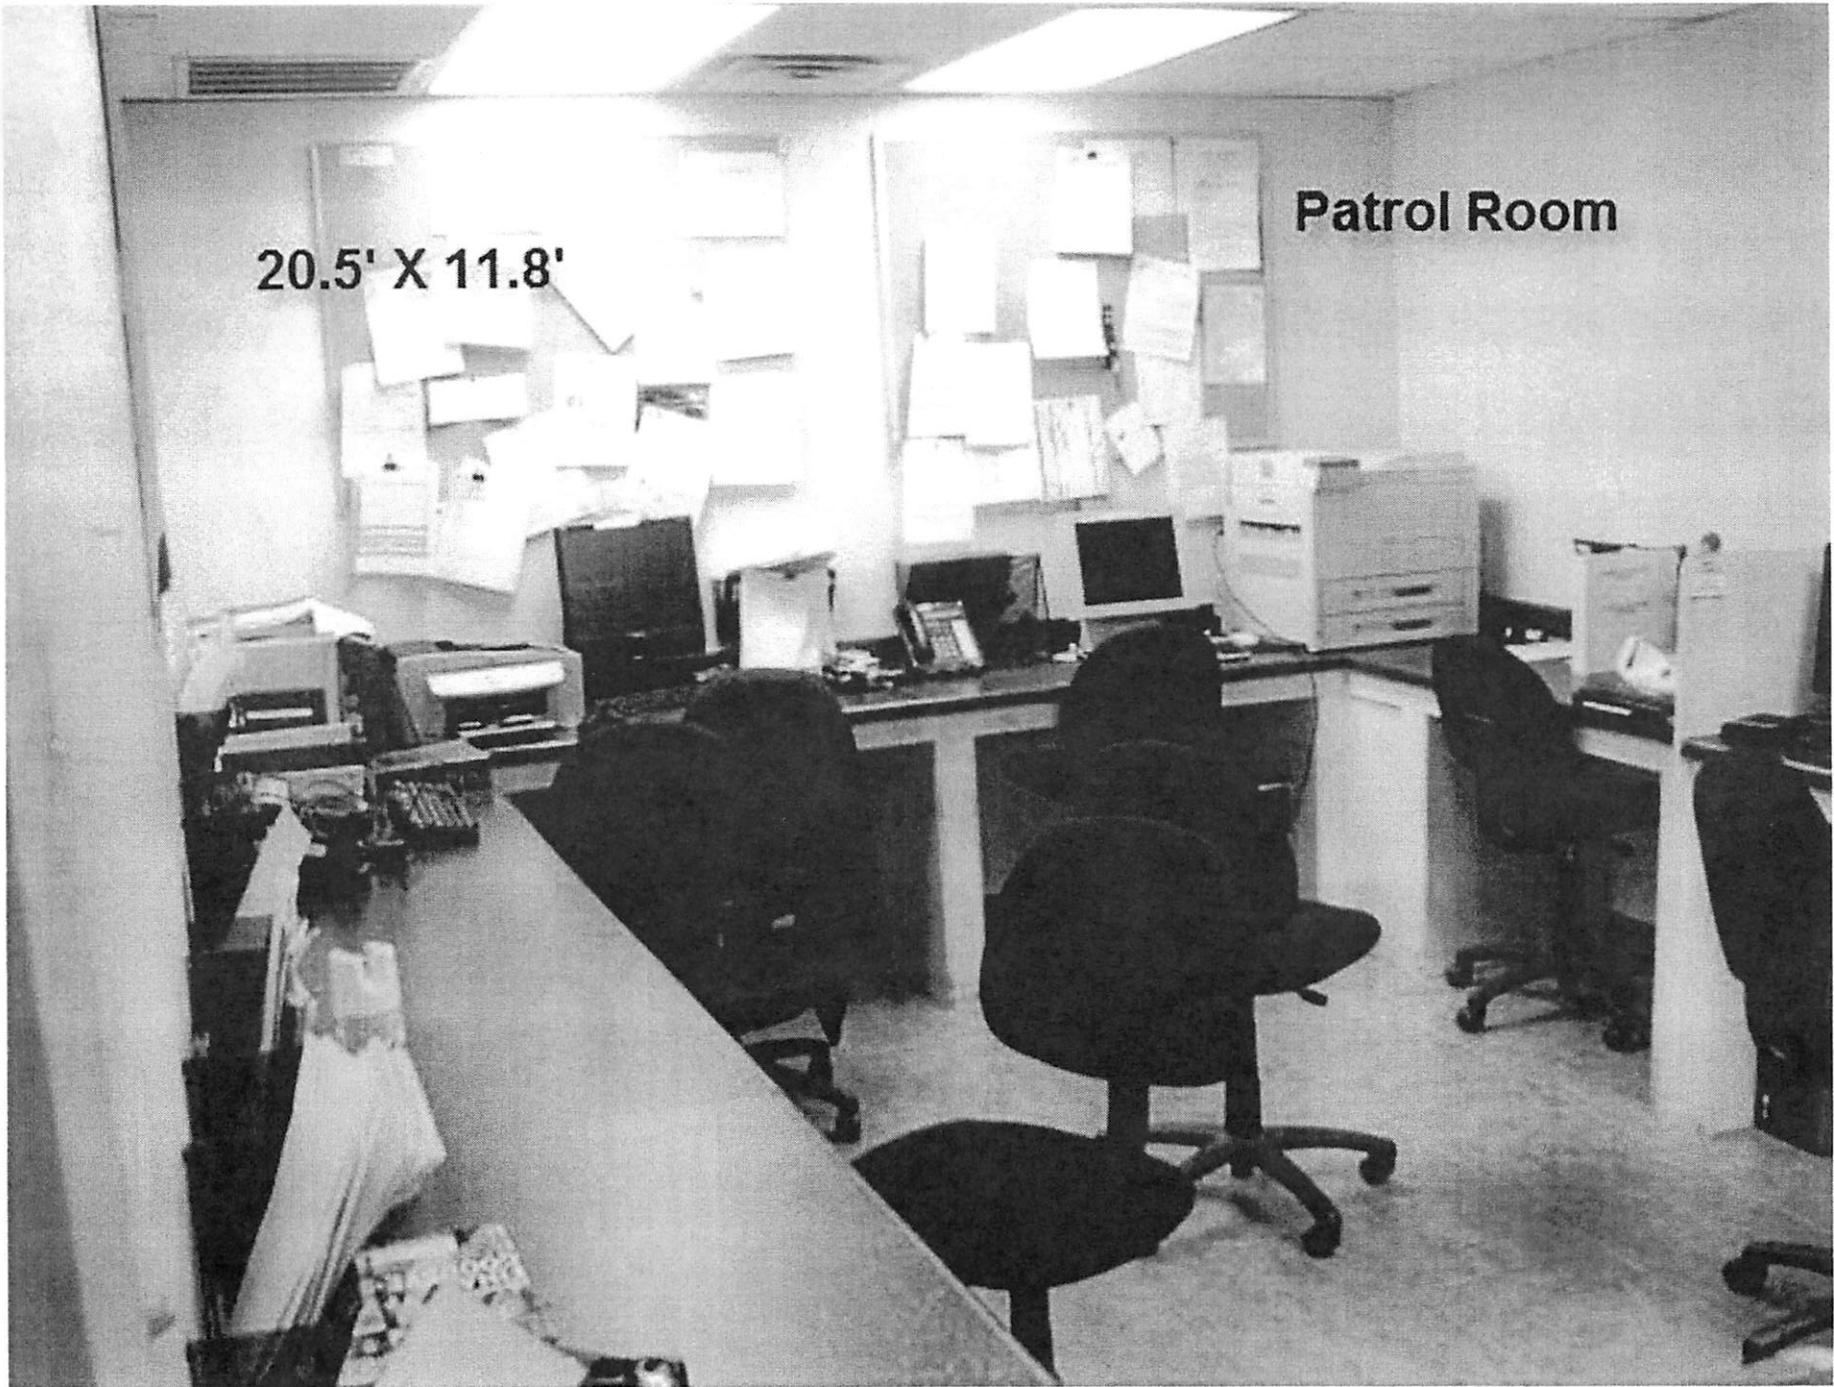
Patrol Room

- The patrol room was expanded in 2006 to accommodate the eight patrol officers. We now have sixteen and hope to have more added in the future. This was done to give each officer his own work space so they would not be on top of each other. We simply do not have enough room for officers who are investigating crimes, speaking with complainants, victims, witnesses or suspects. This could compromise a persons civil rights in certain cases.

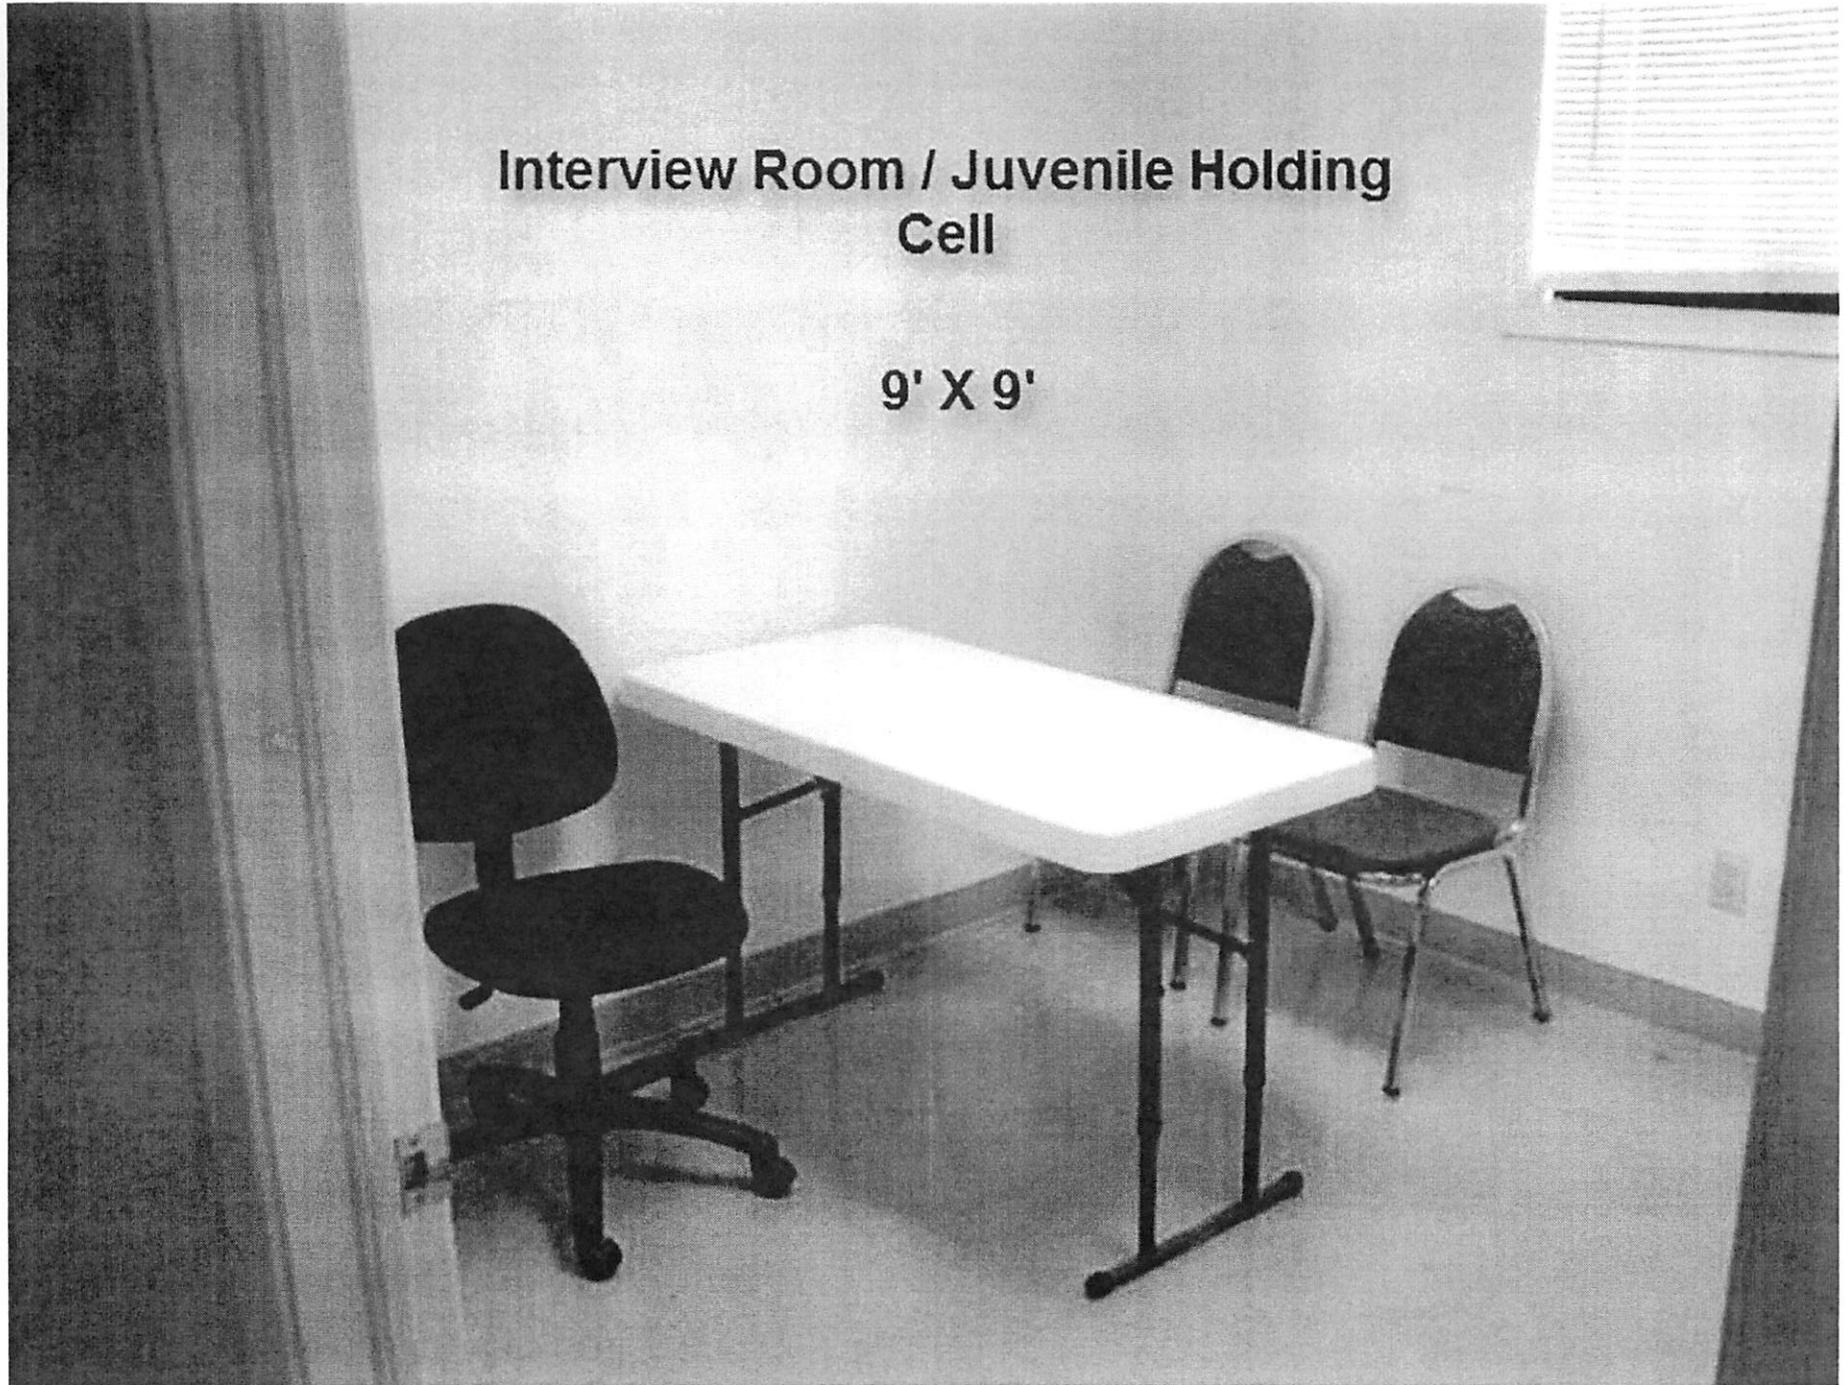
**Interview Room / Juvenile Holding
Cell**

- Currently we have only one interview room which doubles as the juvenile holding room. Large incidents and investigations usually require multiple people to be interviewed at one time, and or separated into different rooms, which is not possible with the space we have now, jeopardizing the integrity and interview evidence of a case. It has a camera, with audio, and it has home made bars on the window. The only way to secure the room is to lock the door from the outside, and this is a flimsy lock at best.

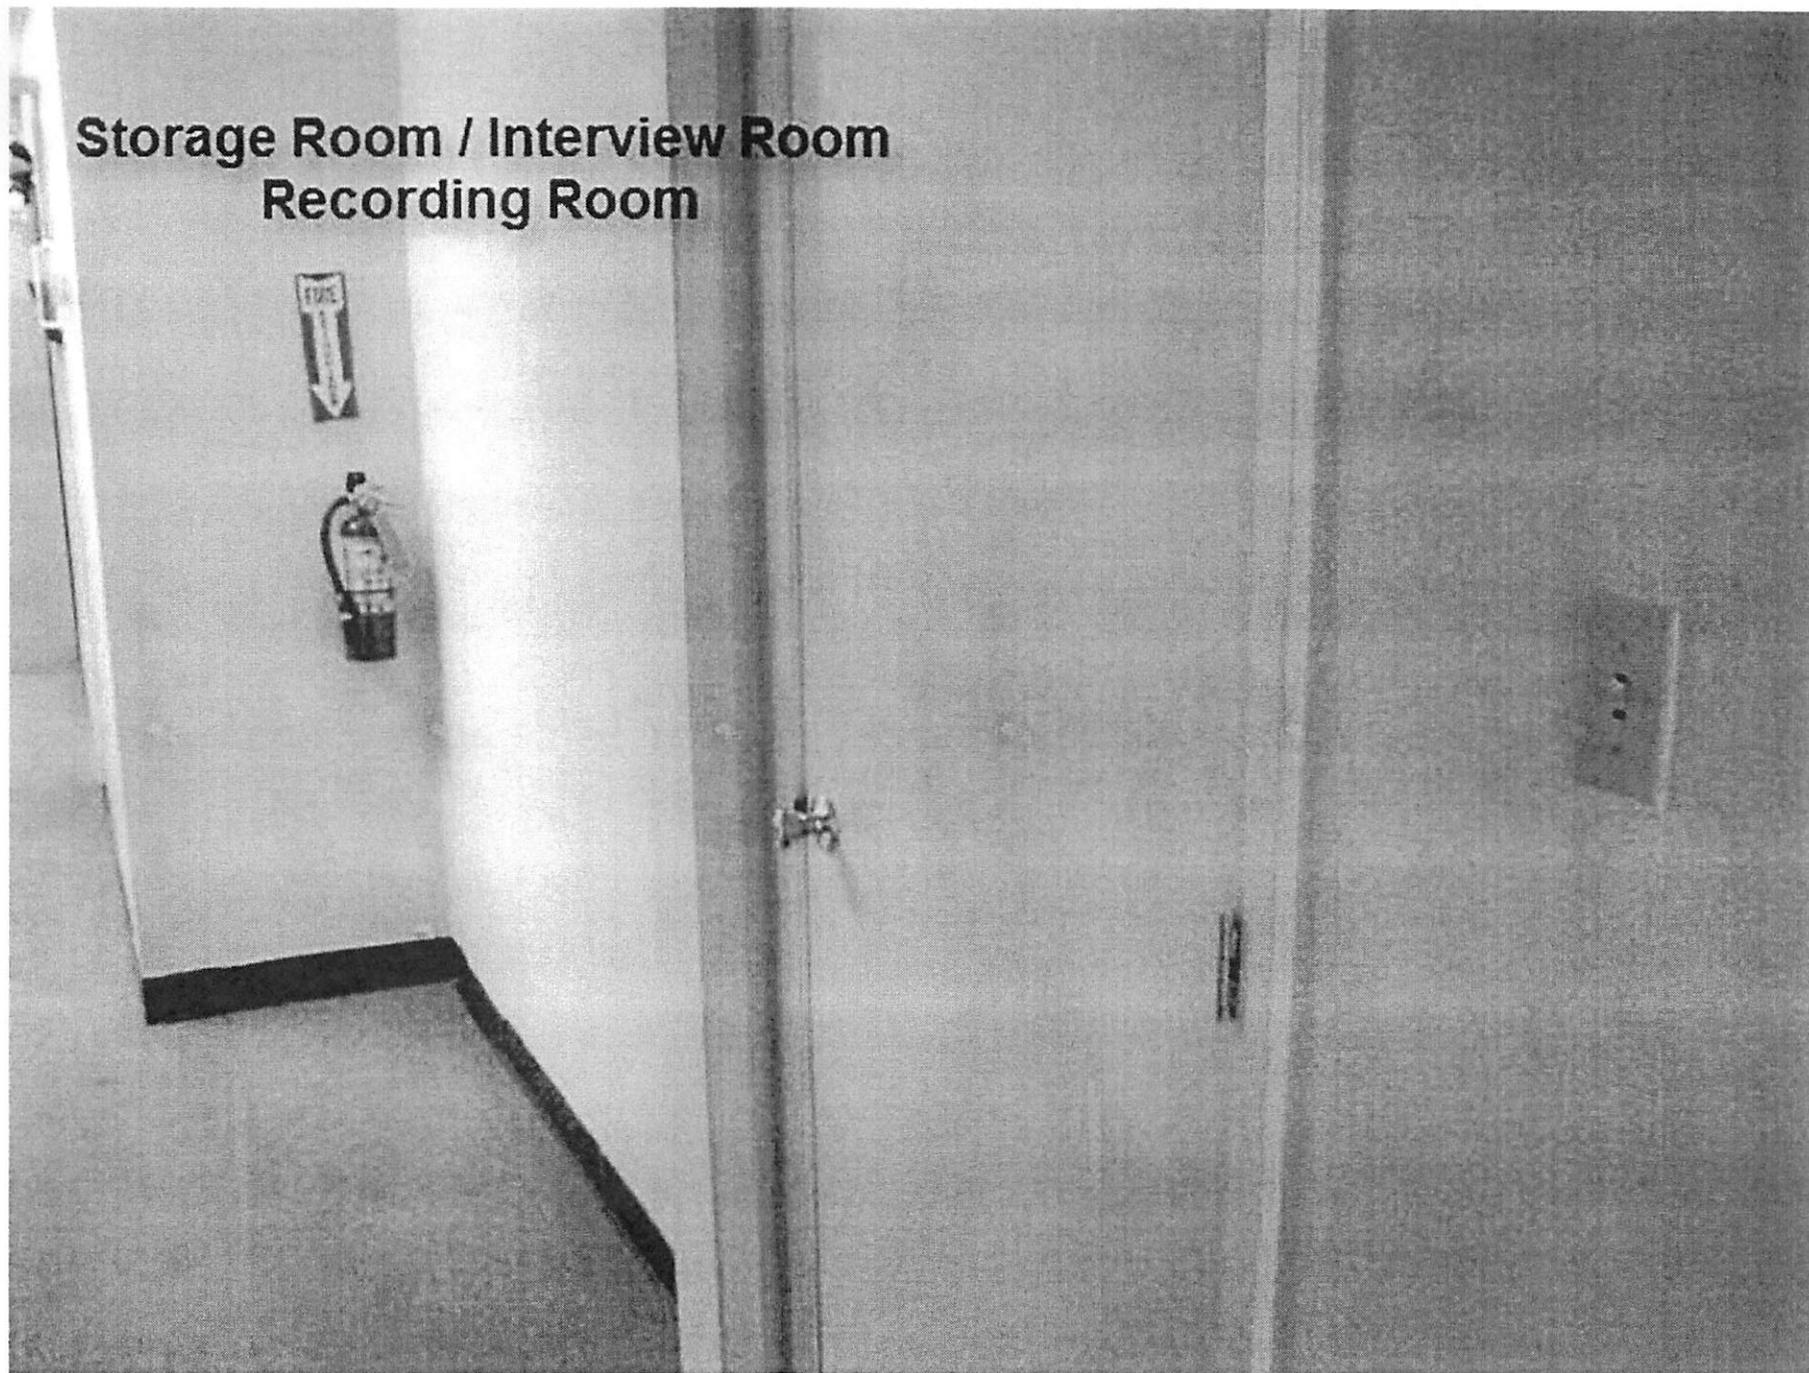
**Storage Room / Interview Room
Recording Room**

- The storage room next to the interview room doubles as the video equipment room. If other officers need to watch an interview they must crowd into a closet. The room is nowhere near sound proof and outside conversations, passing vehicles, and trains passing make some interviews unable to be heard or taint the interview.
