City of Santa Fe Police Department

Public Safety Building Needs Assessment

06/19/2008 - 10/25/2012

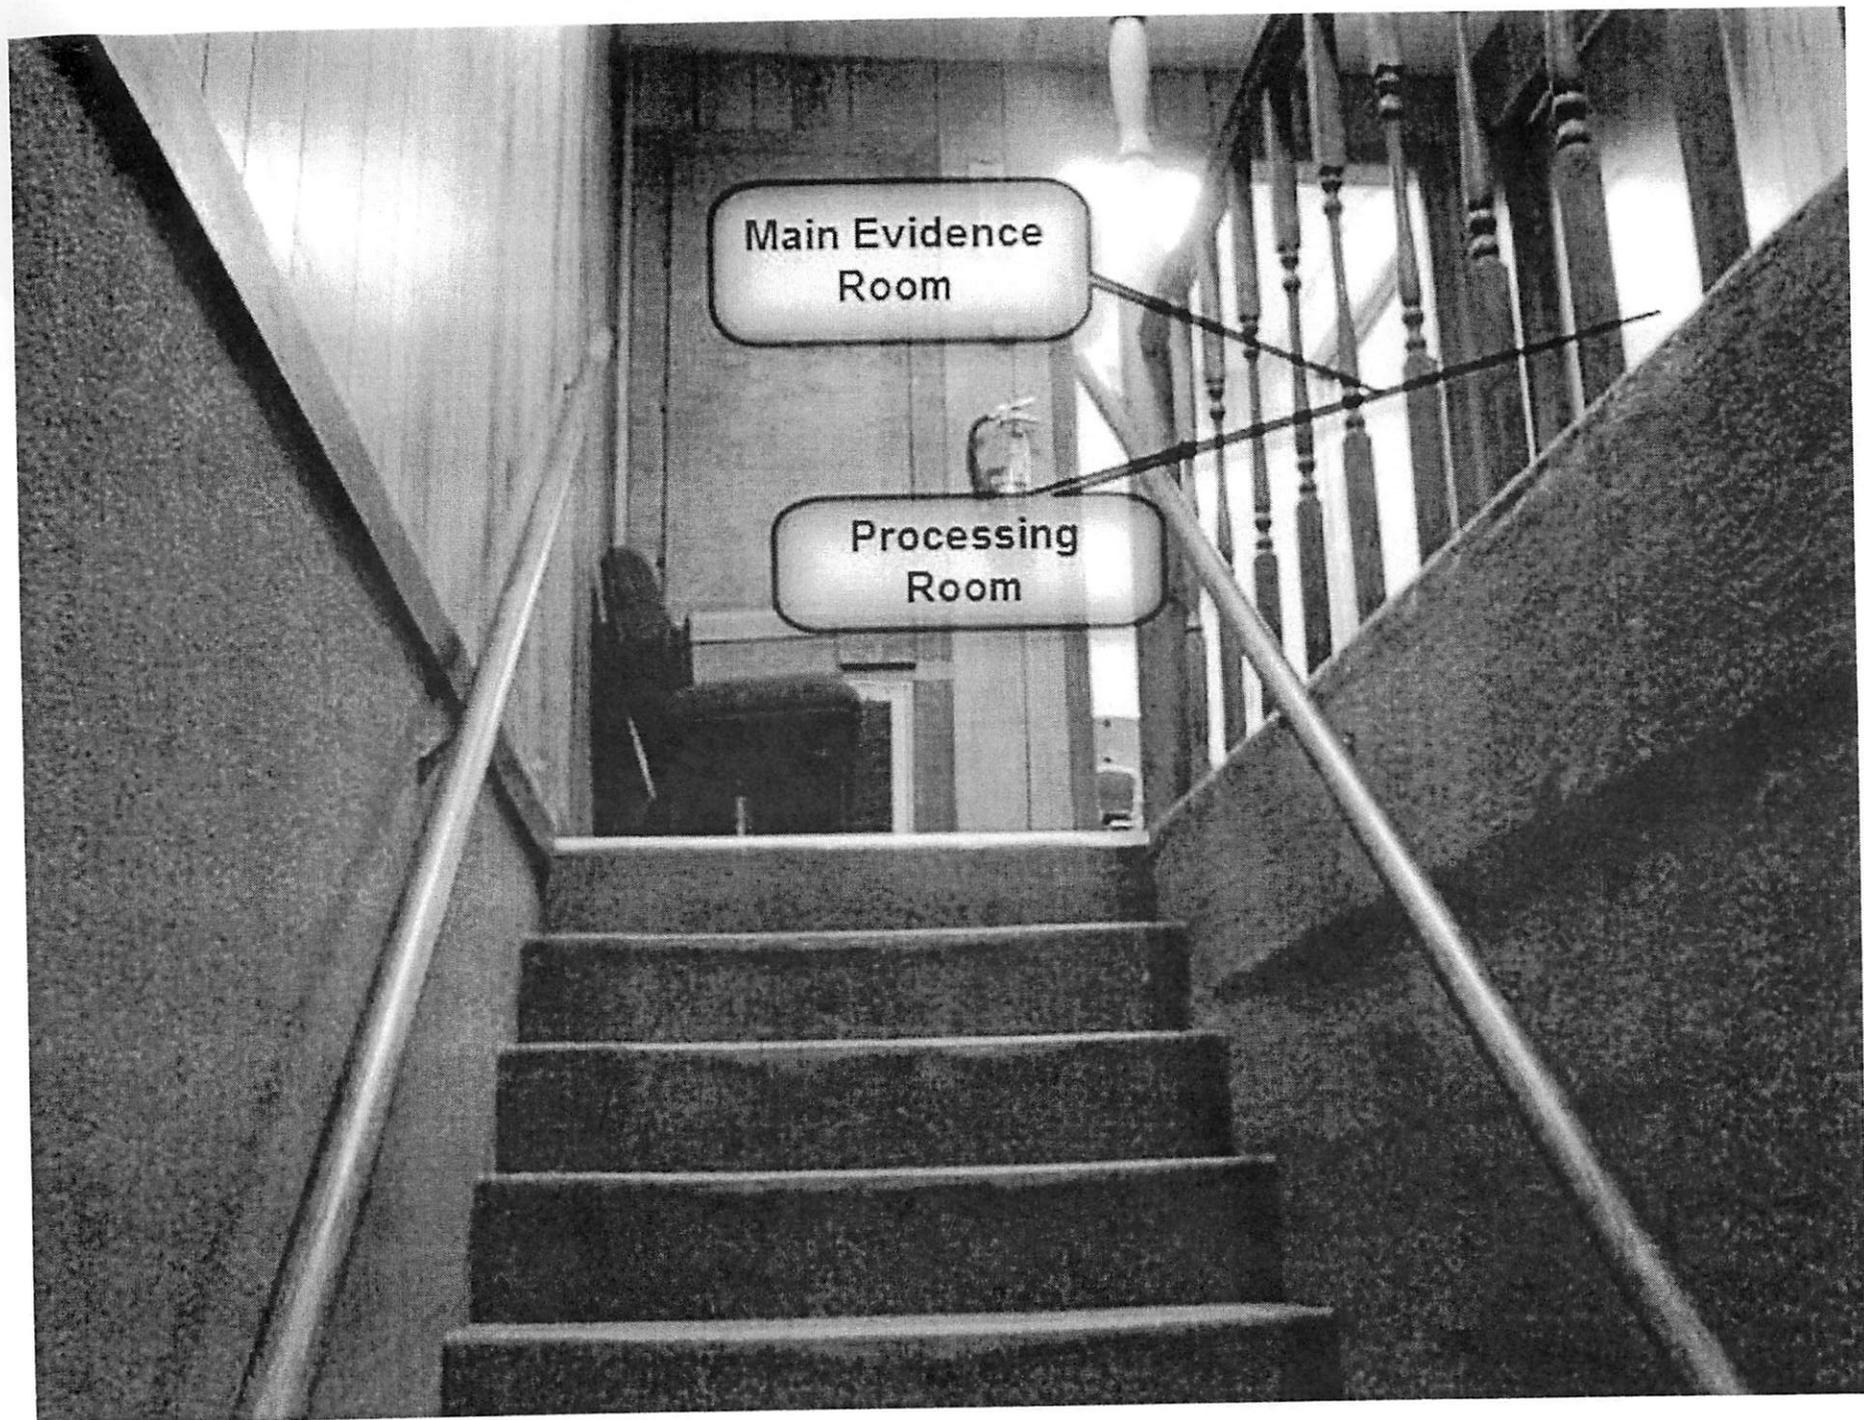
- It is impossible to carry heavy or long items up the stairs, as we learned recently with a stop sign and pole. The drop chute is too small and allows heavy evidence to crush other evidence. It is not secure and the dropped evidence can be reached from the outside. This is a grave concern when testifying to the integrity of the evidence room.

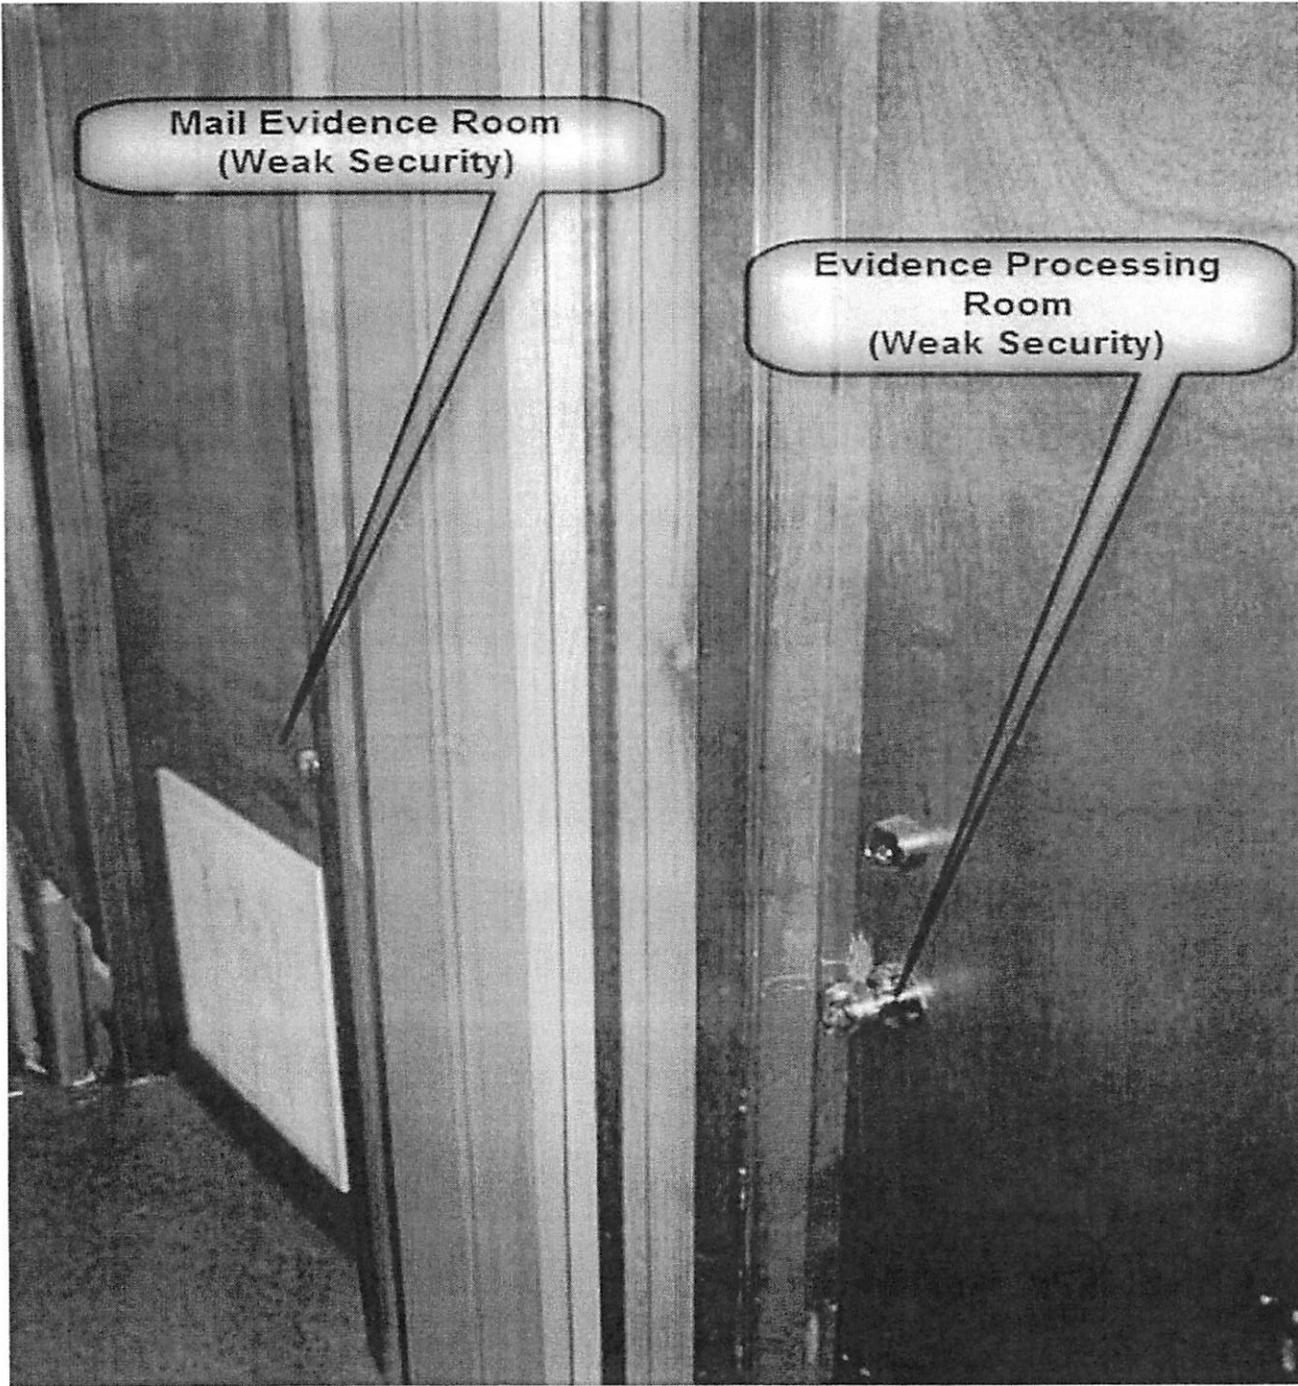
Mail Evidence Room
(Weak Security)

Evidence Processing
Room
(Weak Security)

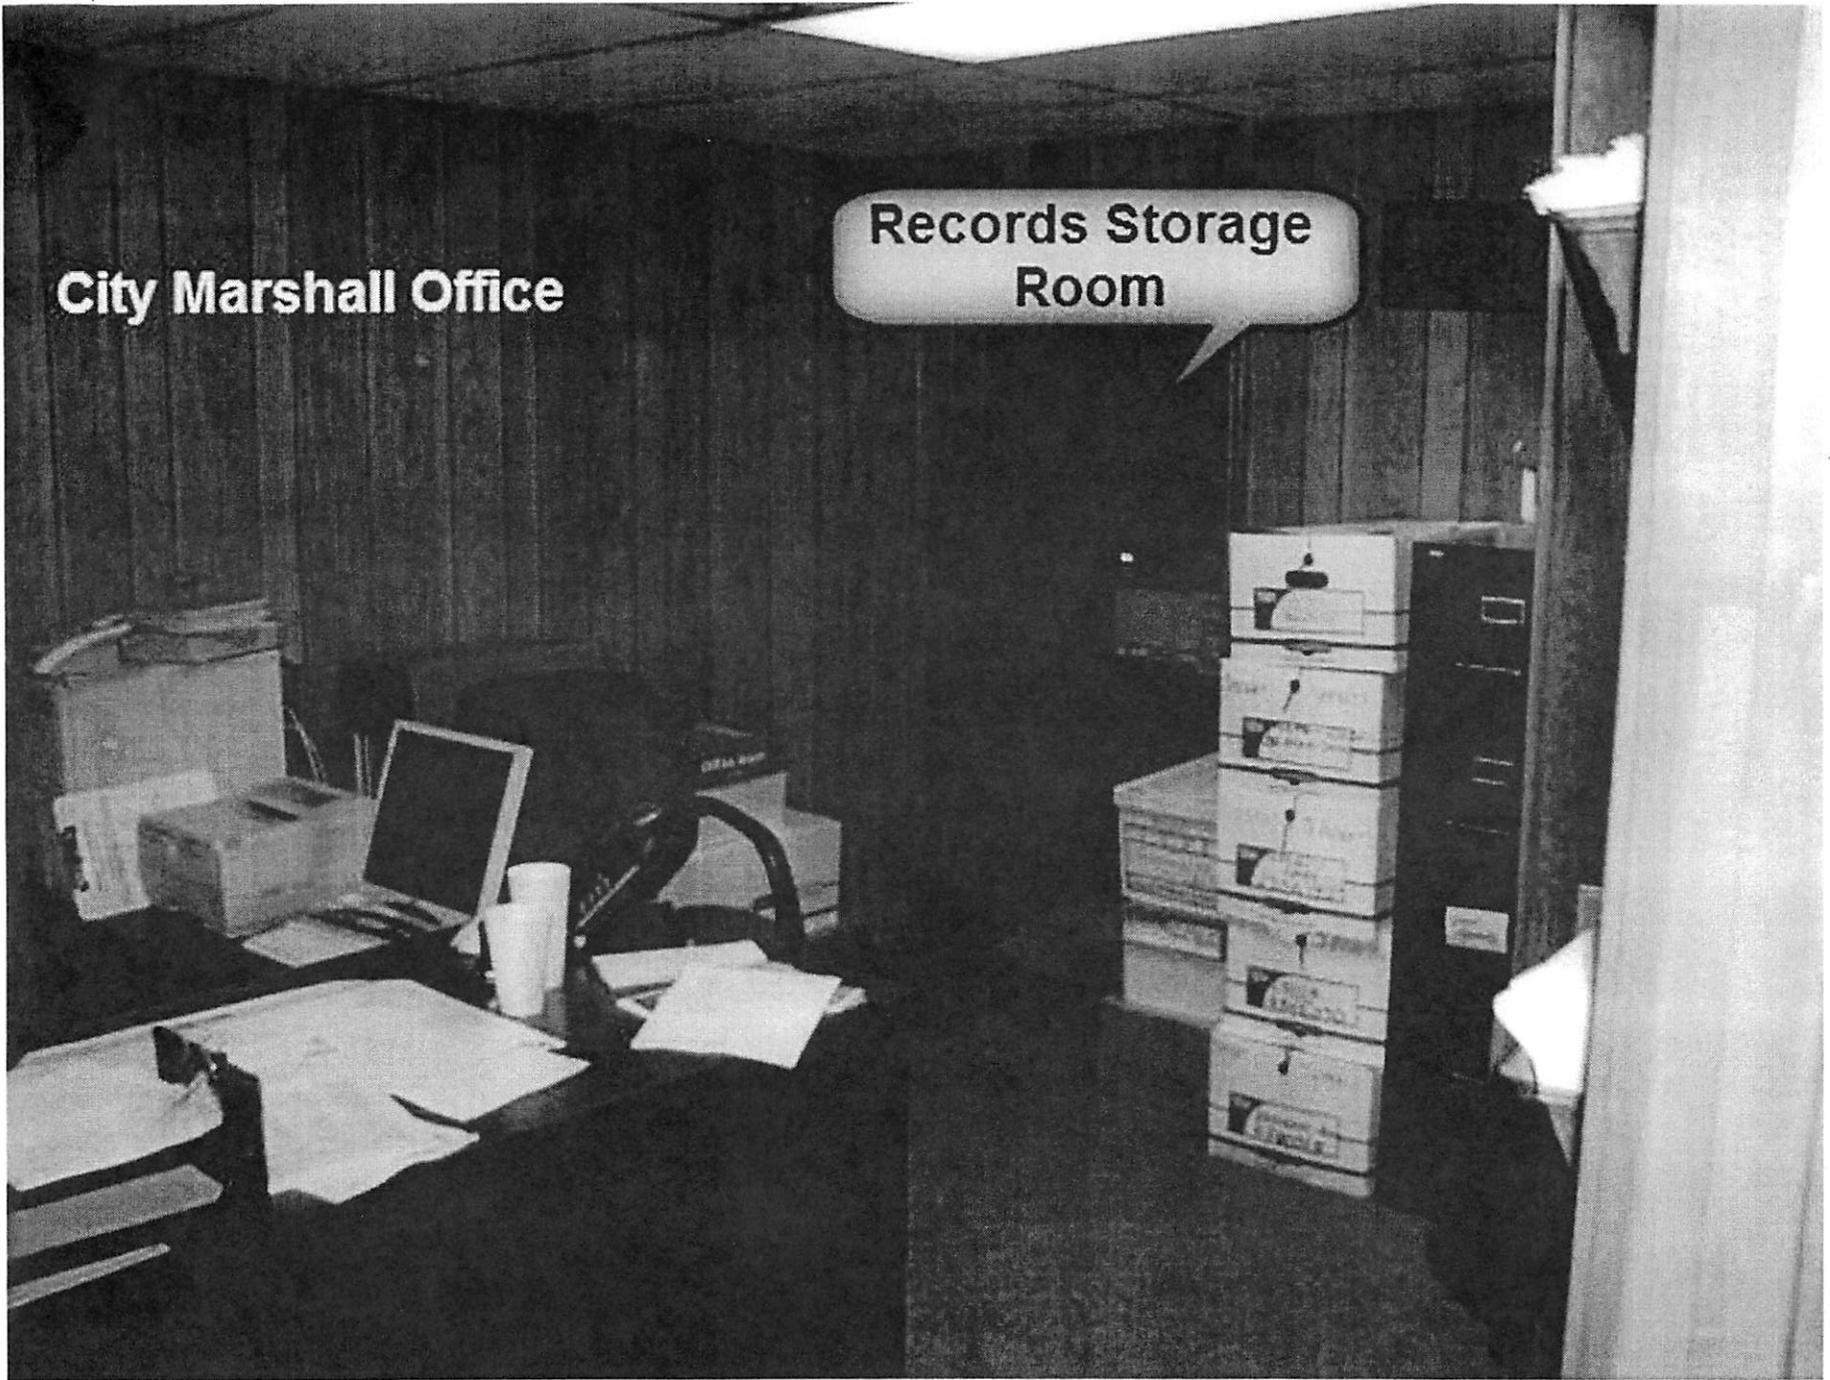
**Records Storage
Room**

- Our current records office is not large enough, causing many records to be stored upstairs on the east end, above the municipal court. This room not only serves as archive storage but also as storage for uniforms and equipment. This room is overcrowded and is currently a disgrace. We currently have to walk through the City Marshall's office to reach this room. A centralized records storage room needs to be added. The concern is again with a hurricane this part of the building will likely be destroyed.
