City of Santa Fe Police Department

Public Safety Building Needs Assessment

06/19/2008 - 10/25/2012

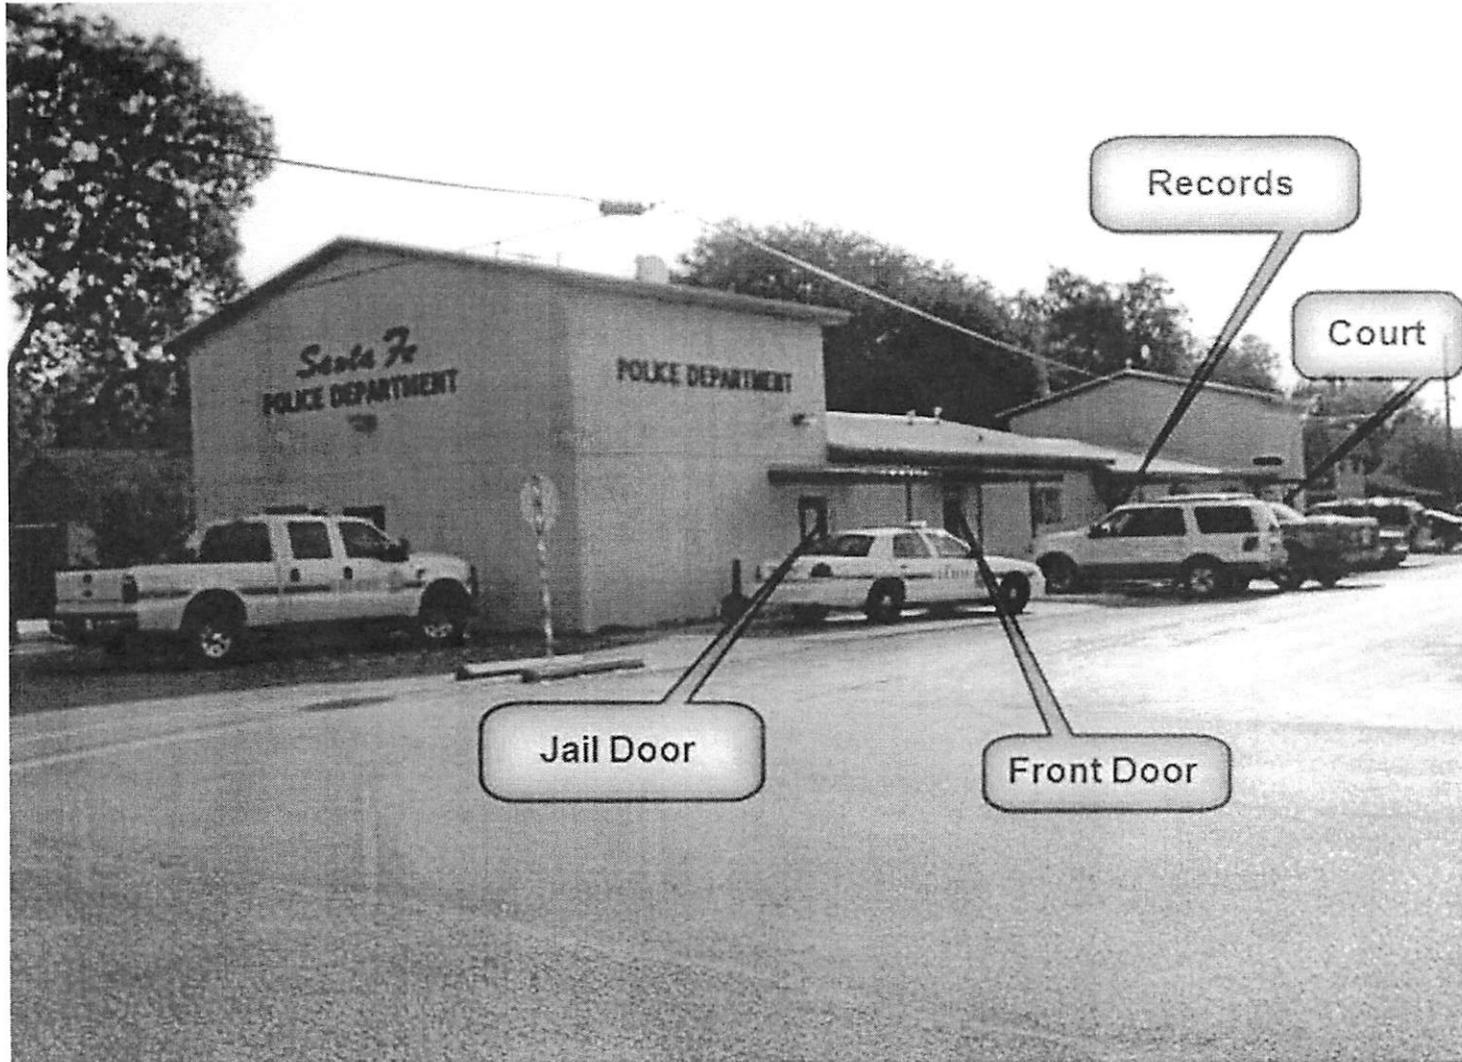
Overview of Access Points

- Limited Parking
 - Not enough office space
 - Not enough storage or work space
- Prisoner transport area unprotected, uncovered, and unsecure
- Evidence room is raised above rest of building and is vulnerable during a storm
 - Too many access points to building

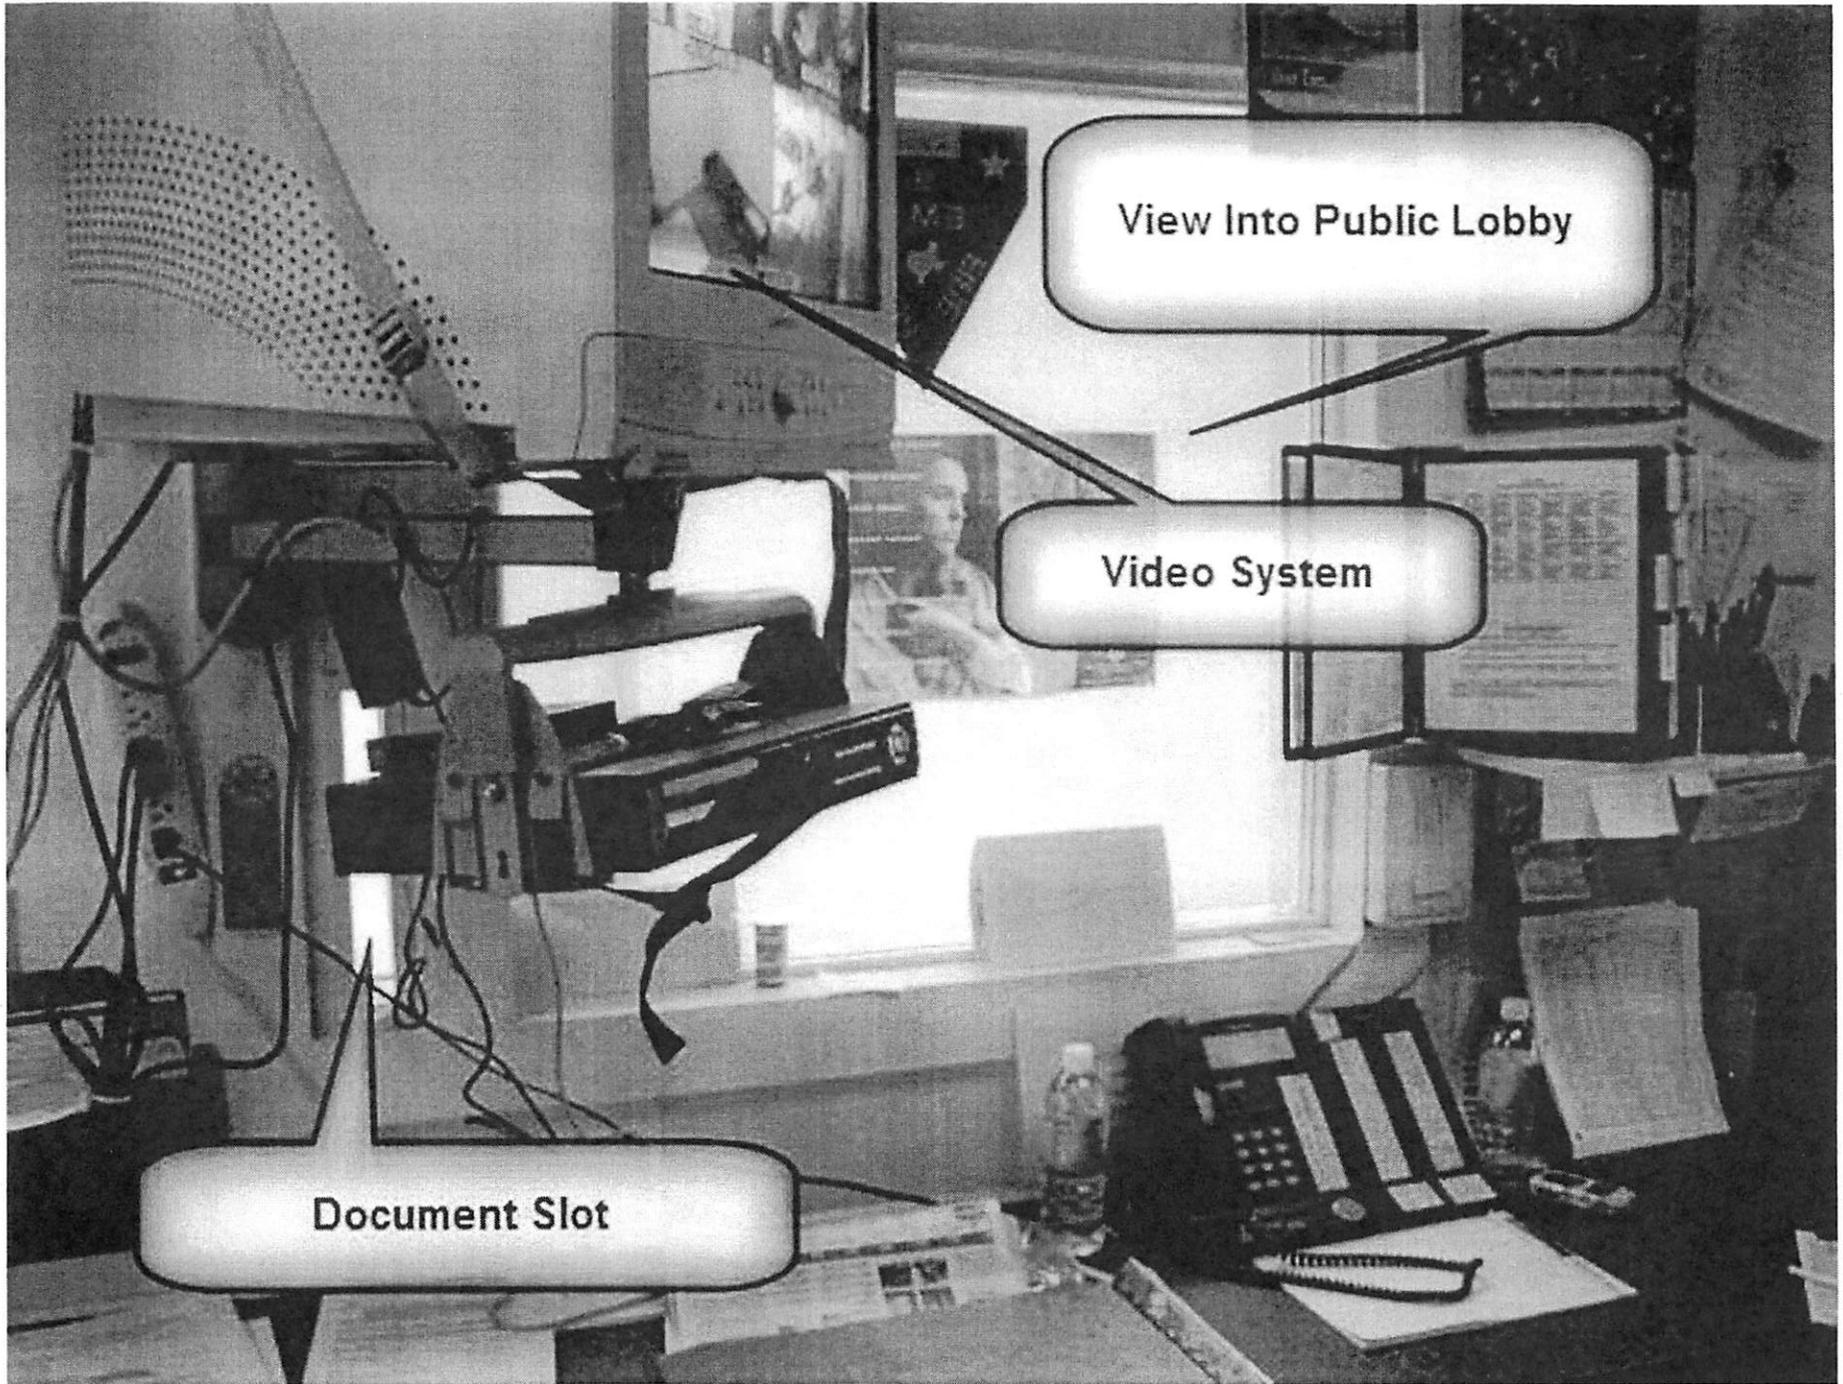
View Into Public Lobby

**Lobby Window
(Not Secure)**

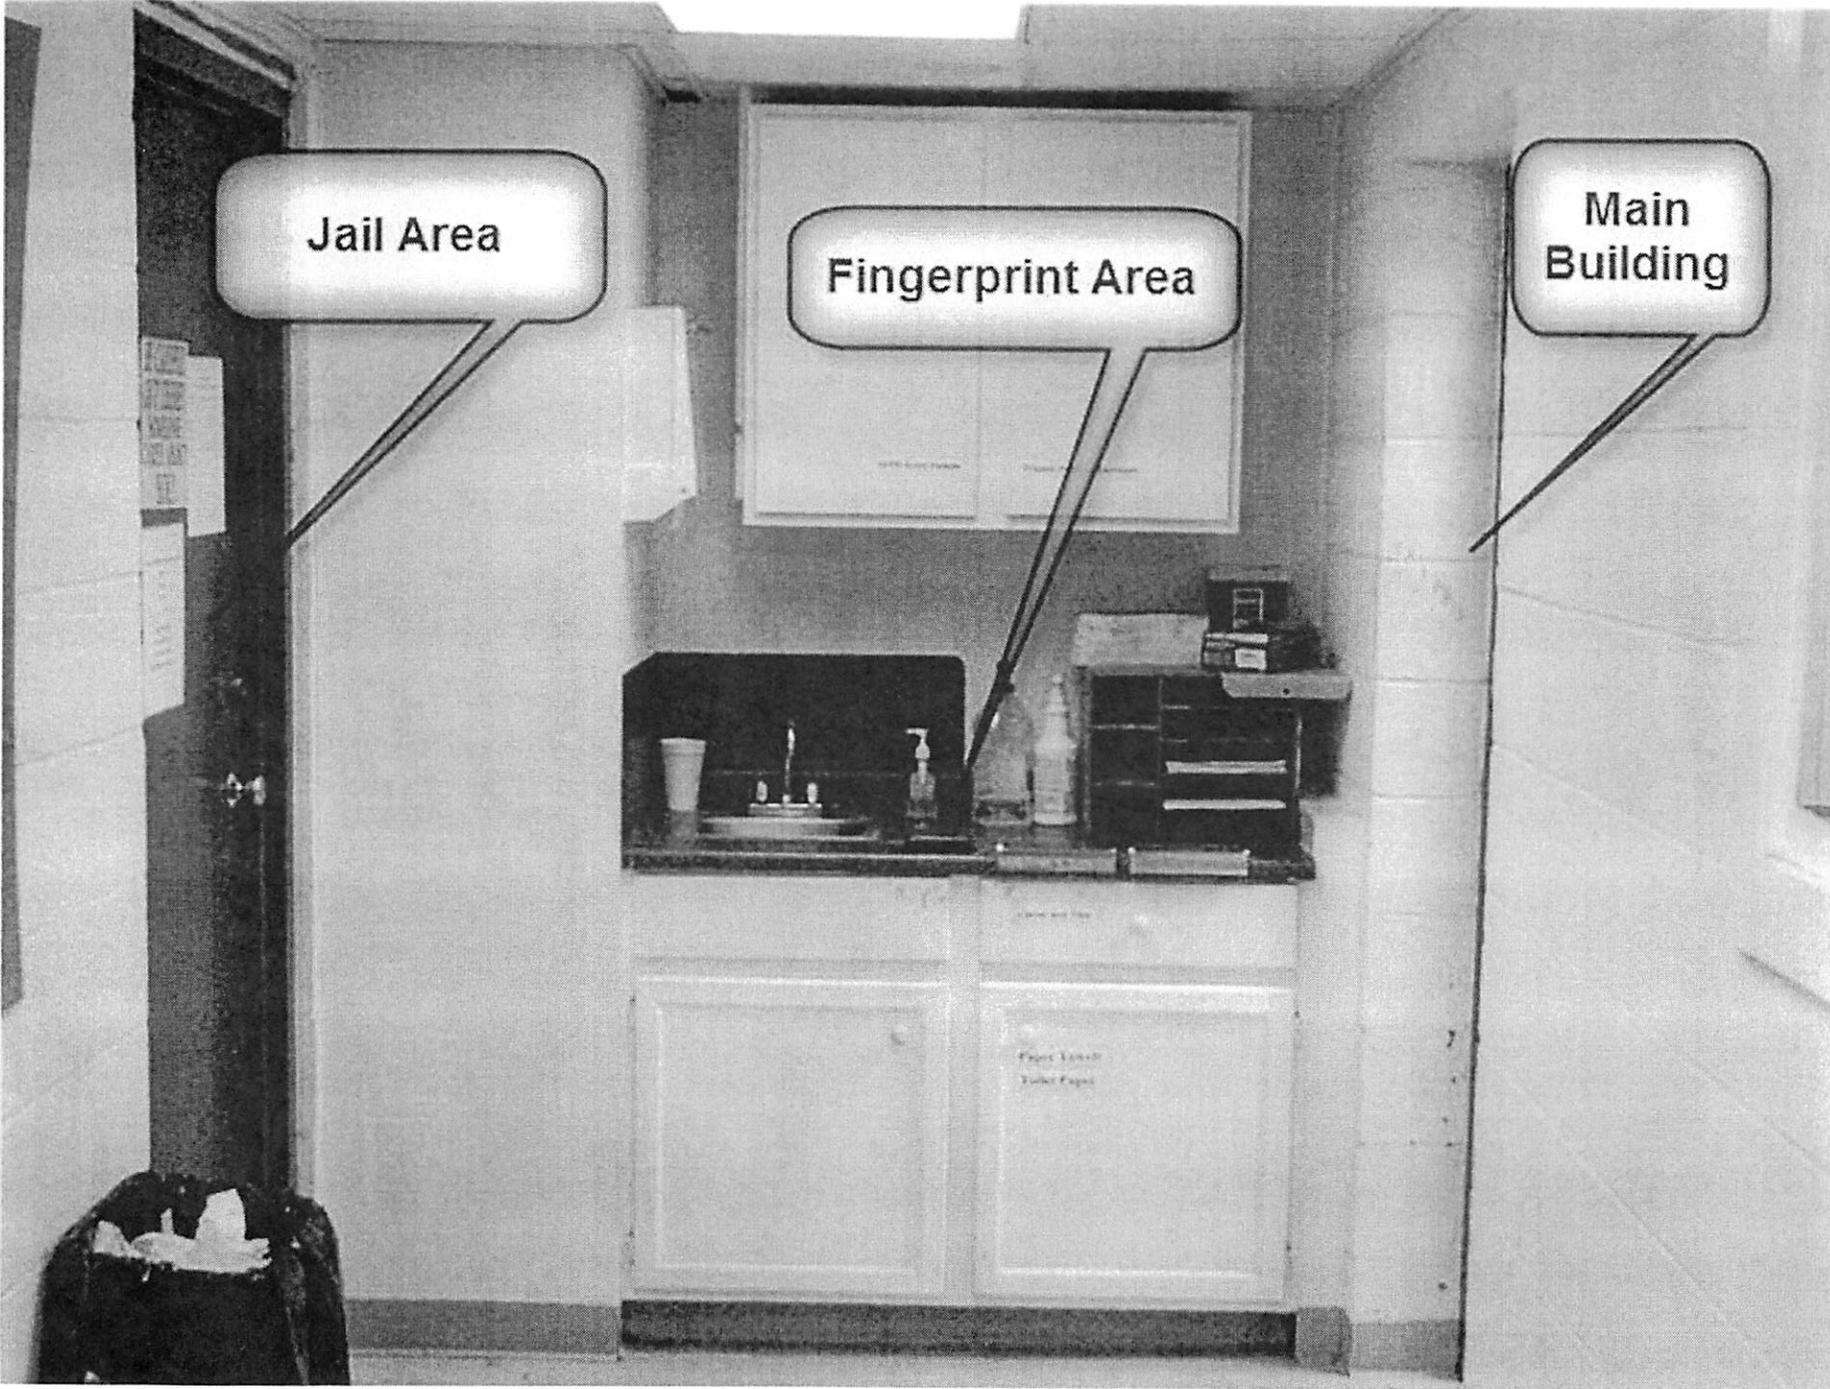
- Presently the booking area is too narrow and requires the officer to turn his back on the arrestee, which is a major officer safety issue. The gun locker is next to dispatch. The prisoner's property is secured in a simple metal locker, and there are often times more prisoners than lockers. This has proven to be a problem with property being mixed and property being misplaced. The fingerprint station is in between the door to the main building and the door to the jail, this is another officer safety issue, especially if there are multiple arrestees present. The booking entrance door from outside is accessible to the public and is not very secure.

6' X 18'

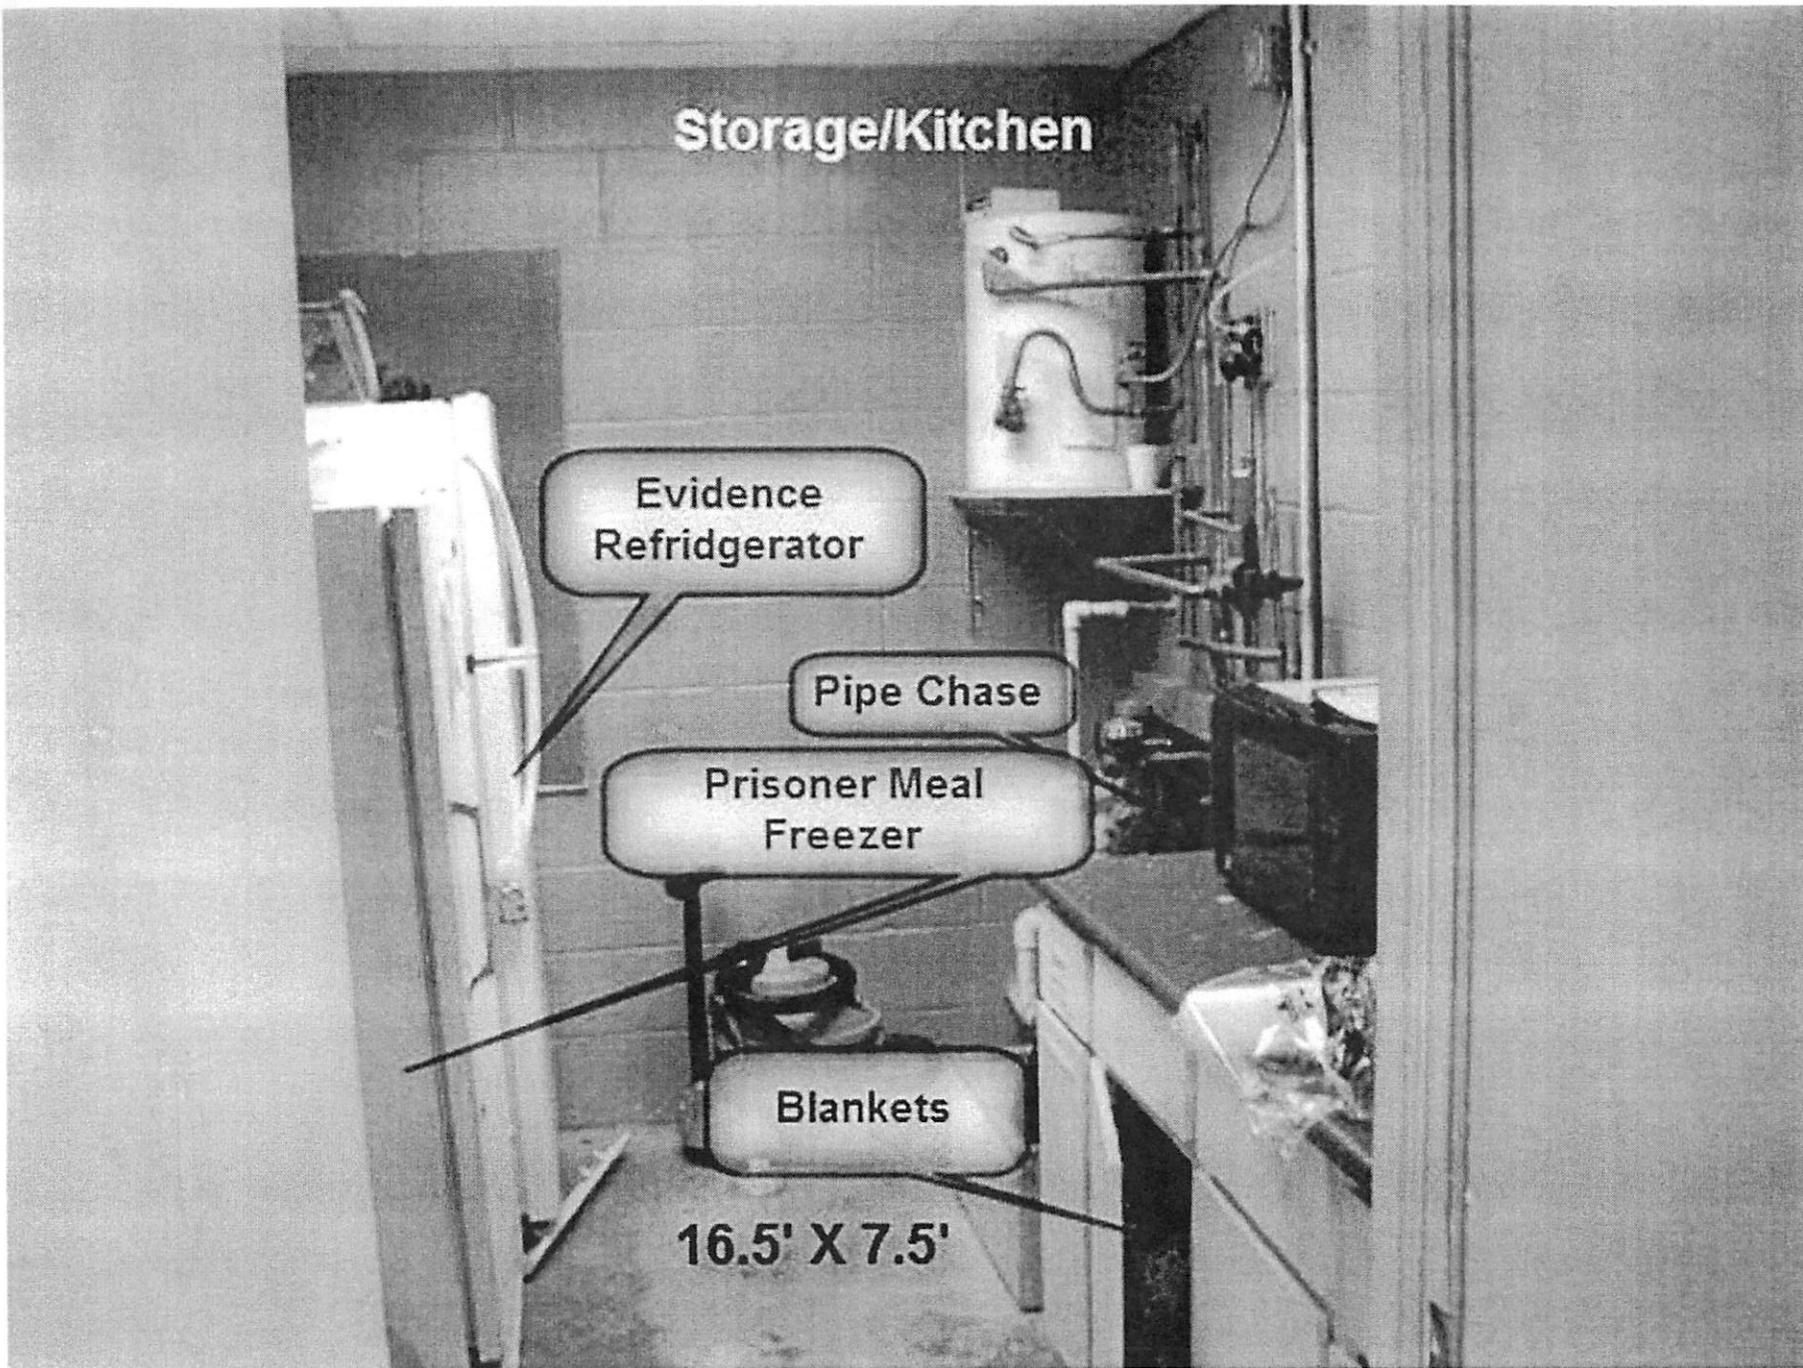
Storage/Kitchen

Evidence
Refridgerator

16.5' X 7.5'

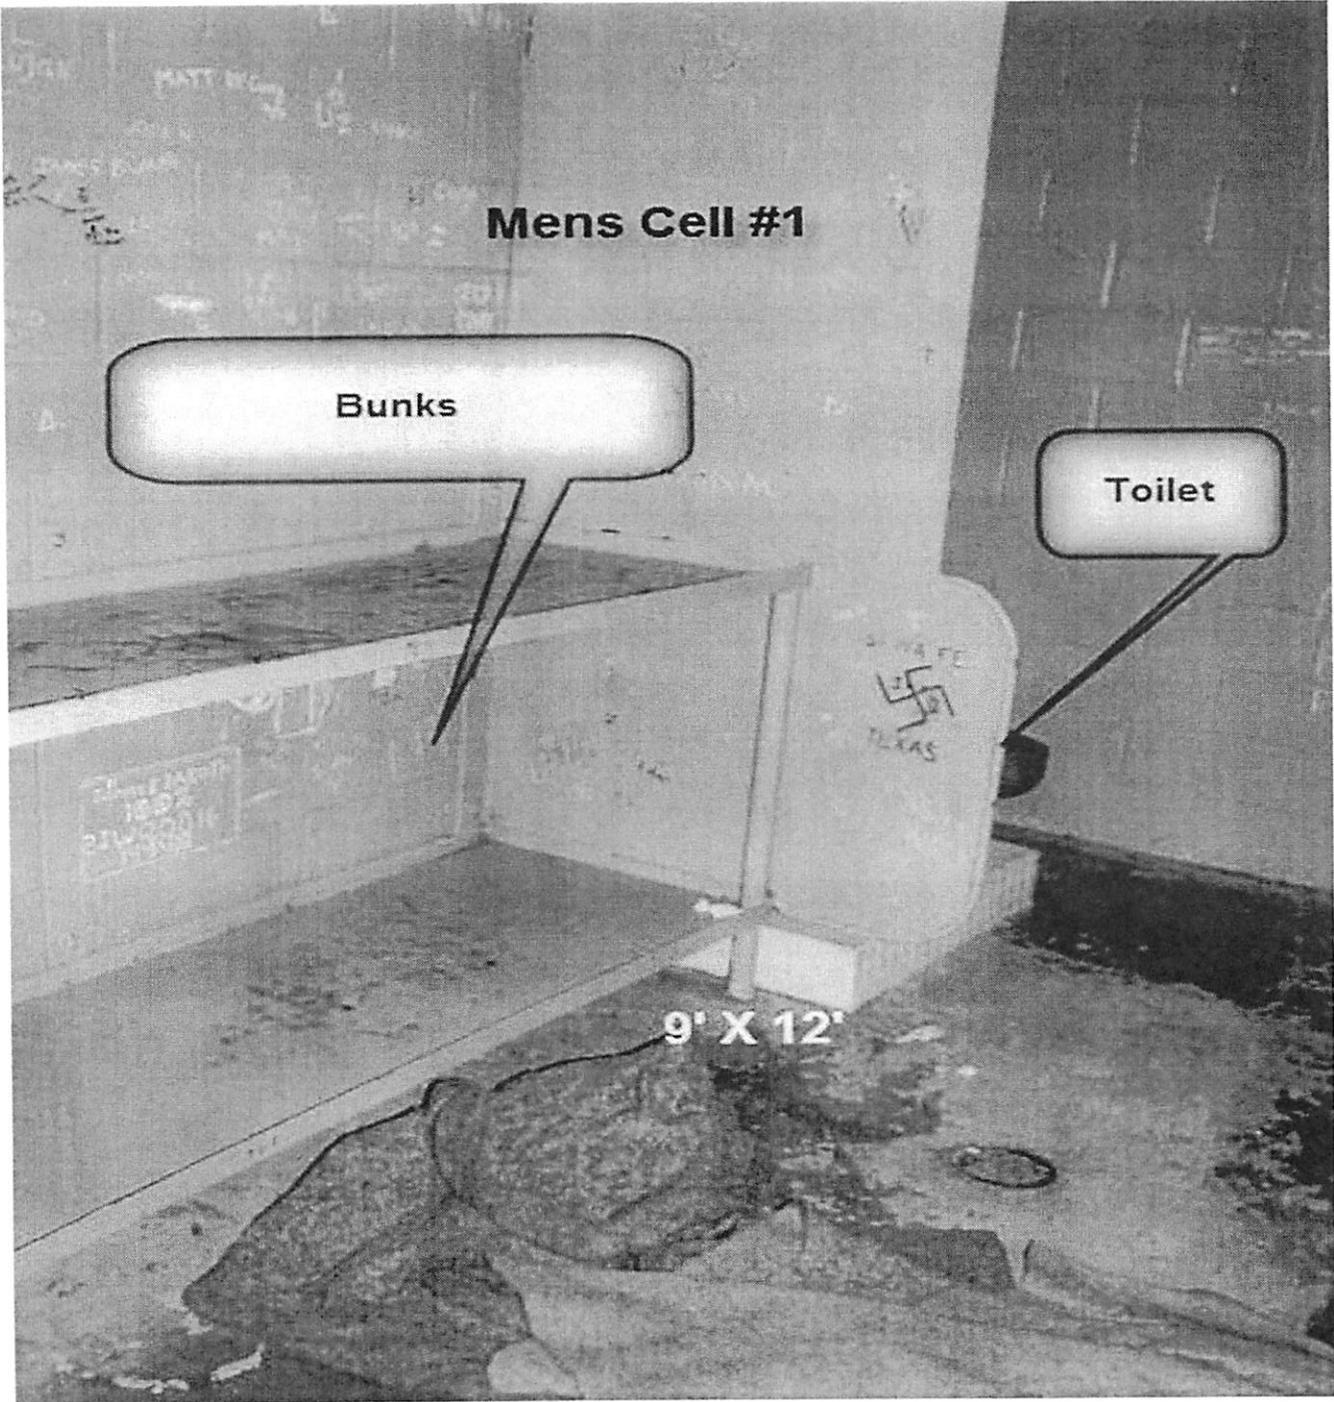
Mens Cell #1

- Currently we have three jail cells, two male and one female. The cells are designed to accommodate two prisoners per cell. More often than not we have at least four people in each cell, requiring at least two per cell to be on the floor. The jail needs to be updated in its fixtures, jail access, lighting, bunks, and size. There is no juvenile cell. The storage area in the jail triples as the jail kitchen and has an evidence cold storage refrigerator in it.

9' X 12'

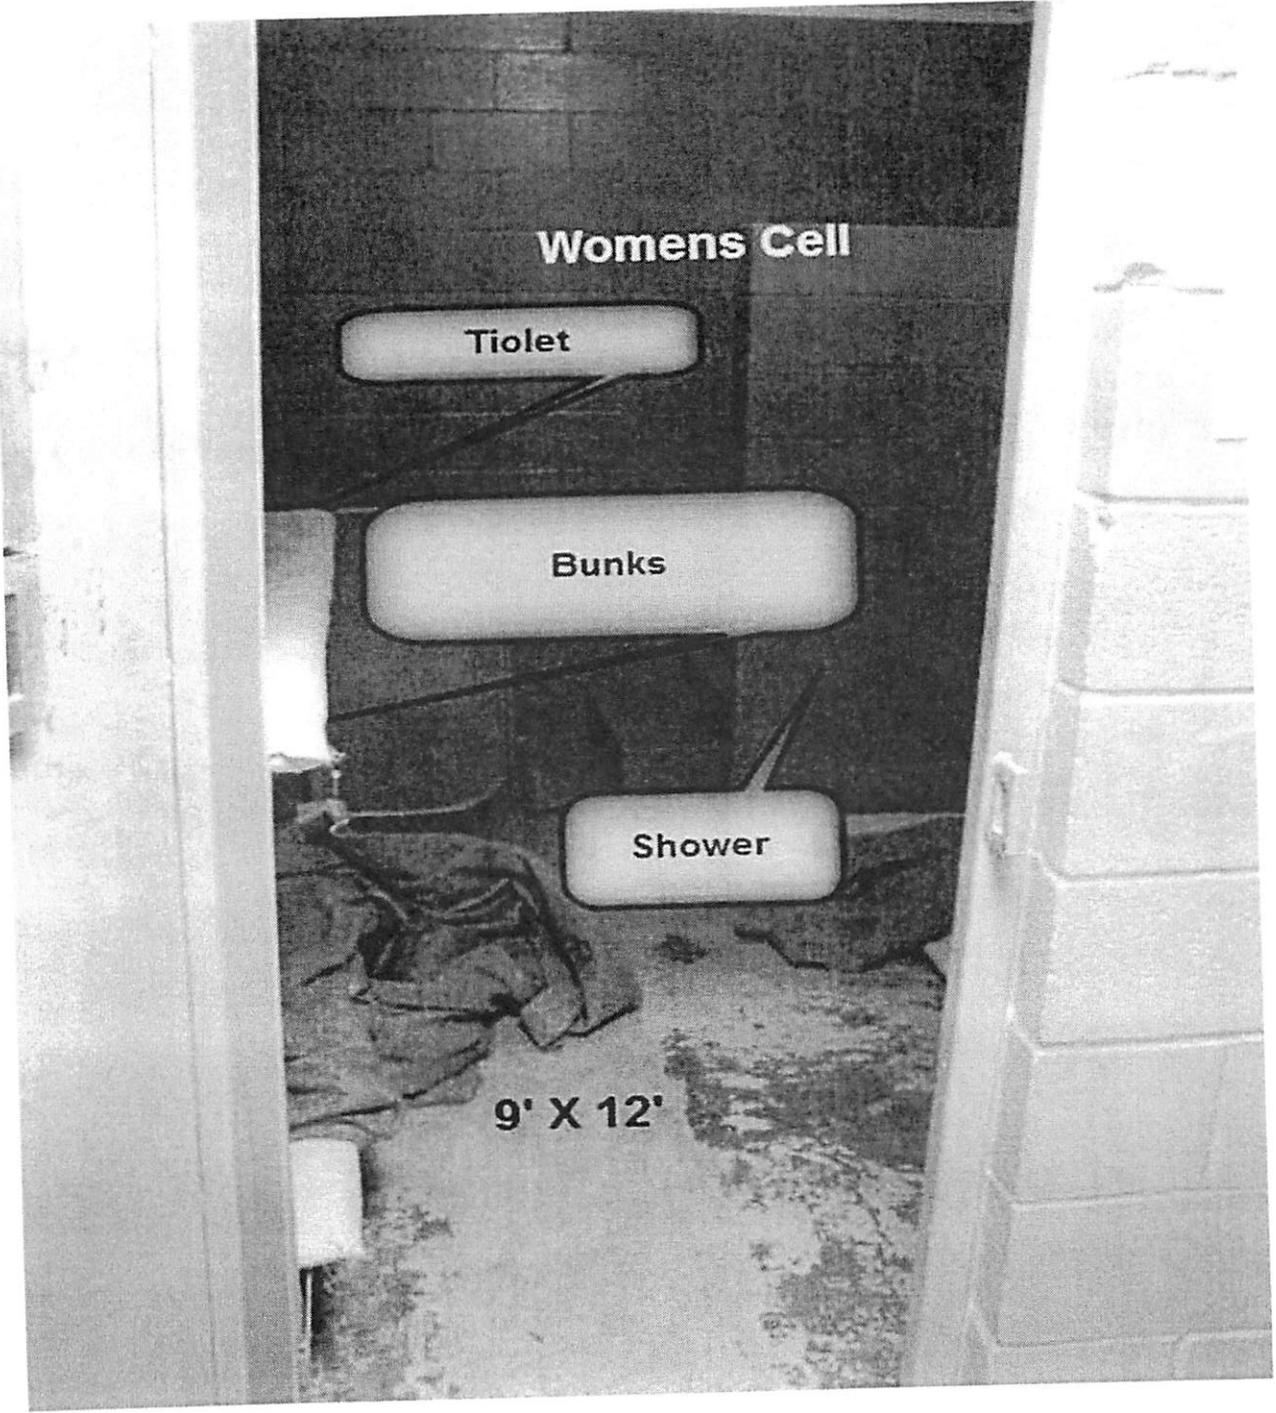
Womens Cell

9' X 12'

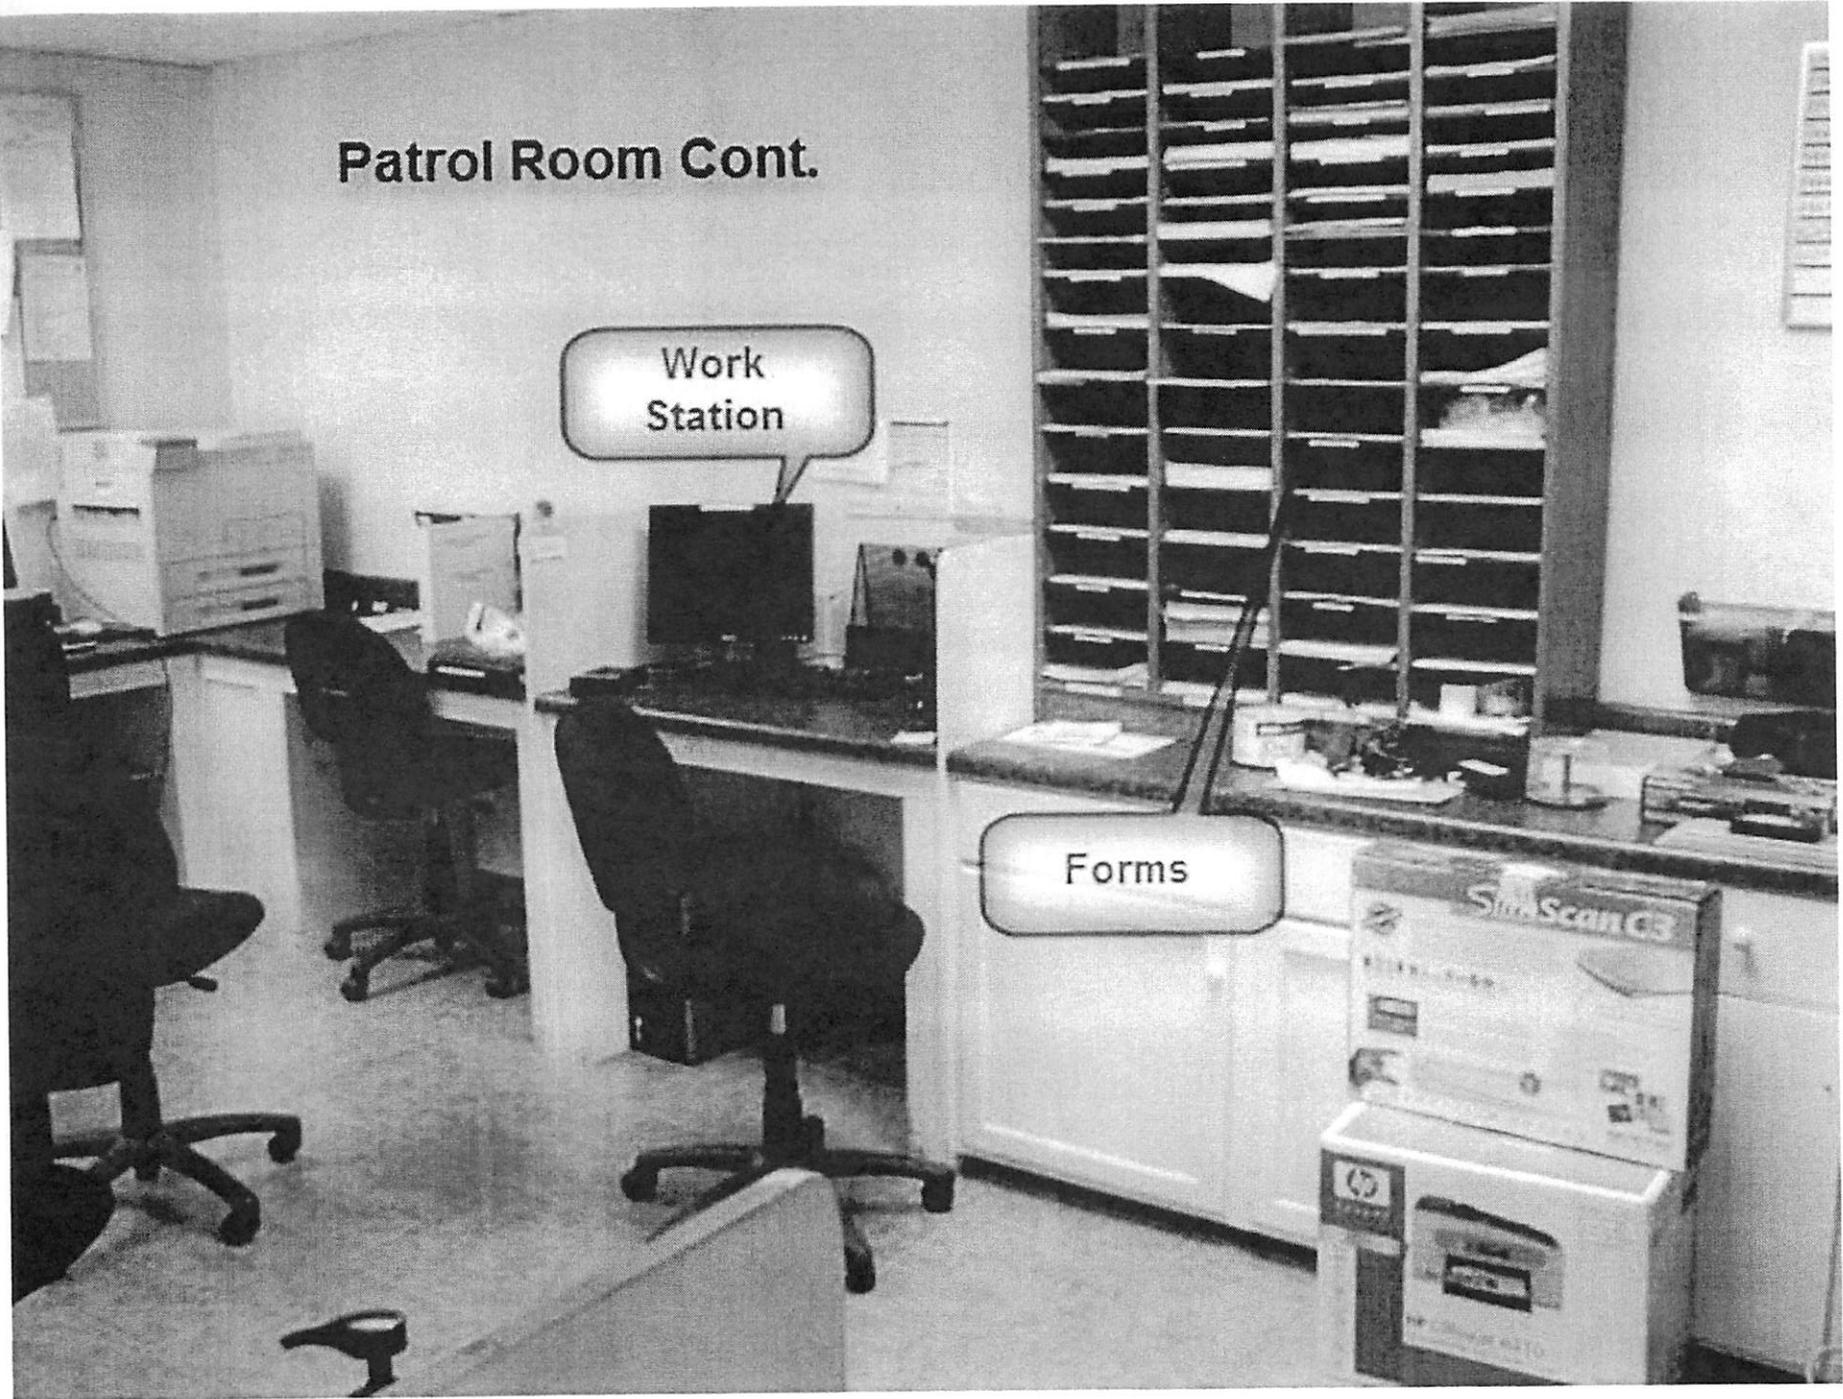
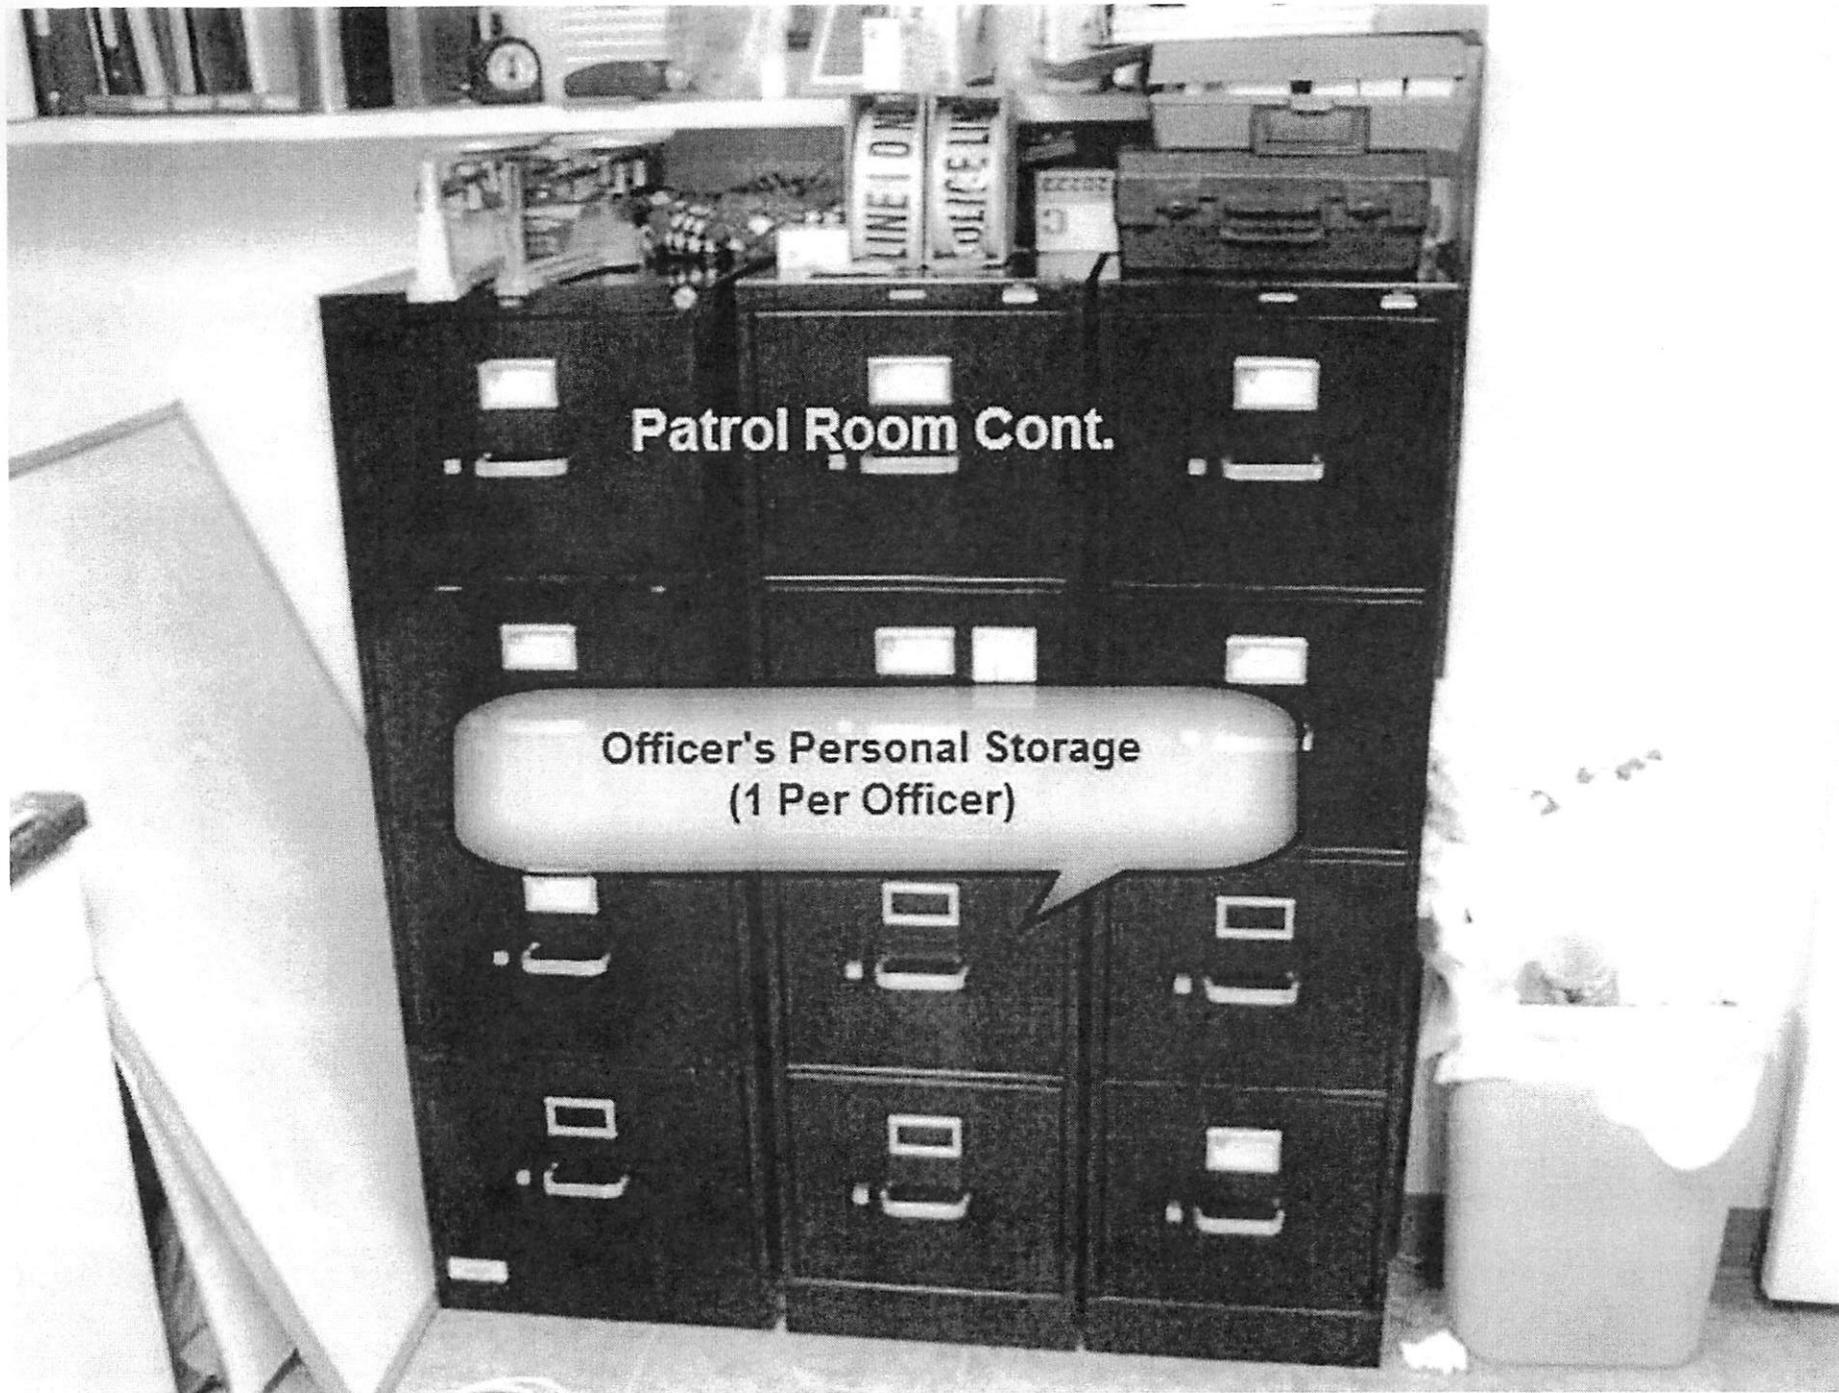
Patrol Room Cont.

- The patrol room was expanded in 2006 to accommodate the eight patrol officers. We now have sixteen and hope to have more added in the future. This was done to give each officer his own work space so they would not be on top of each other. We simply do not have enough room for officers who are investigating crimes, speaking with complainants, victims, witnesses or suspects. This could compromise a persons civil rights in certain cases.

**Officer's Personal Storage
(1 Per Officer)**

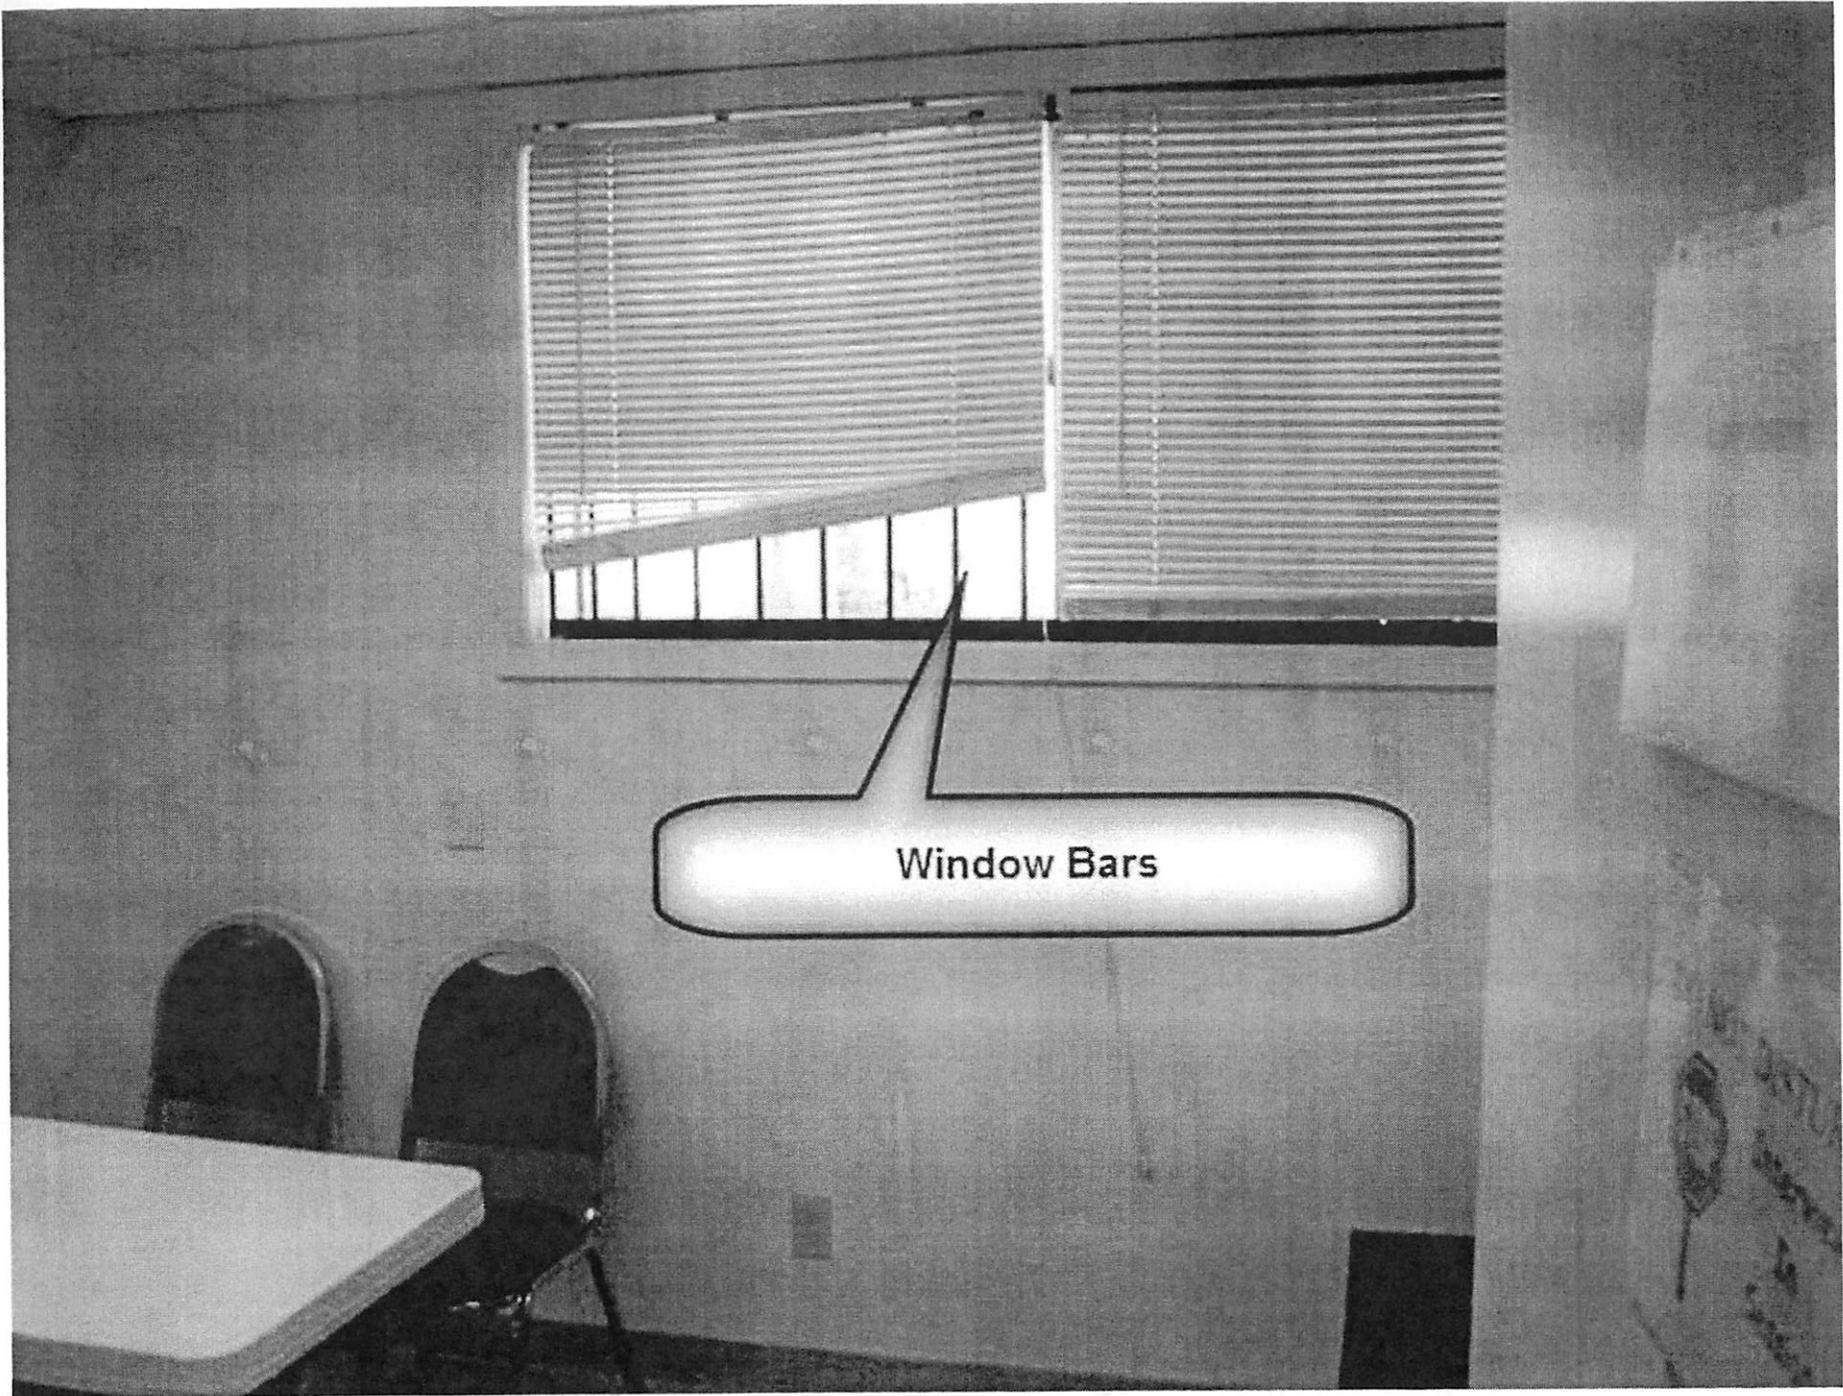
- Currently we have only one interview room which doubles as the juvenile holding room. Large incidents and investigations usually require multiple people to be interviewed at one time, and or separated into different rooms, which is not possible with the space we have now, jeopardizing the integrity and interview evidence of a case. It has a camera, with audio, and it has home made bars on the window. The only way to secure the room is to lock the door from the outside, and this is a flimsy lock at best.

Window Bars
