City of Santa Fe Police Department

Public Safety Building Needs Assessment

06/19/2008 - 10/25/2012

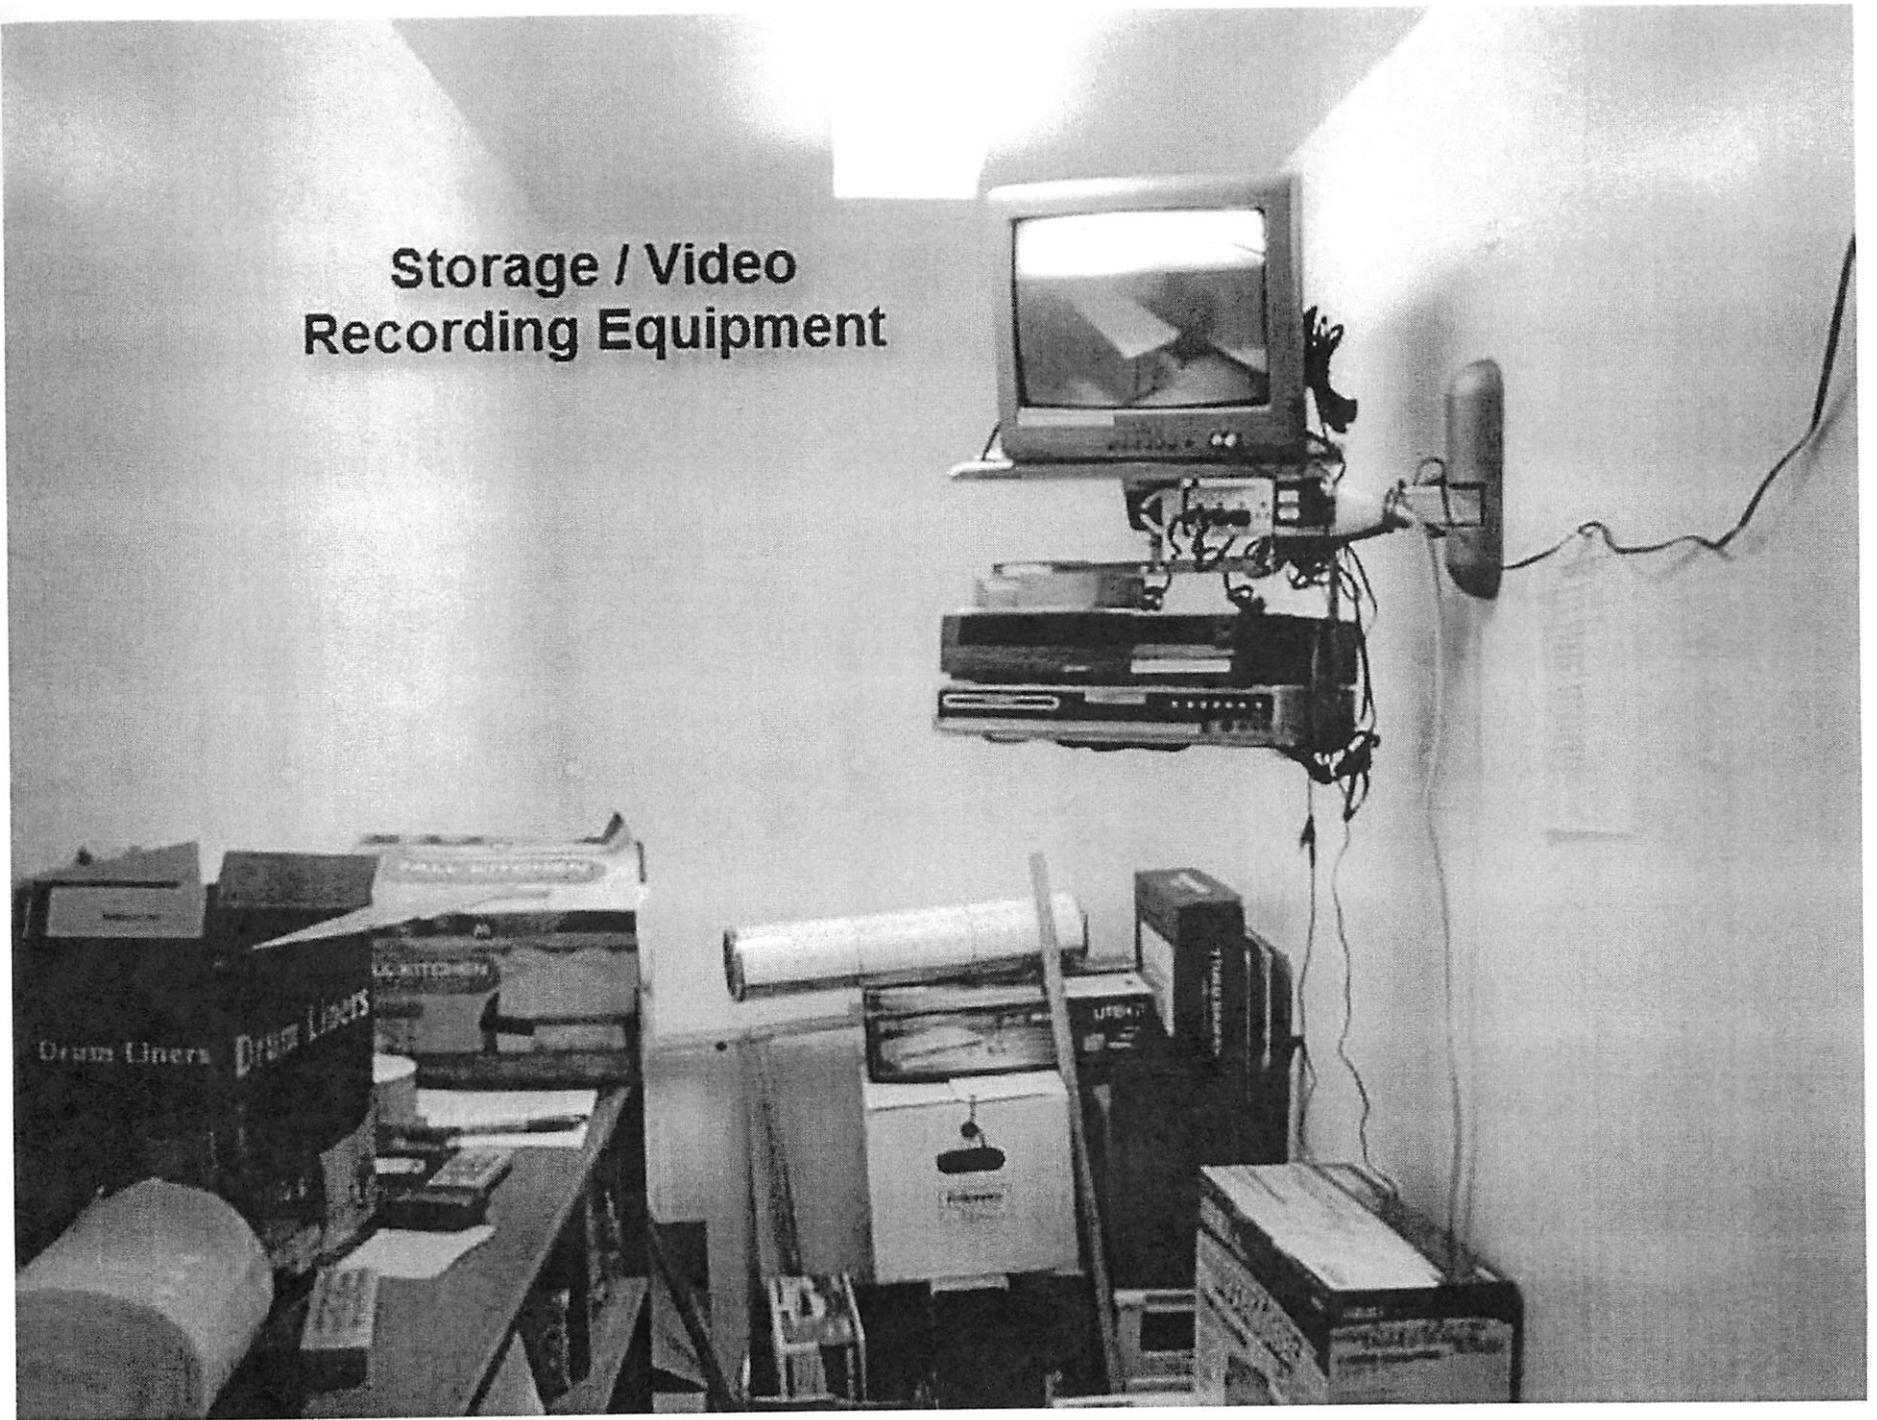
**Storage / Video
Recording Equipment**

- The storage room next to the interview room doubles as the video equipment room. If other officers need to watch an interview they must crowd into a closet. The room is nowhere near sound proof and outside conversations, passing vehicles, and trains passing make some interviews unable to be heard or taint the interview.

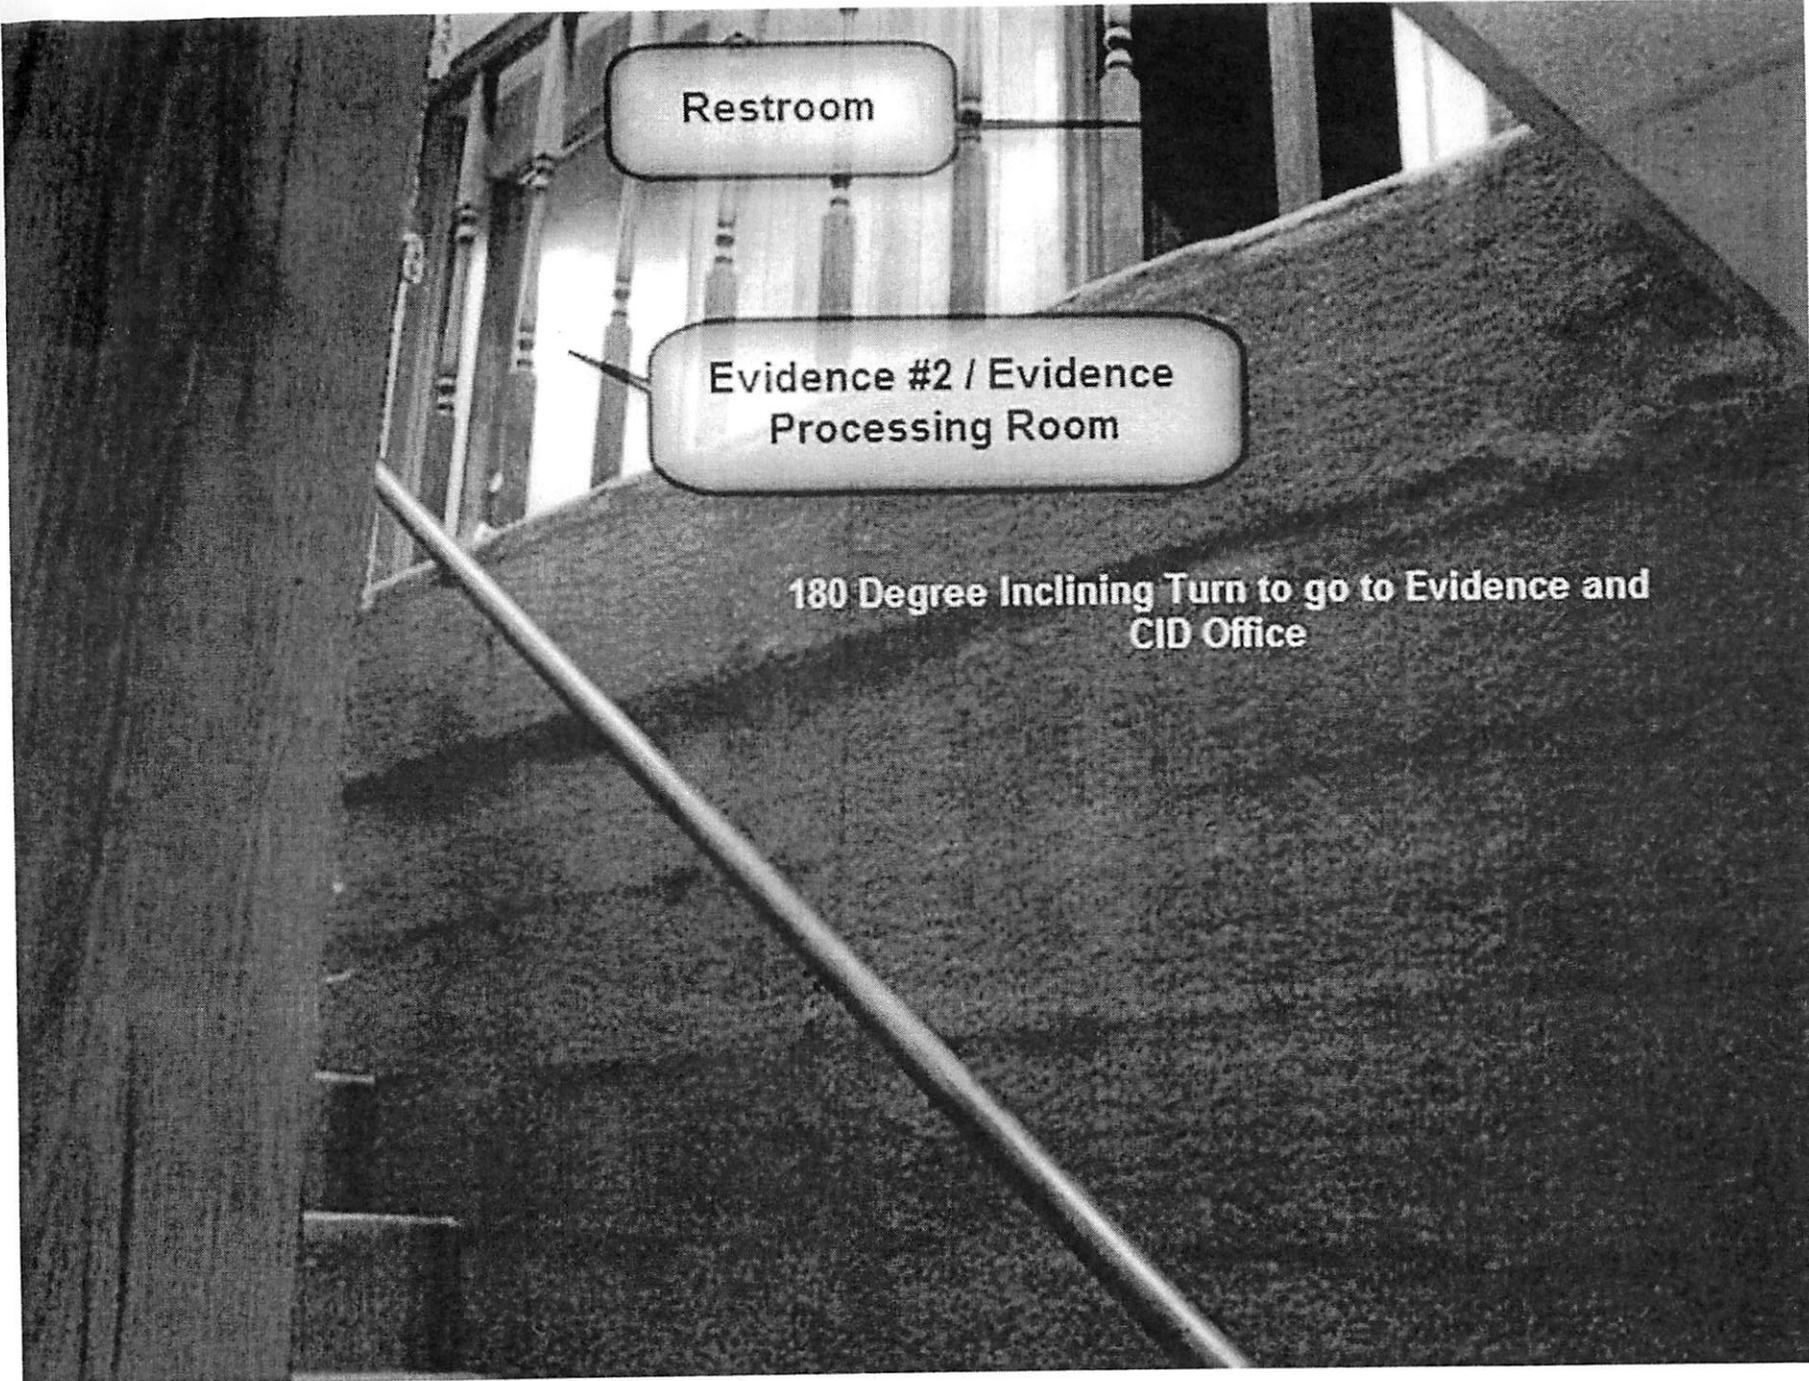
- The evidence room is one of the major concerns. The evidence room is located upstairs on the west end of the building. The evidence room is only secured by a simple deadbolt lock. There is a small area in the adjacent room for processing evidence, this is no where near adequate. Storage space is very limited and the design of the evidence room is poor at best. The evidence room being on the second floor is a concern because a major storm will probably destroy that part of the building.

- It is impossible to carry heavy or long items up the stairs, as we learned recently with a stop sign and pole. The drop chute is too small and allows heavy evidence to crush other evidence. It is not secure and the dropped evidence can be reached from the outside. This is a grave concern when testifying to the integrity of the evidence room.

180 Degree Inclining Turn to go to Evidence and
CID Office

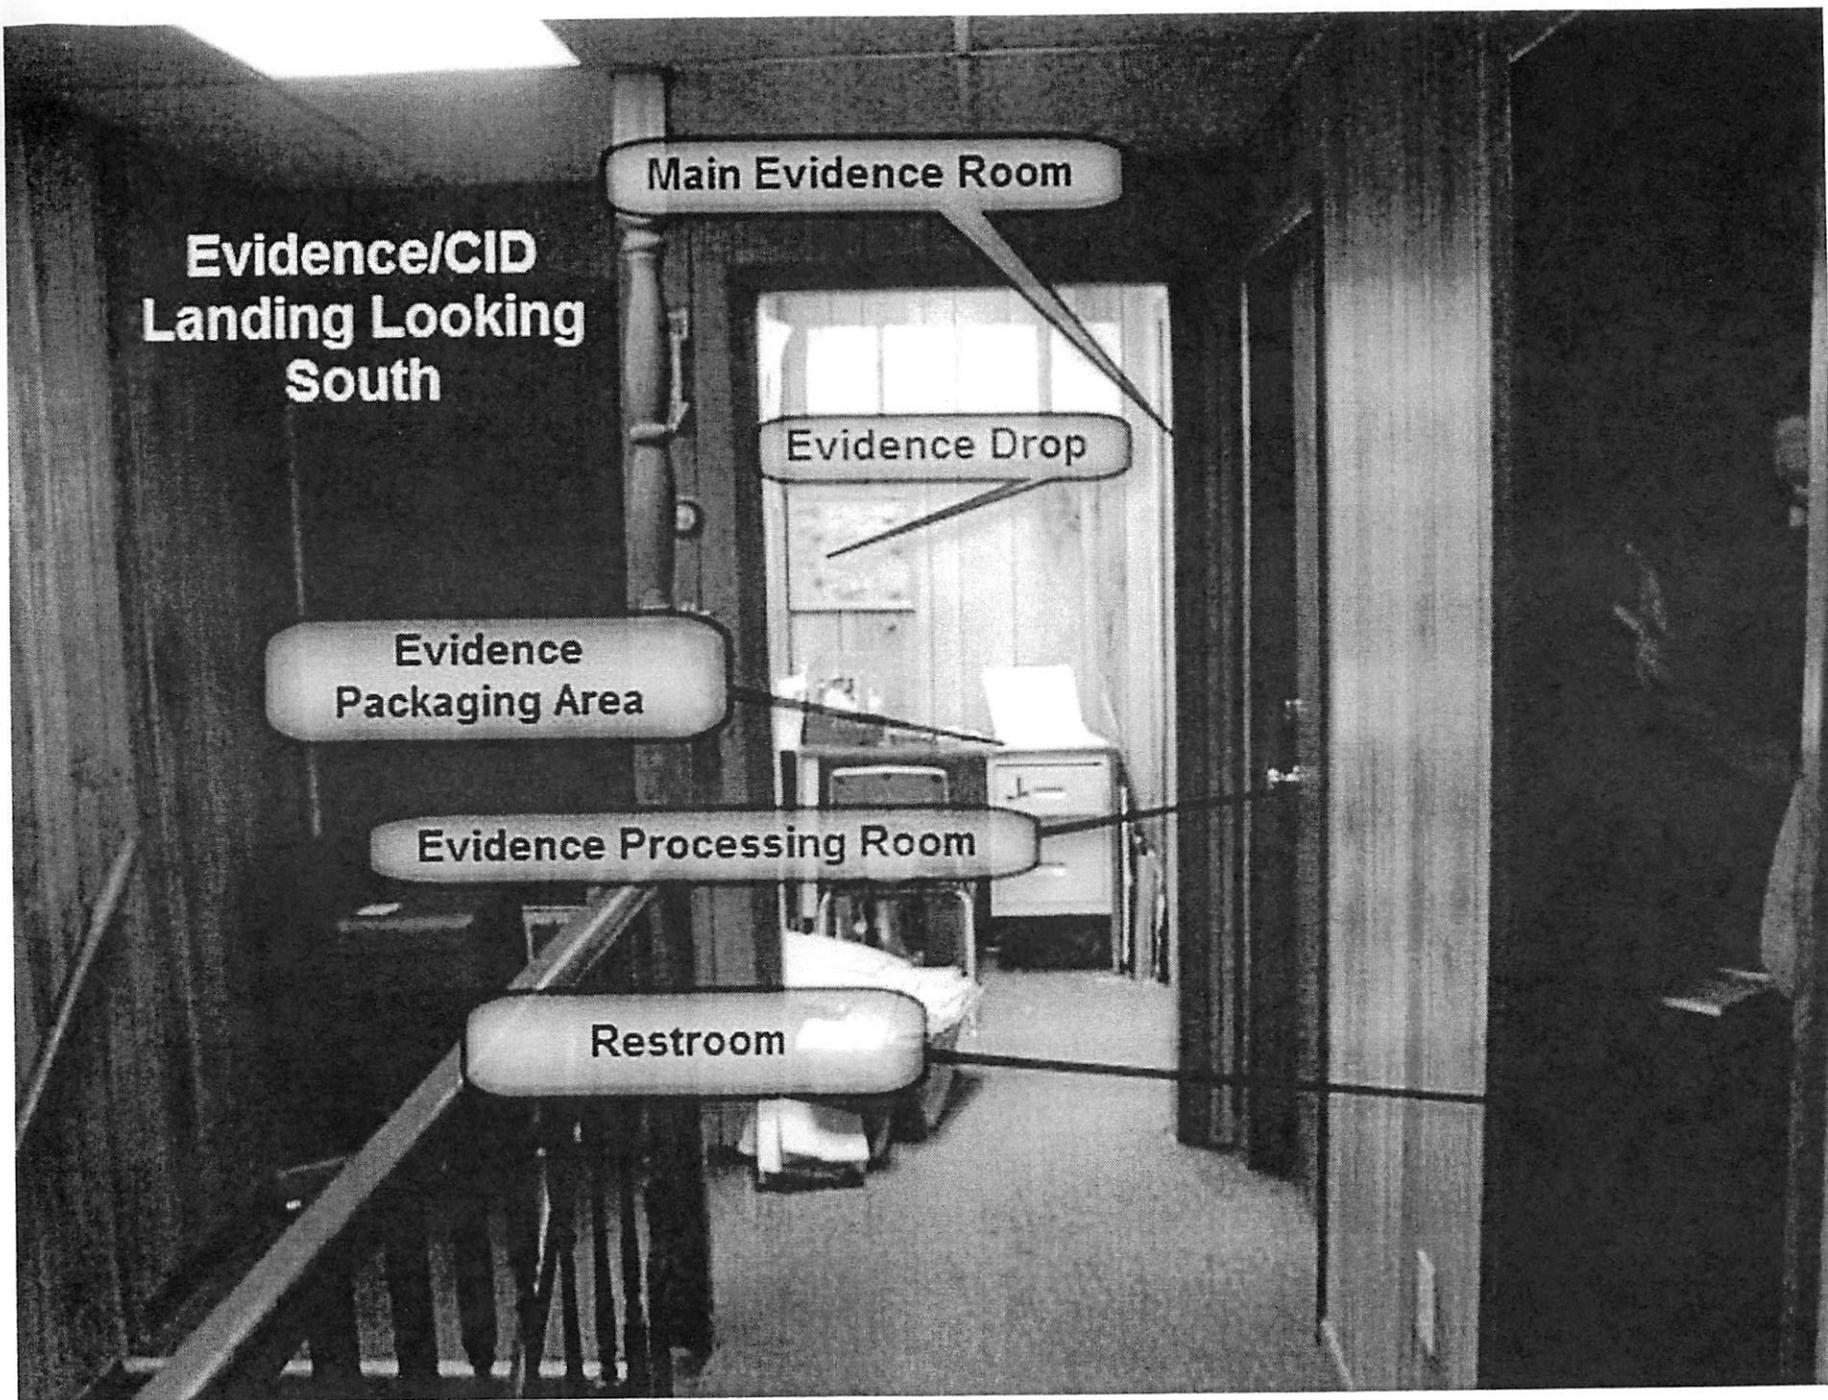
Mail Evidence Room
(Weak Security)

Evidence Processing
Room
(Weak Security)

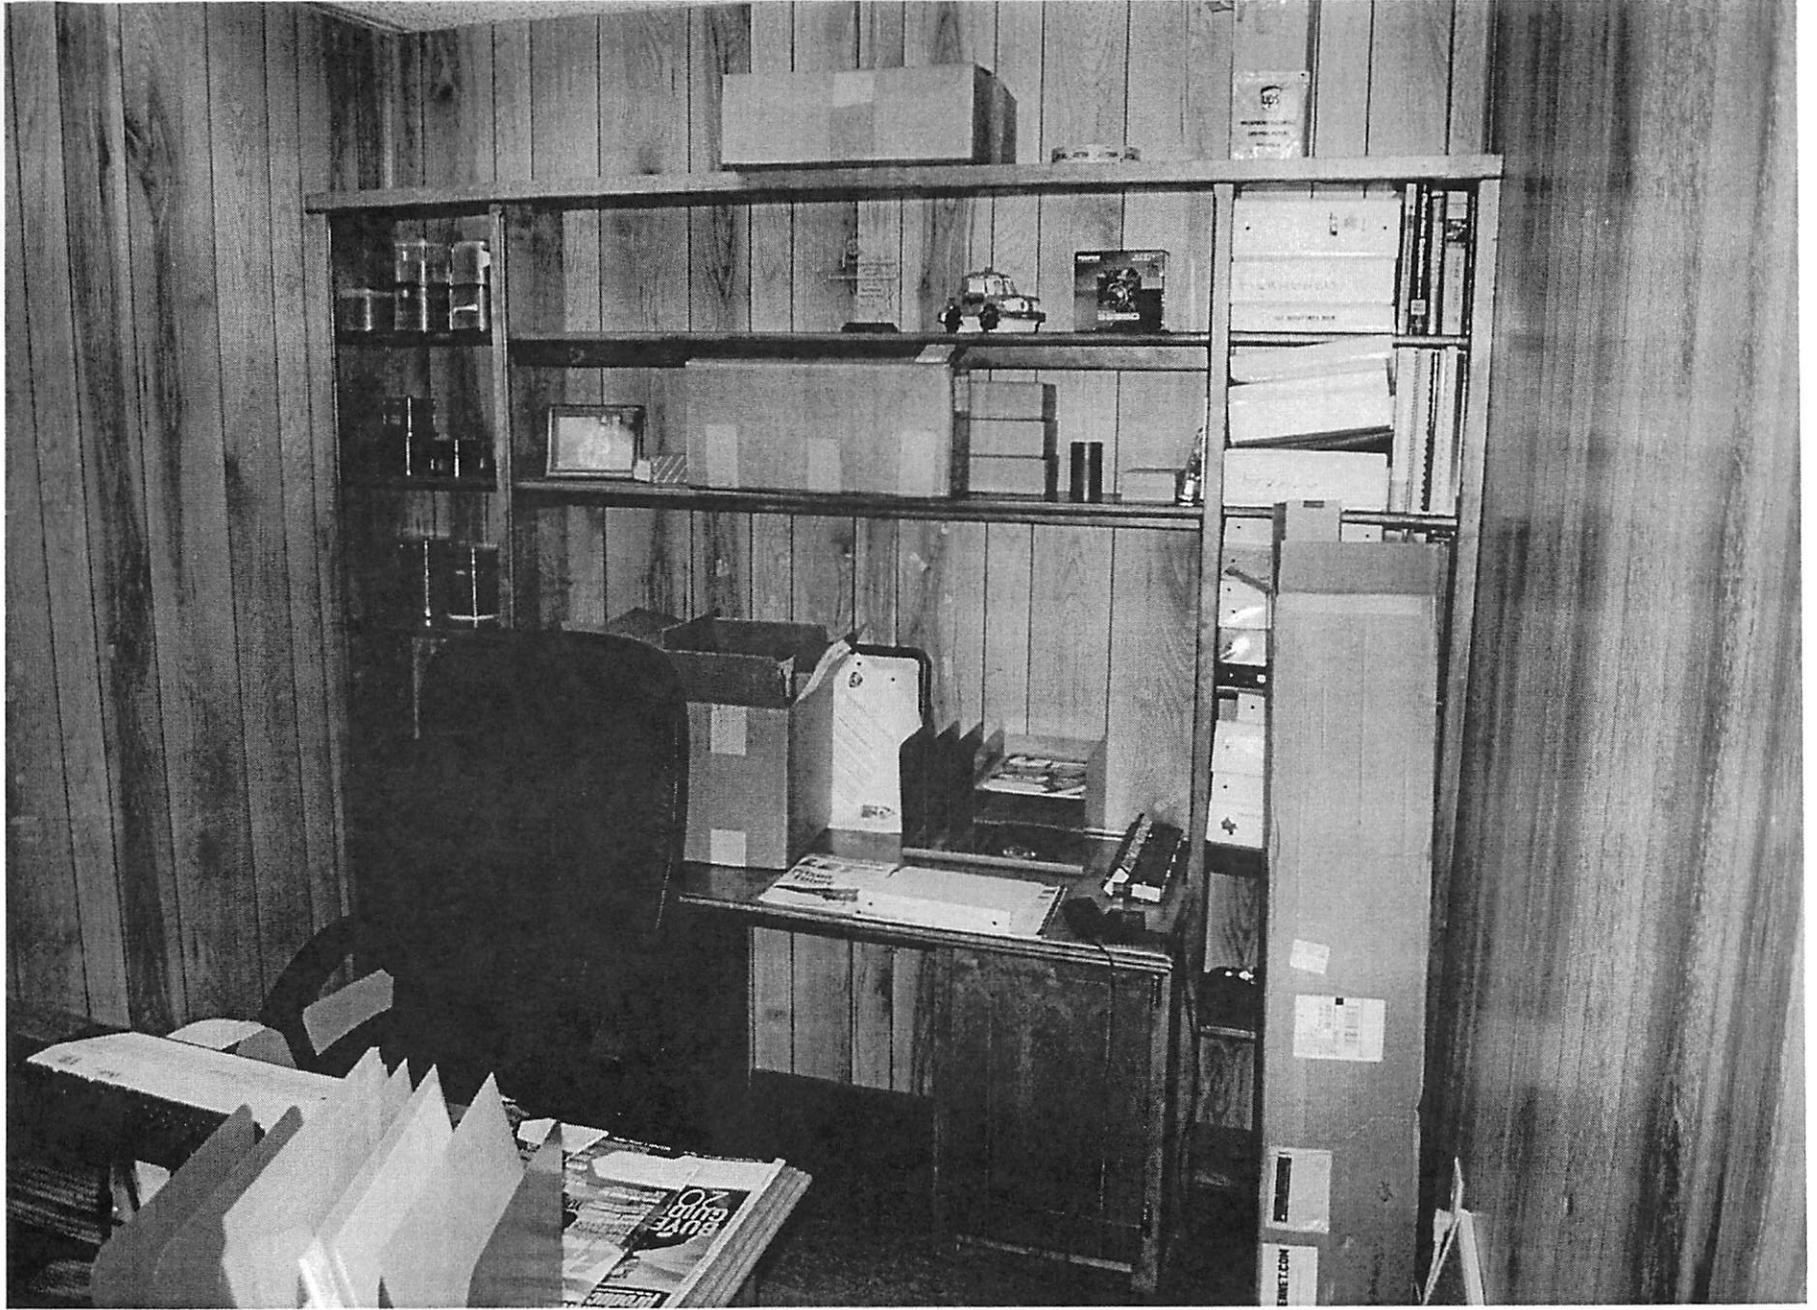
Detectives / CID

- Currently there are three Detectives with hopes of adding a fourth one in the near future due to the increase in active case loads and reports. At this time there are only two Detective office's. The current office's are too small to accommodate more than one or two witnesses, victims, etc. while working on a case.

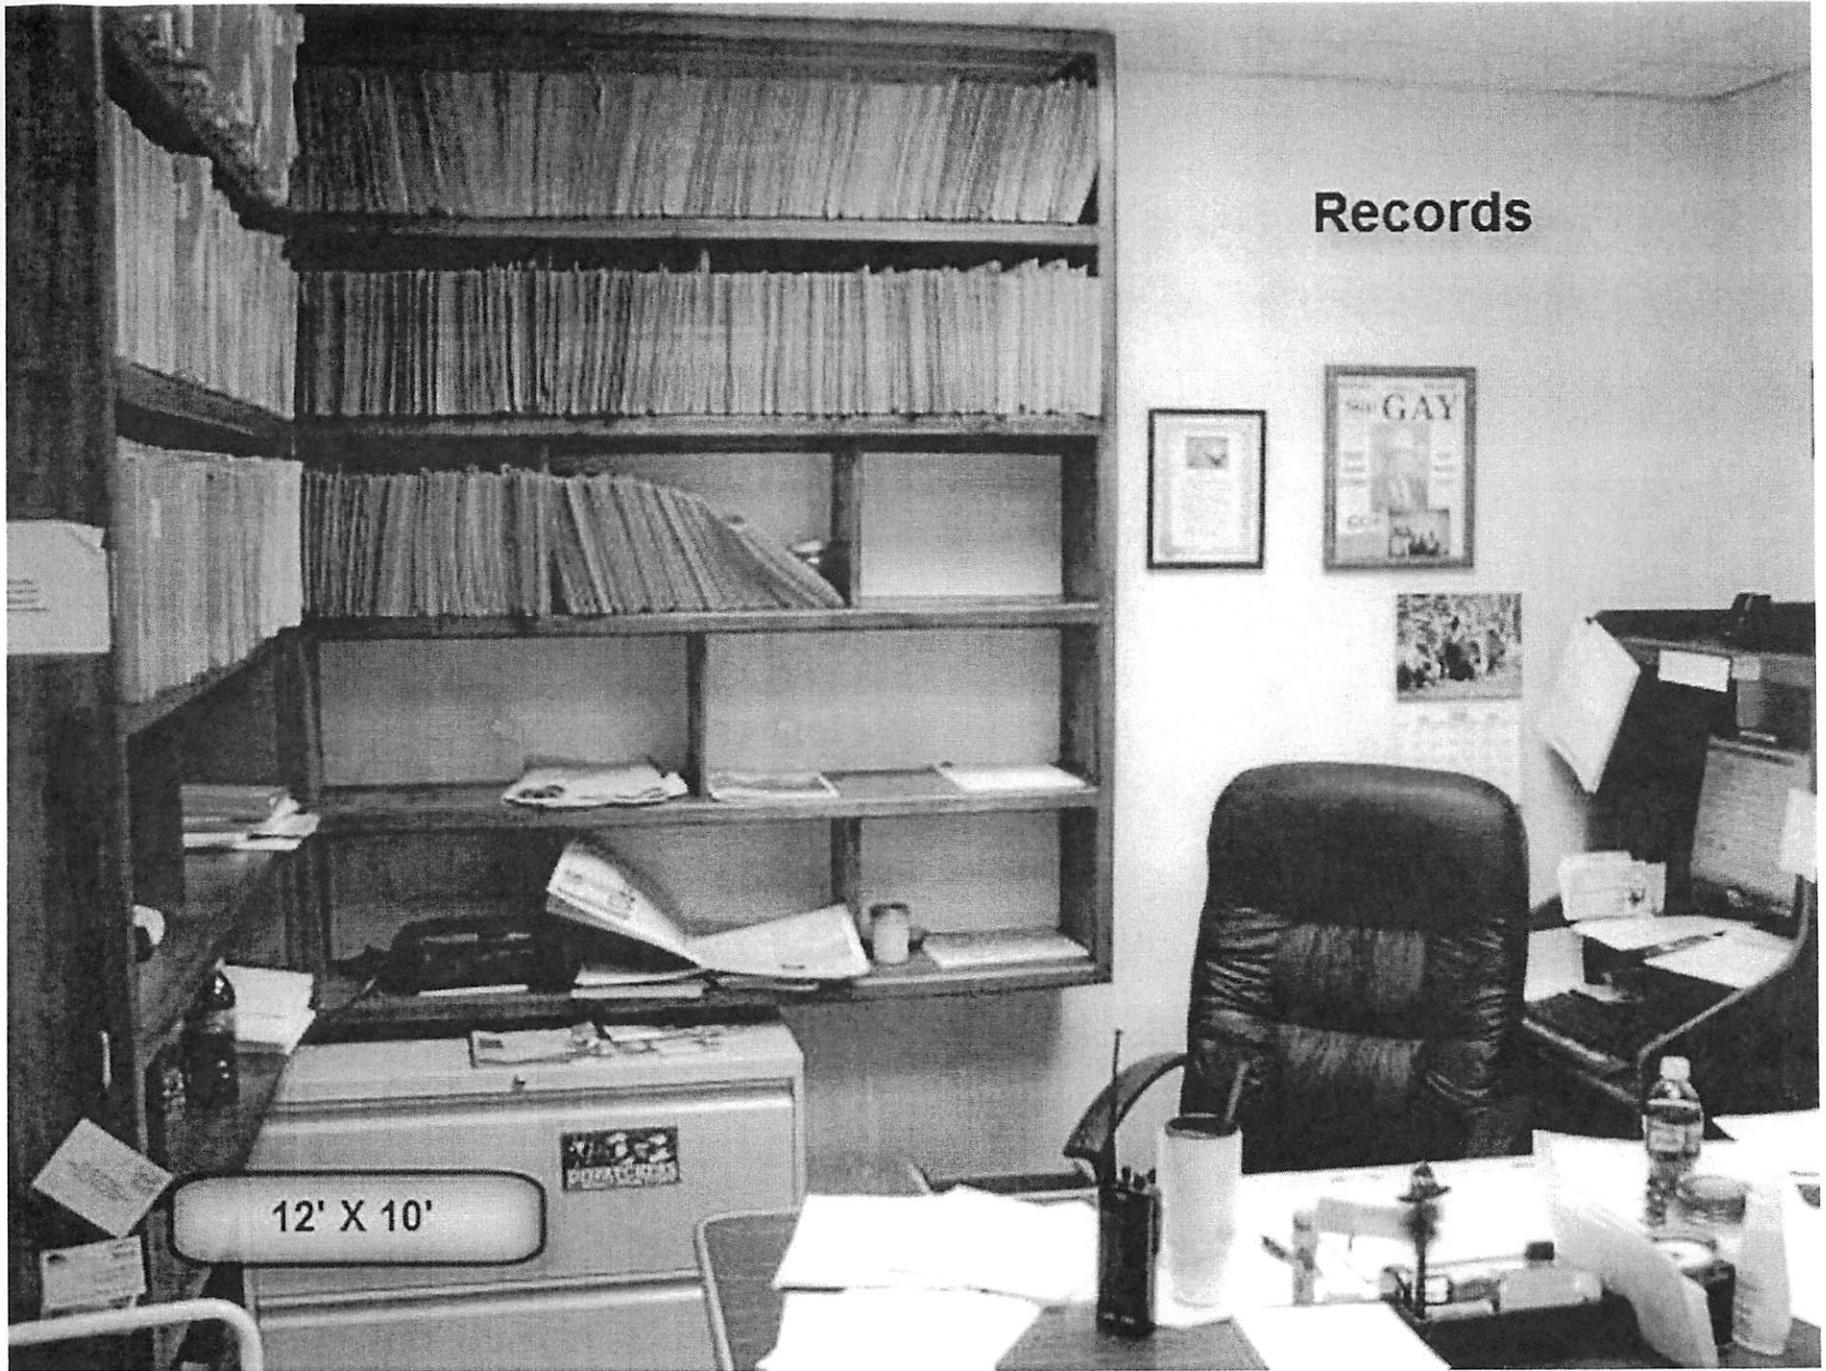
Records

- The records office is located on the opposite end of the building from the dispatch center. Our dispatch supervisor is also the records clerk and needs to be near dispatch to assist and supervise. There is also a separate records lobby which is often times confusing to the public. Many times dispatchers have to deal with walk in complainants, giving out accident reports, and other reports left in dispatch to give to the public. It seems more feasible for the record clerk to handle this and if it is a complainant refer them to dispatch.

12' X 10'

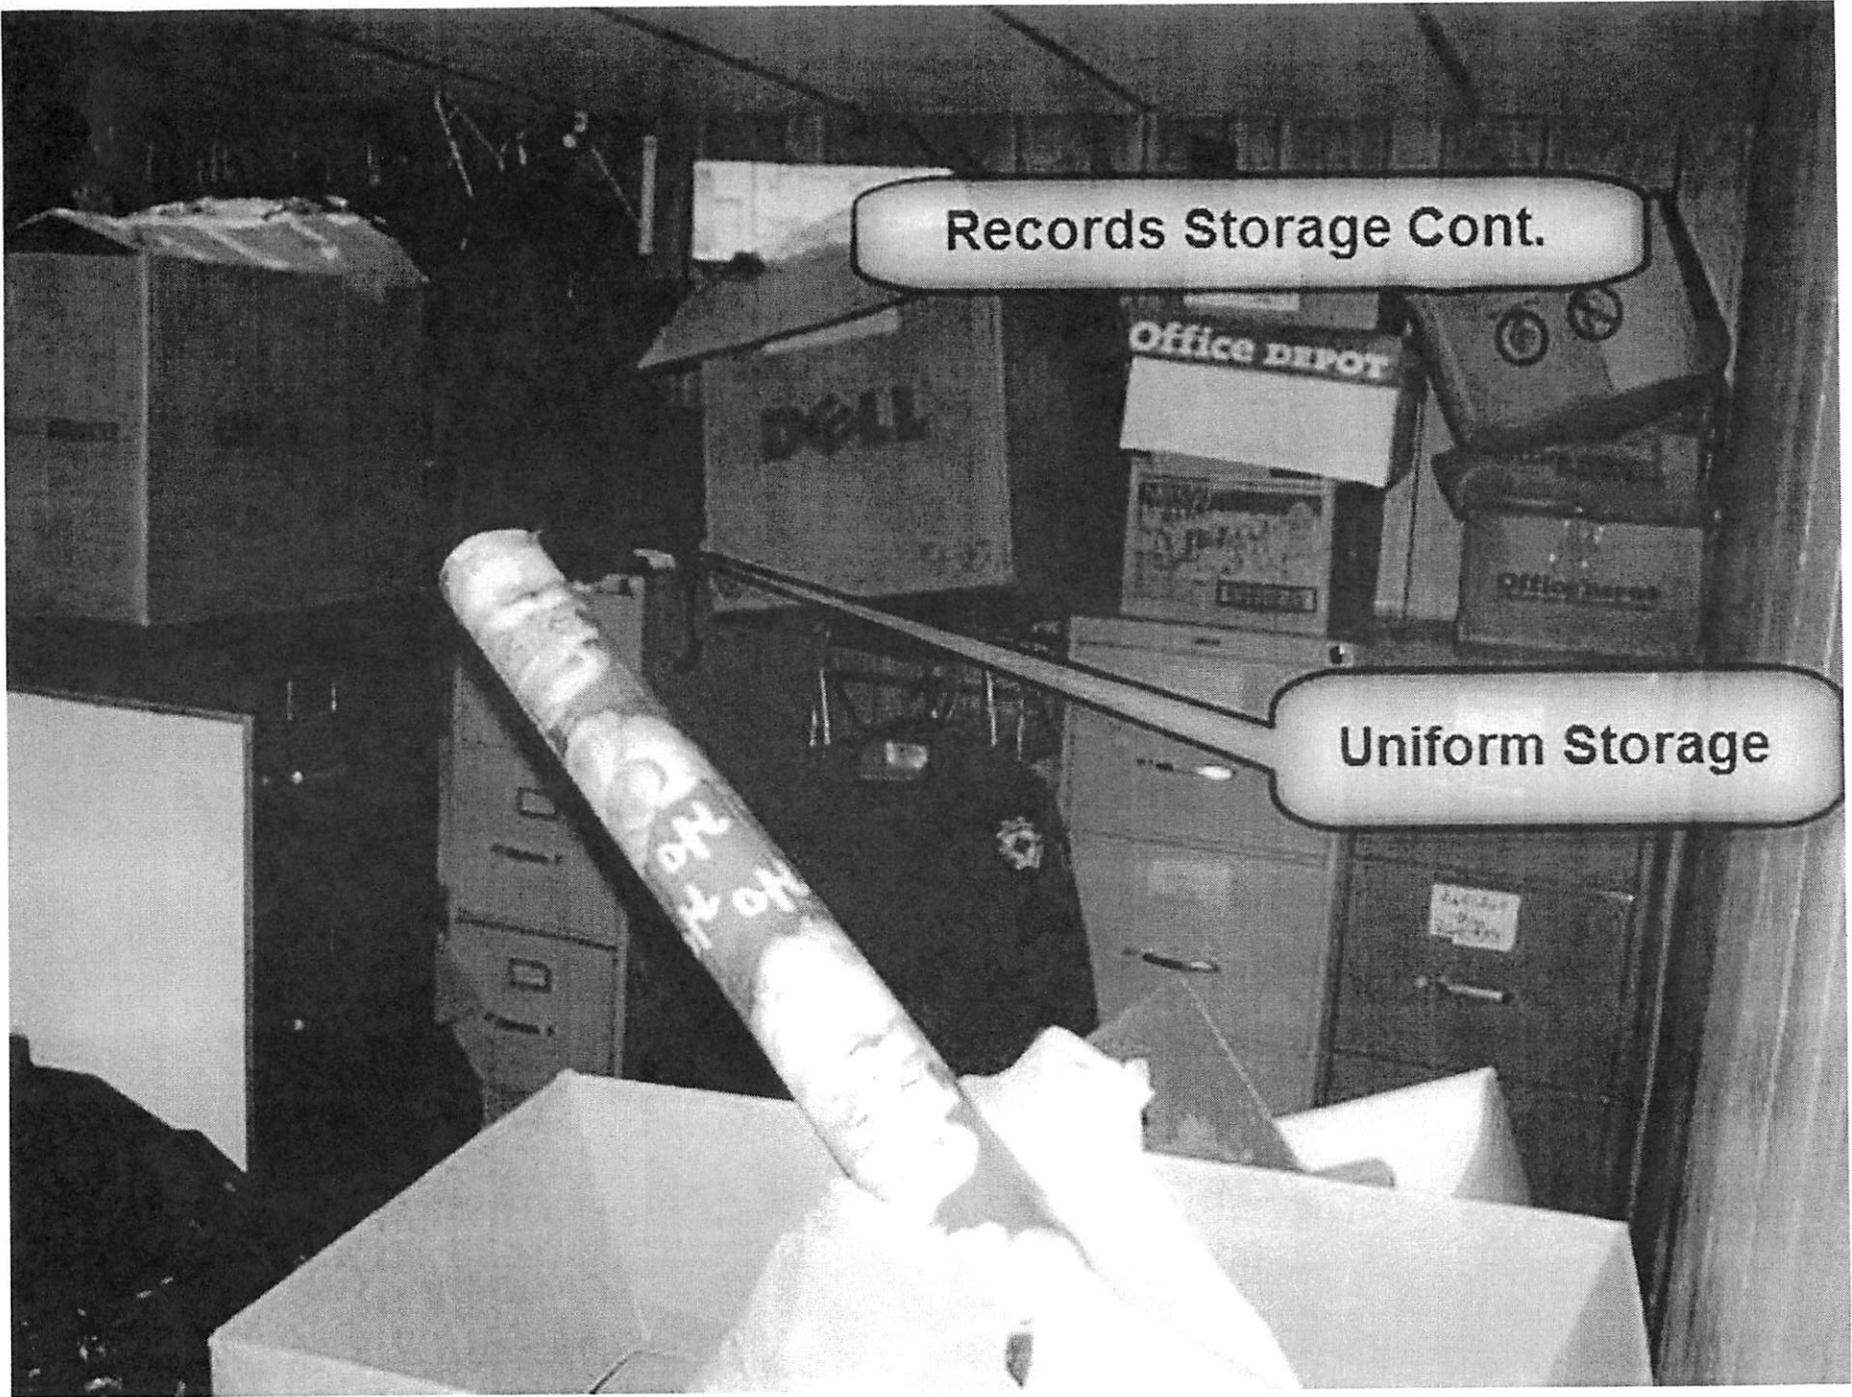
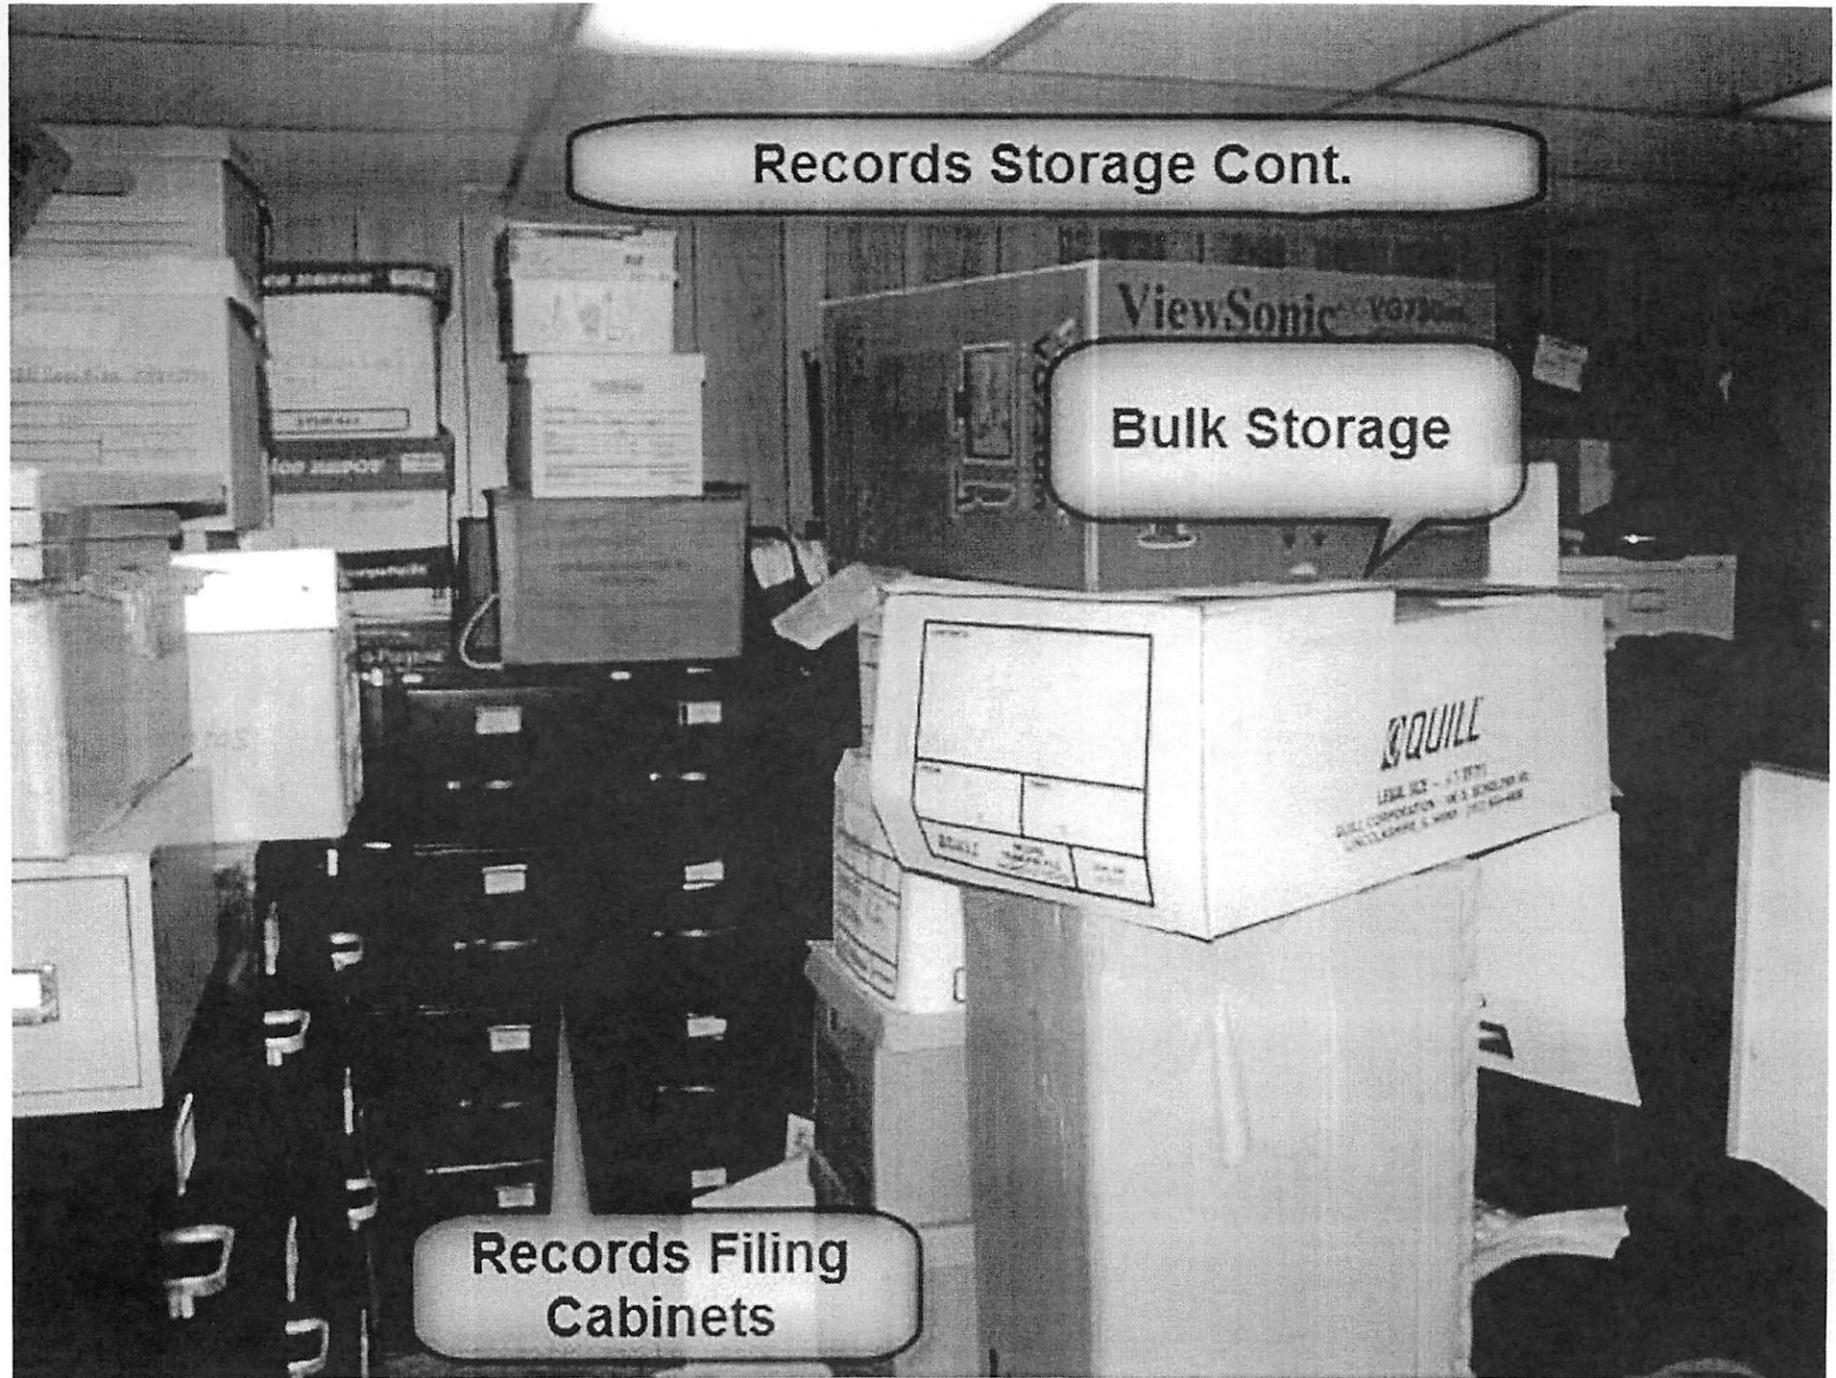
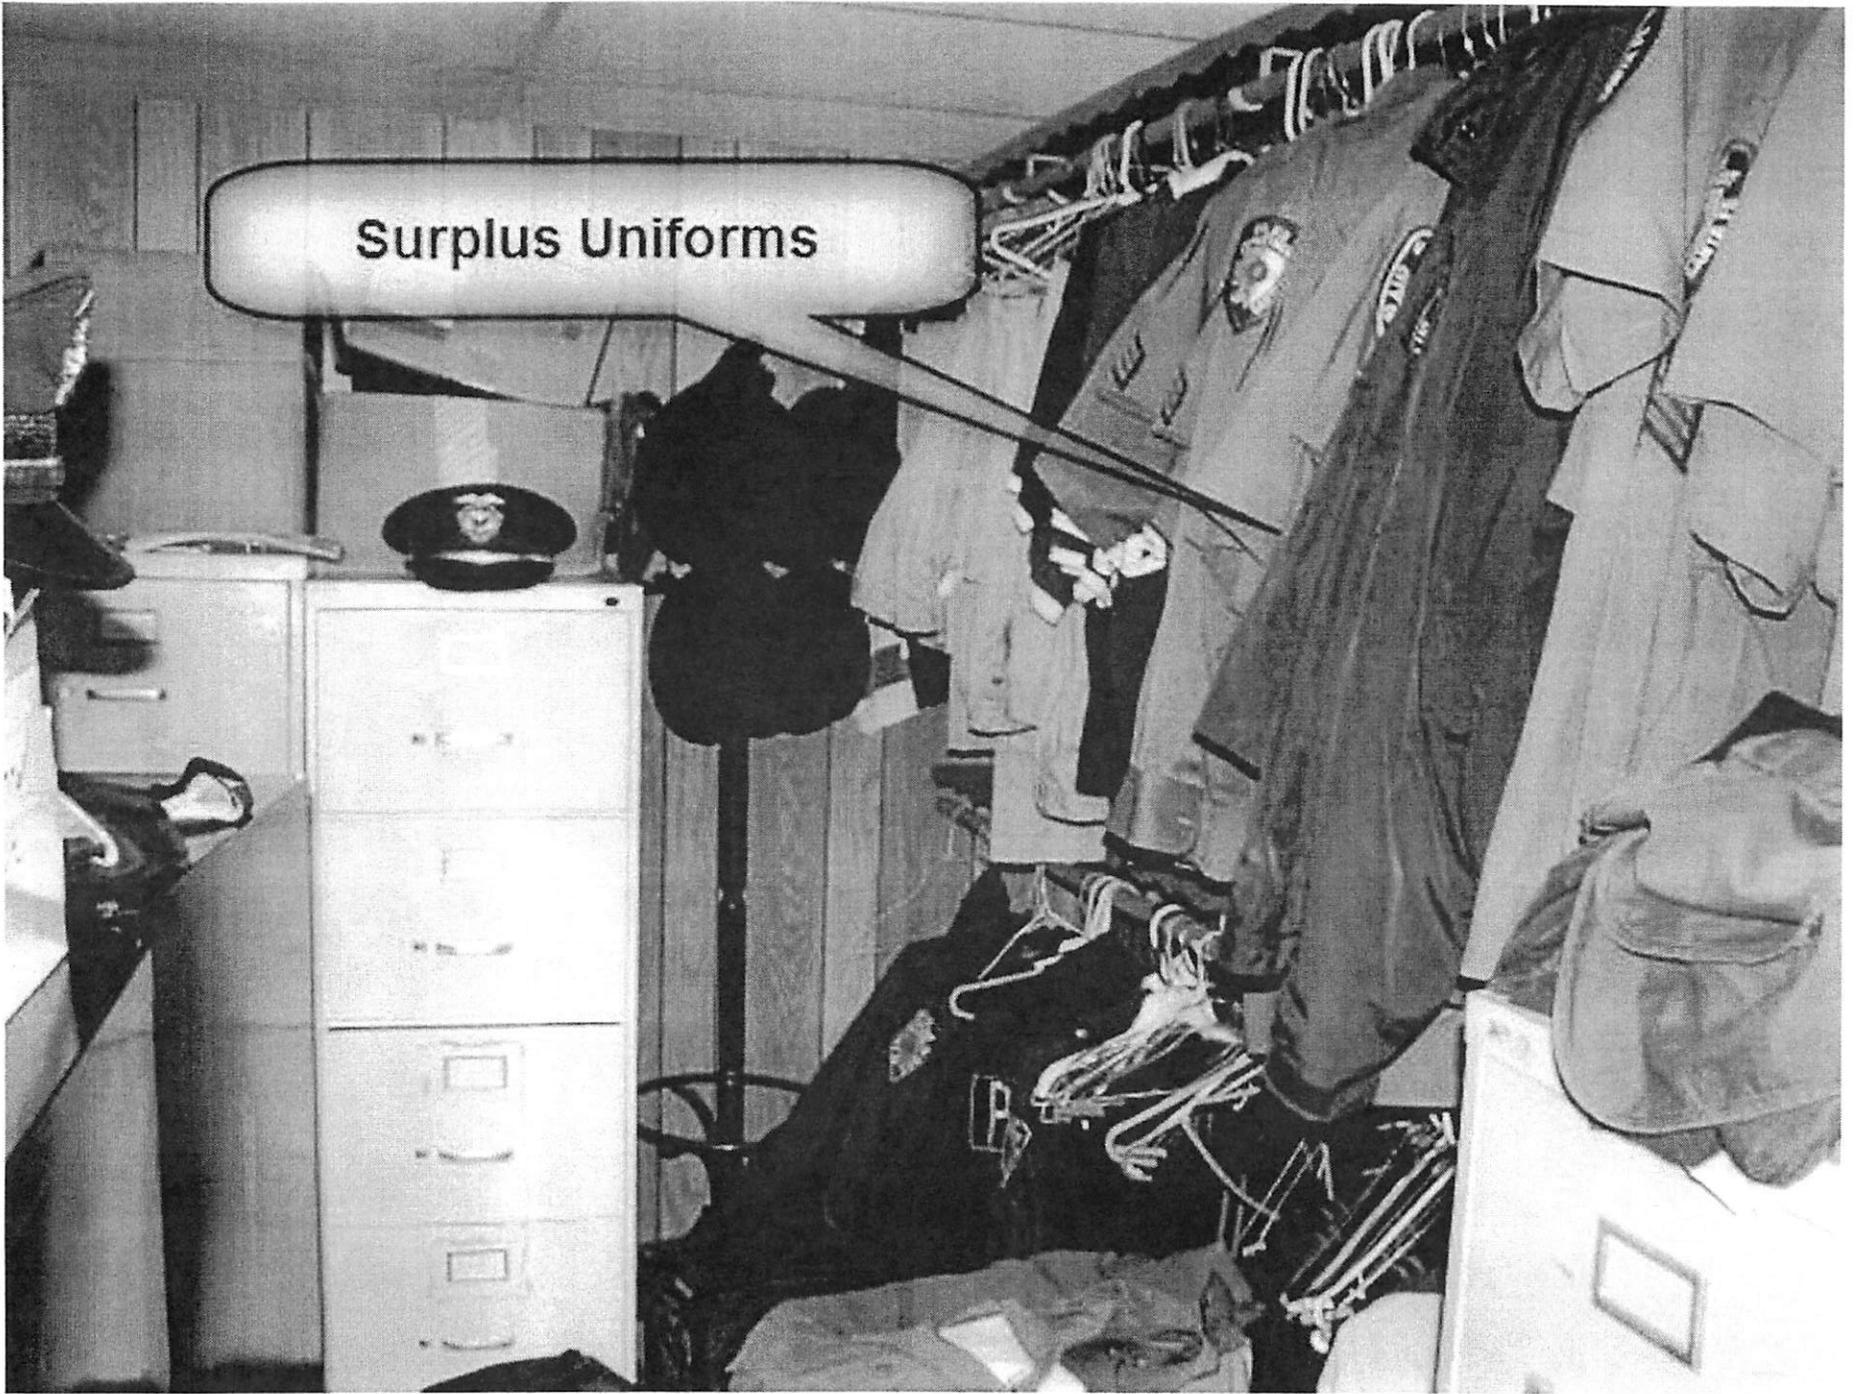
Records Storage Cont.

- Our current records office is not large enough, causing many records to be stored upstairs on the east end, above the municipal court. This room not only serves as archive storage but also as storage for uniforms and equipment. This room is overcrowded and is currently a disgrace. We currently have to walk through the City Marshall's office to reach this room. A centralized records storage room needs to be added. The concern is again with a hurricane this part of the building will likely be destroyed.

Uniform Storage

Bulk Storage

Surplus Uniforms
