City of Santa Fe Police Department

Public Safety Building Needs Assessment

06/19/2008 - 10/25/2012

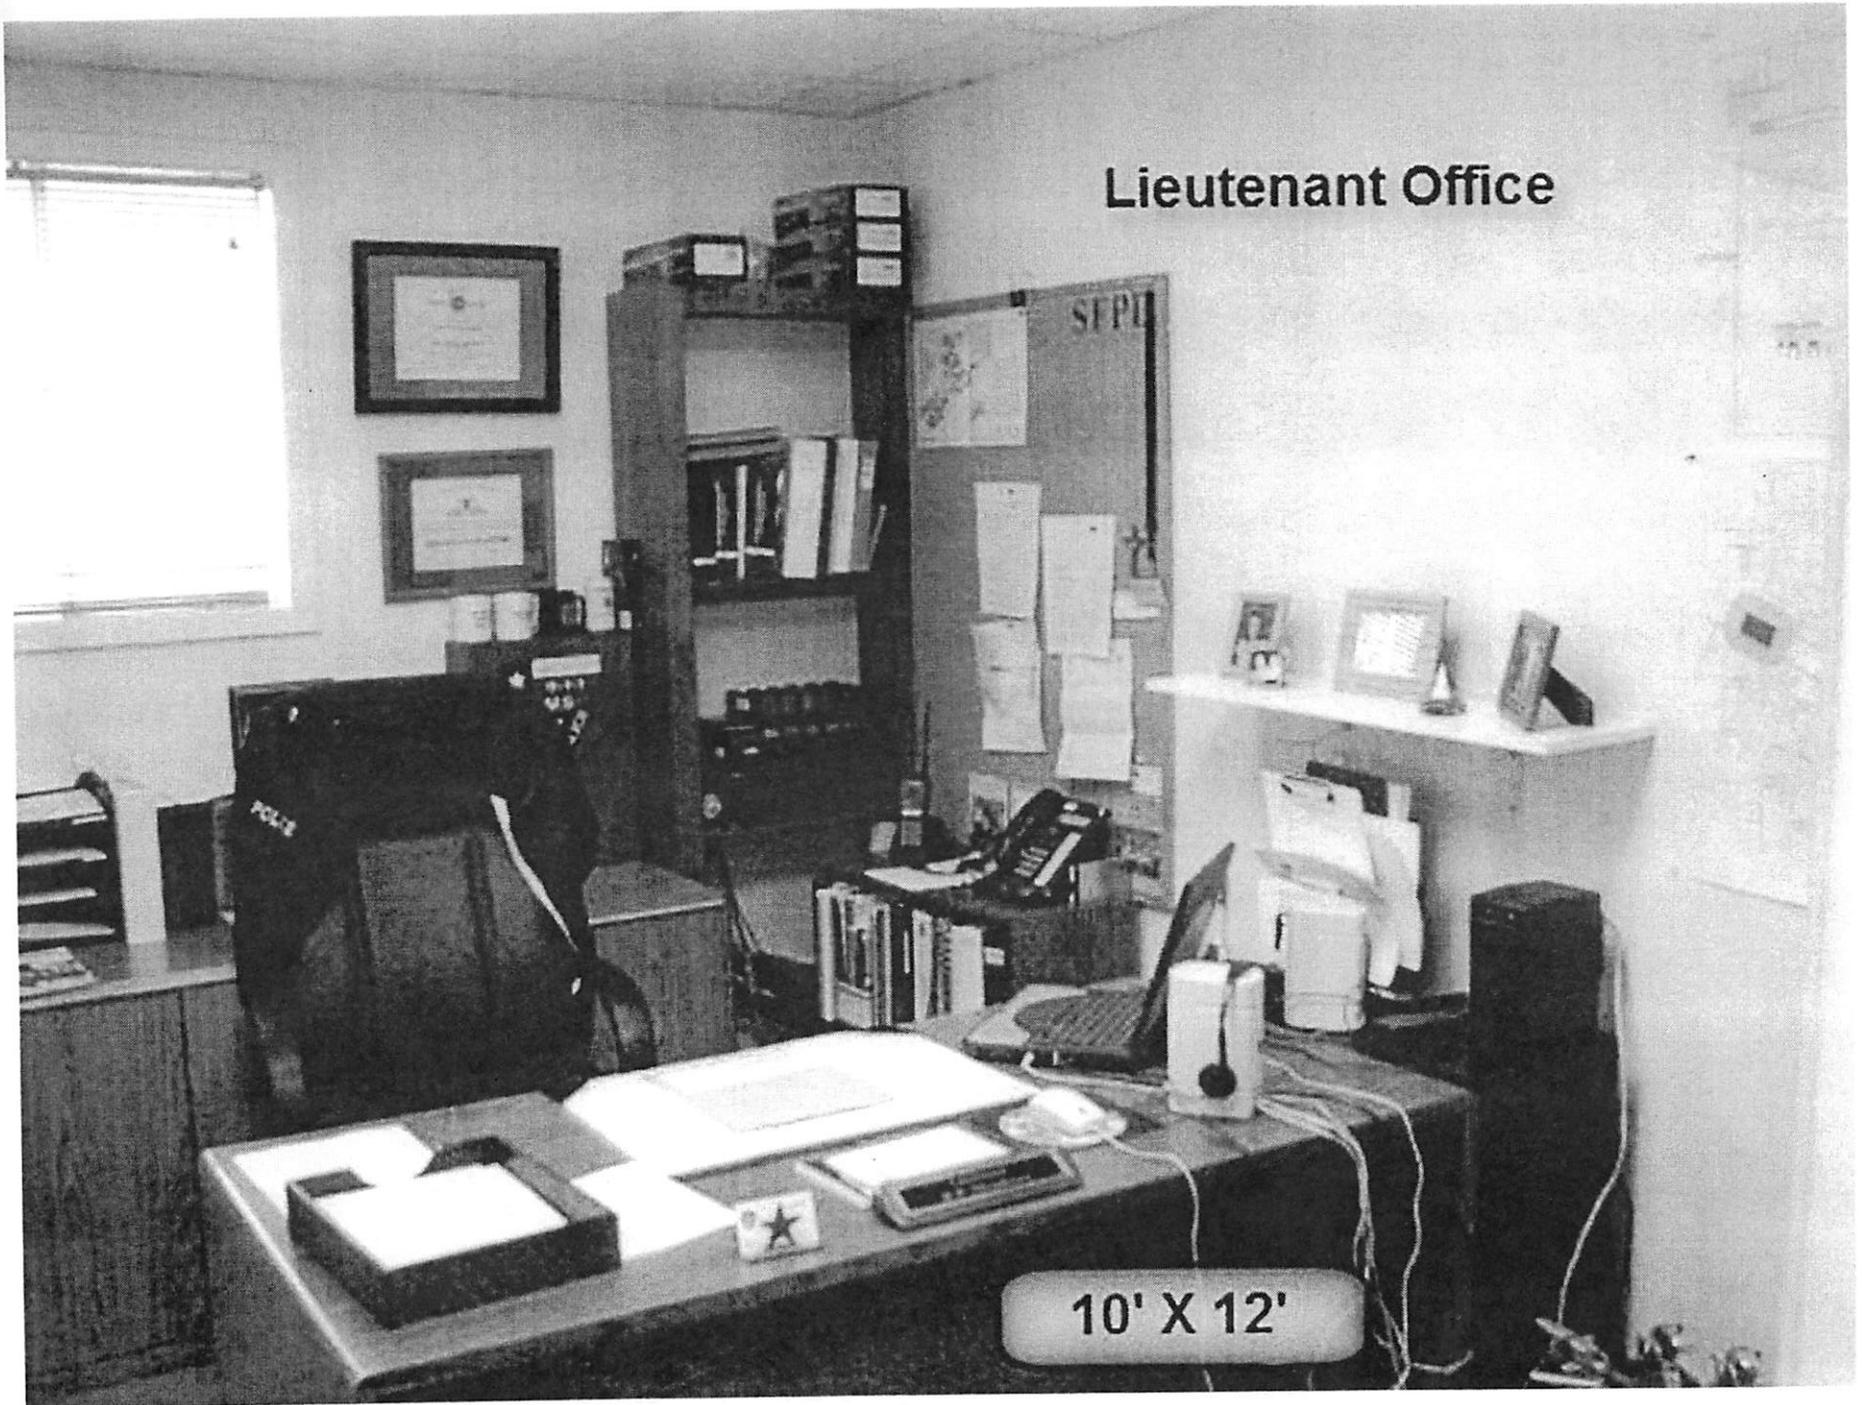
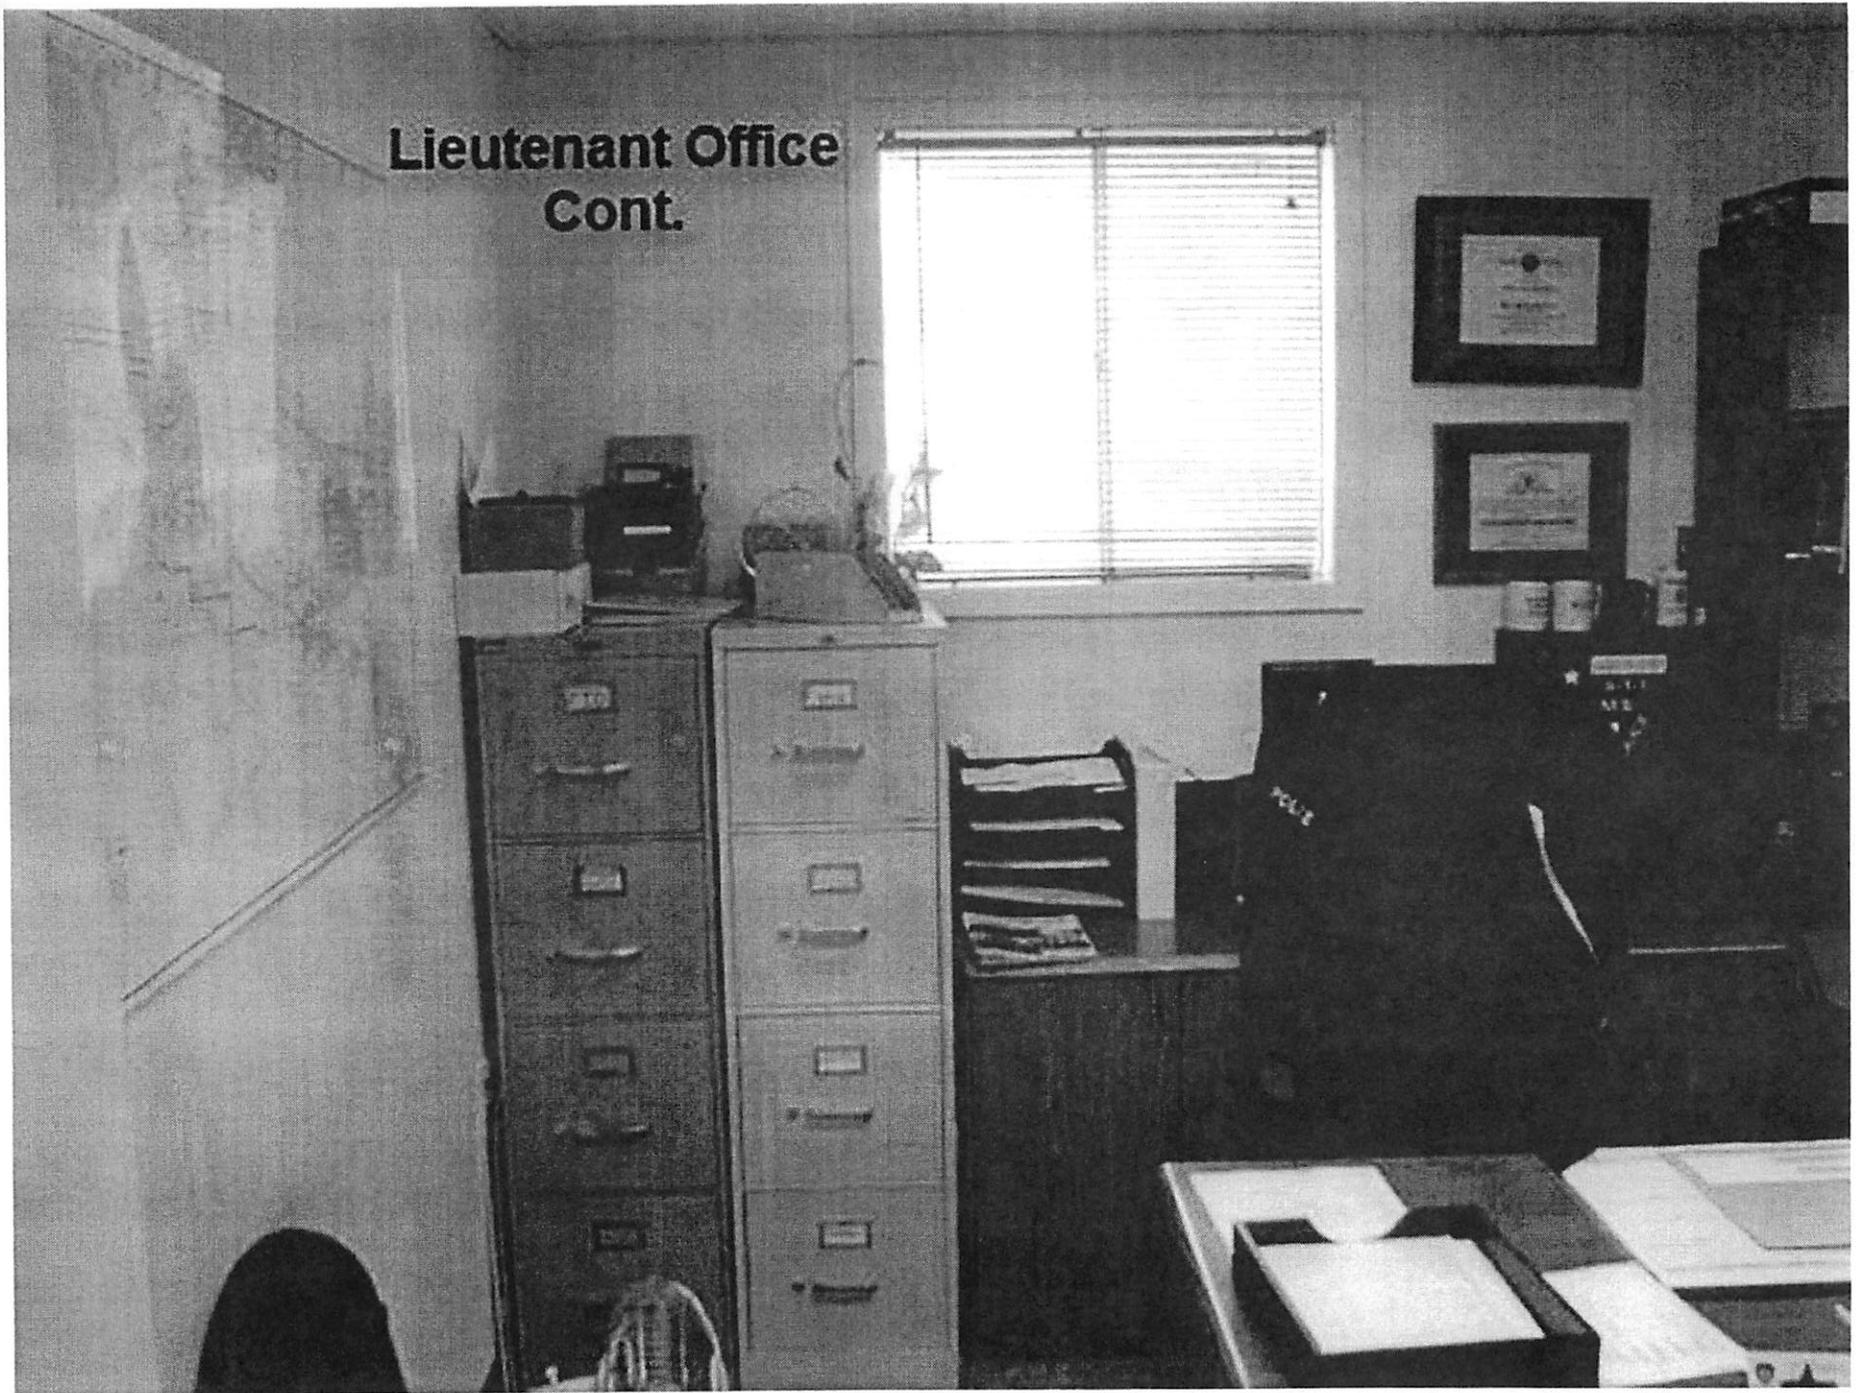
Lieutenant Office

- The lieutenants office needs to be larger to meet with sergeants and officers as well as store files and equipment which is housed in his office. The Lieutenant needs more privacy while dealing with disciplinary issues. The Lieutenant is also responsible for interviewing and registering sex offenders, as well as keeping and housing the sex offenders personal files.

10' X 12'

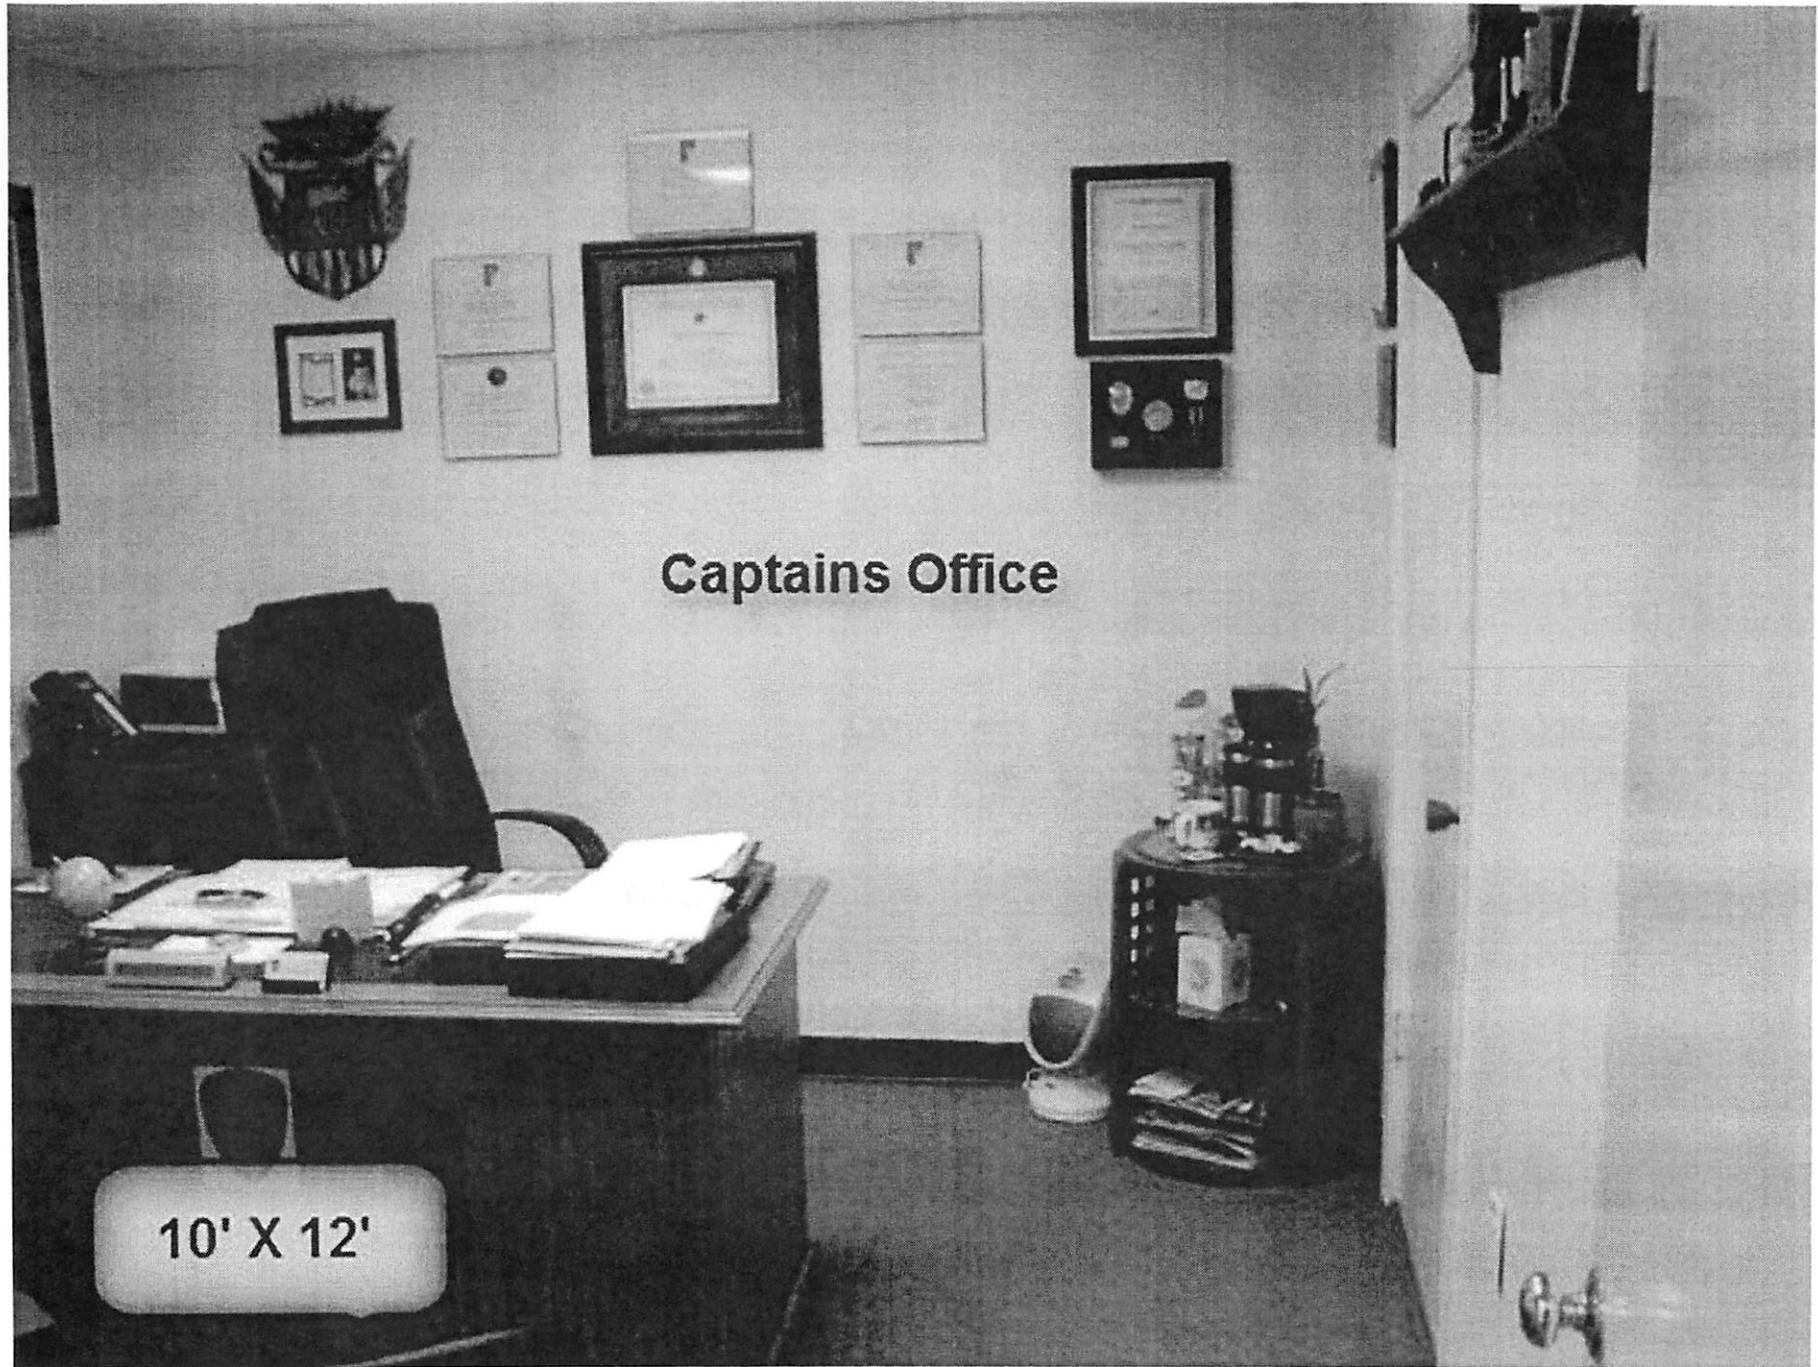
Captains Office

- The Captain needs a larger office for space and storing personal files and Internal Affair files which are required to be secured and locked up. Privacy is an issue with this office as well, as the Captain deals with a lot of sensitive issues and needs privacy to speak with officers, complainants, and complete internal affair investigations.

10' X 12'

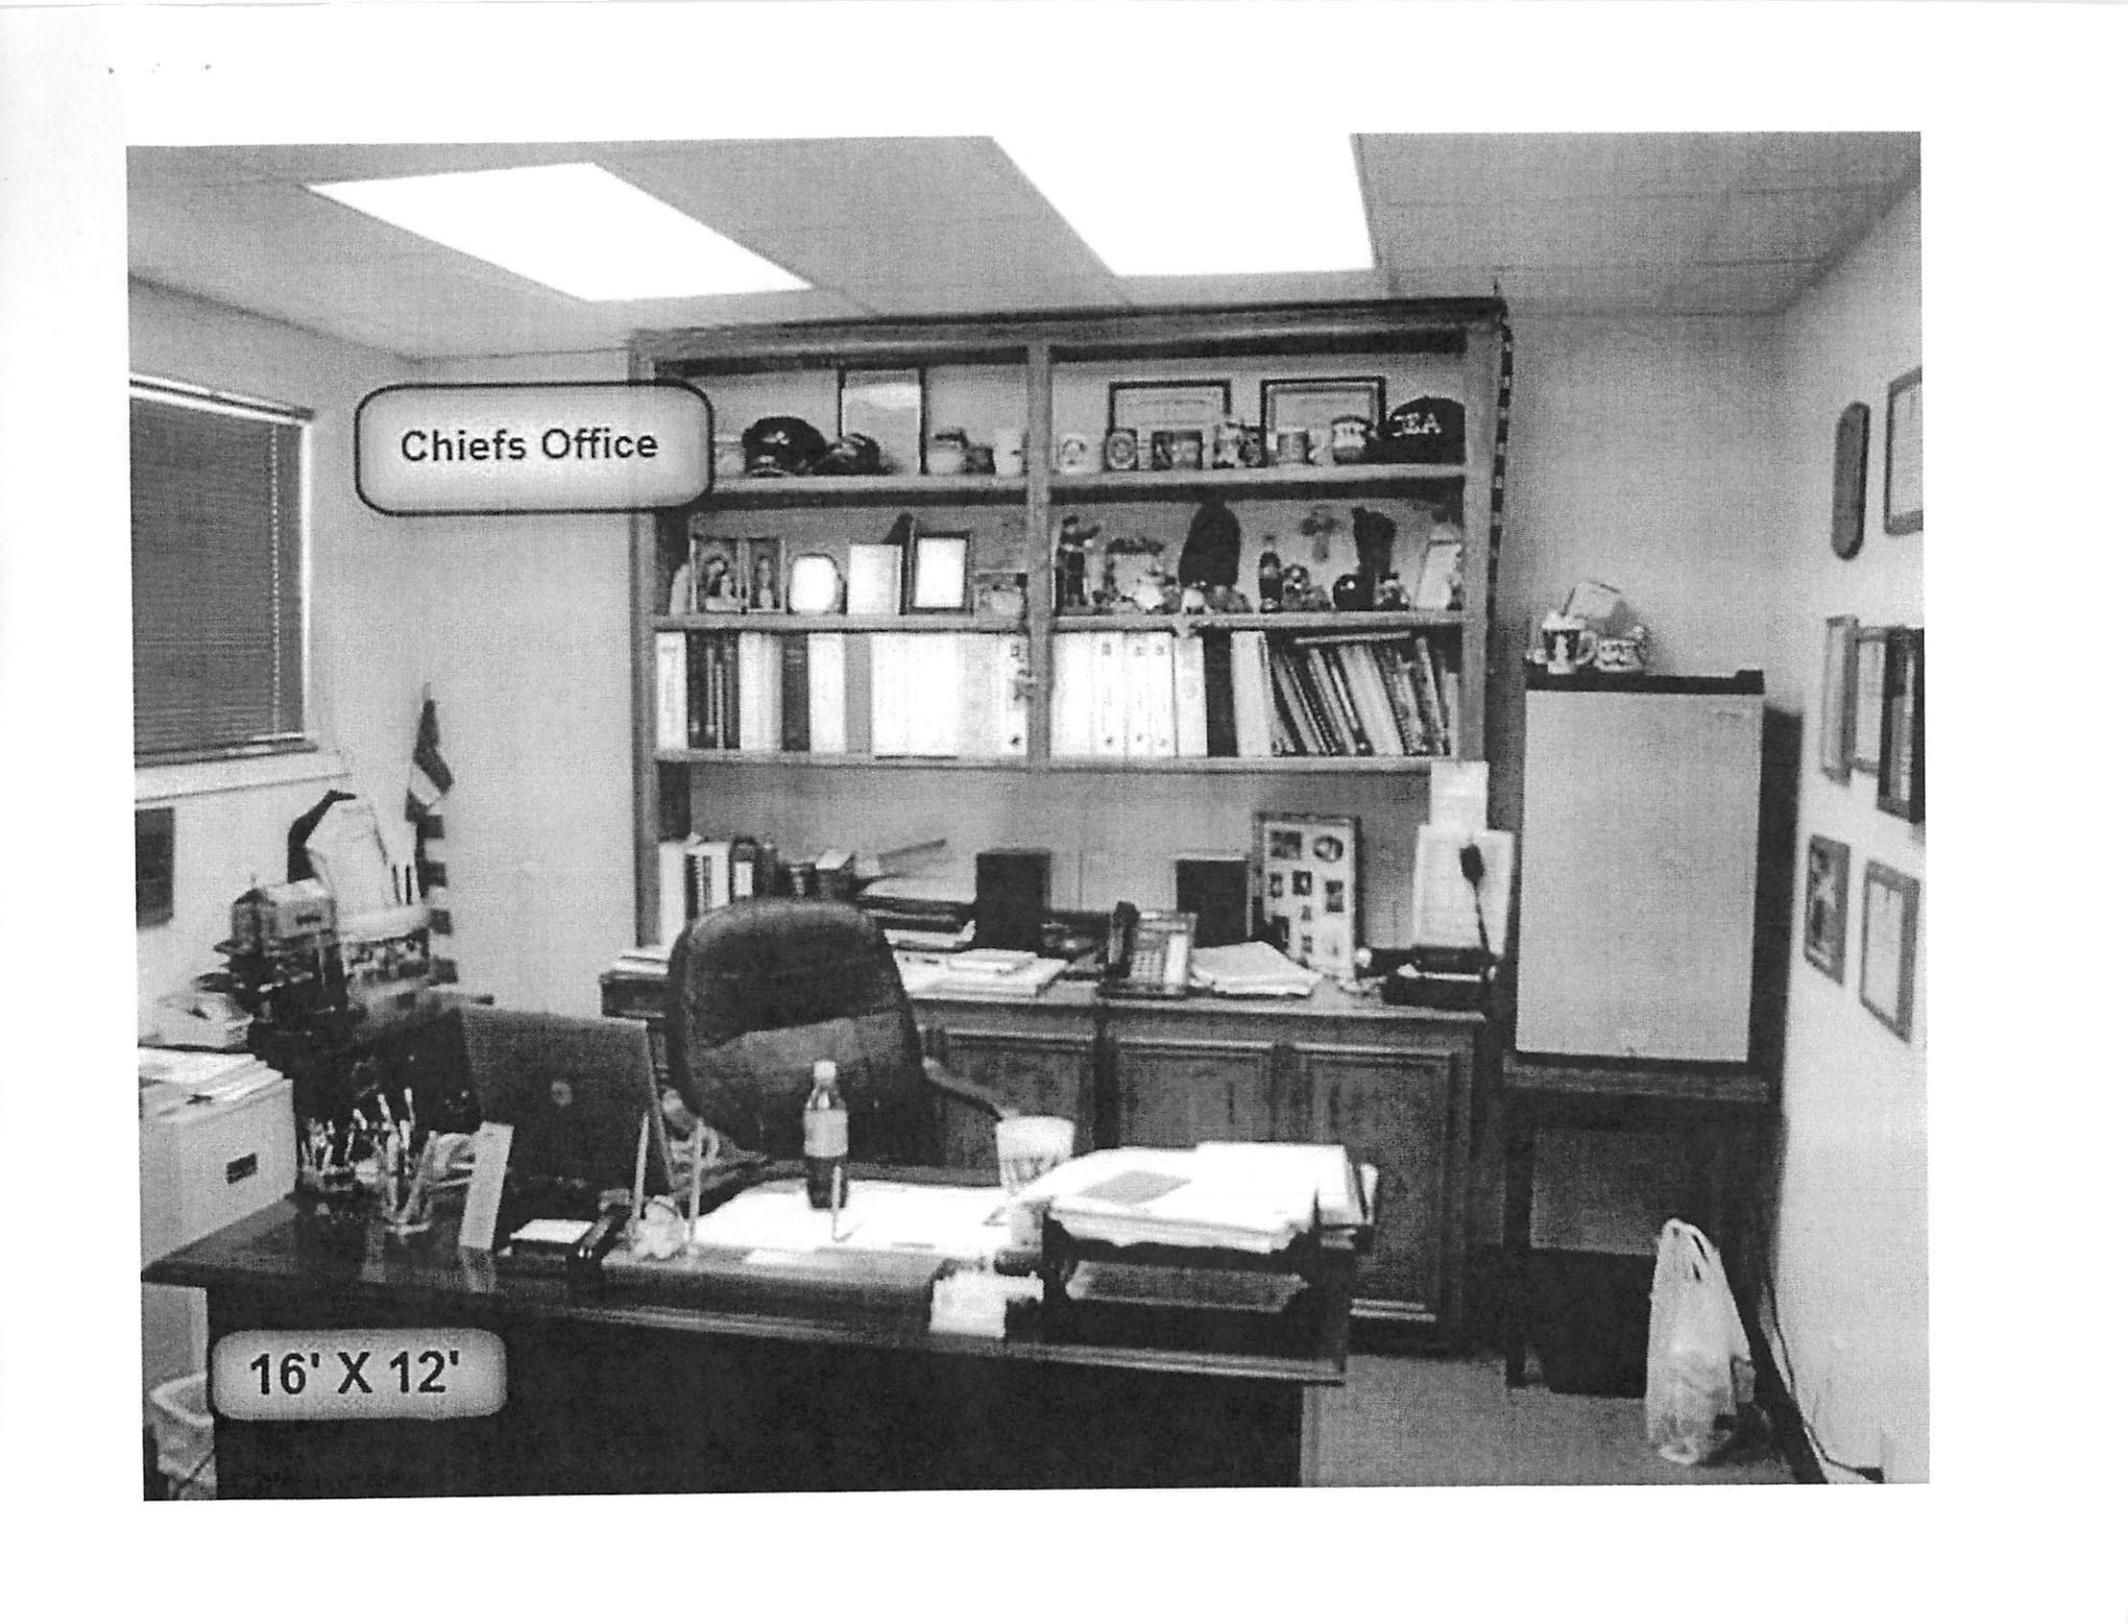
Chiefs Office

- The Chief's Office in and of itself seems to be adequate in size. There is a need for a conference area for meetings with staff, officers, and citizens. Currently there are some items being stored in the Chief's Office. When storage is addressed in any future office it will free up space in the Chief's Office.

16' X 12'

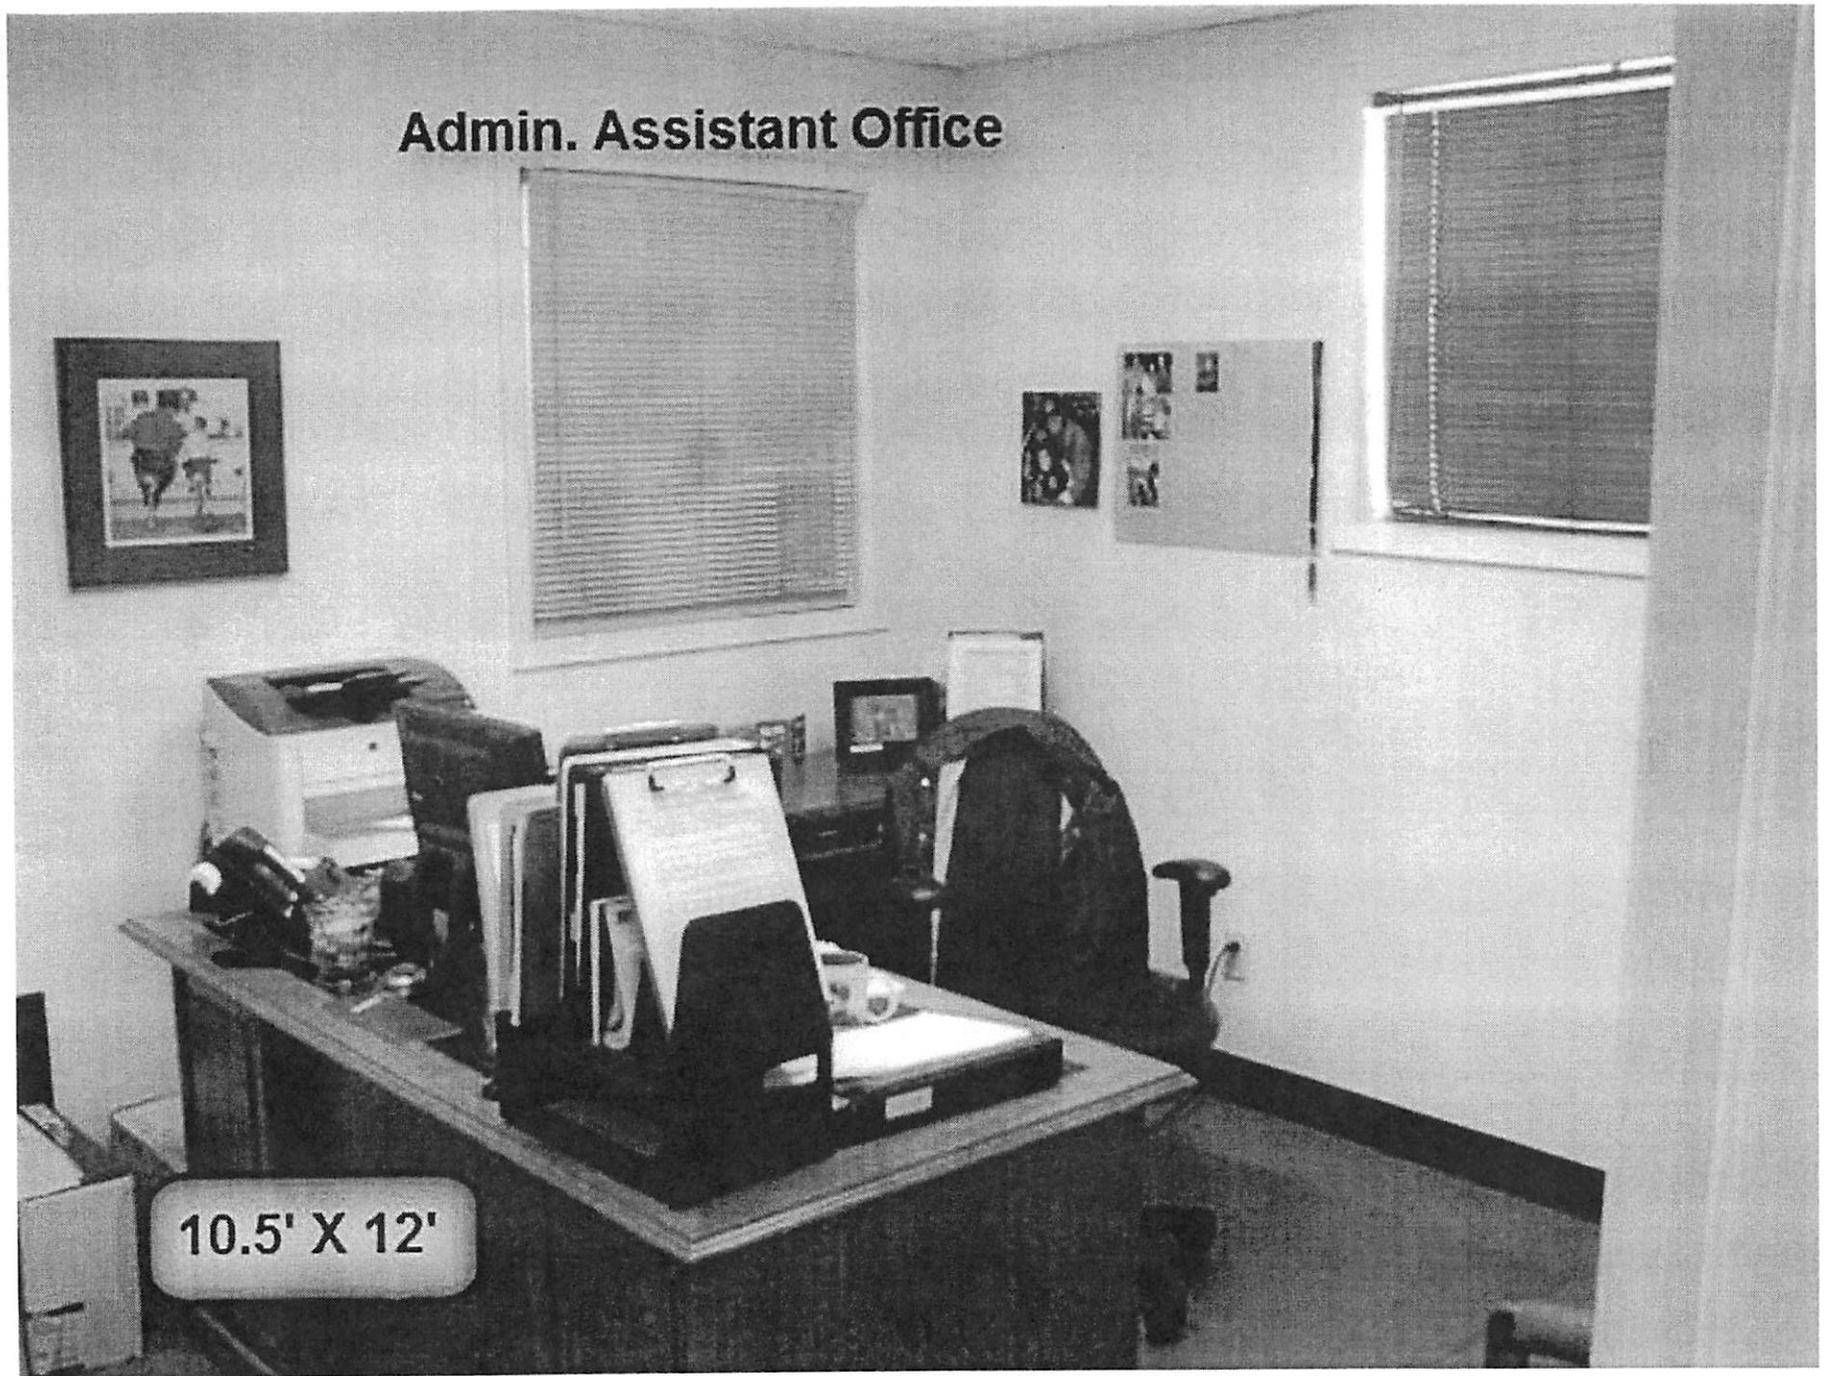
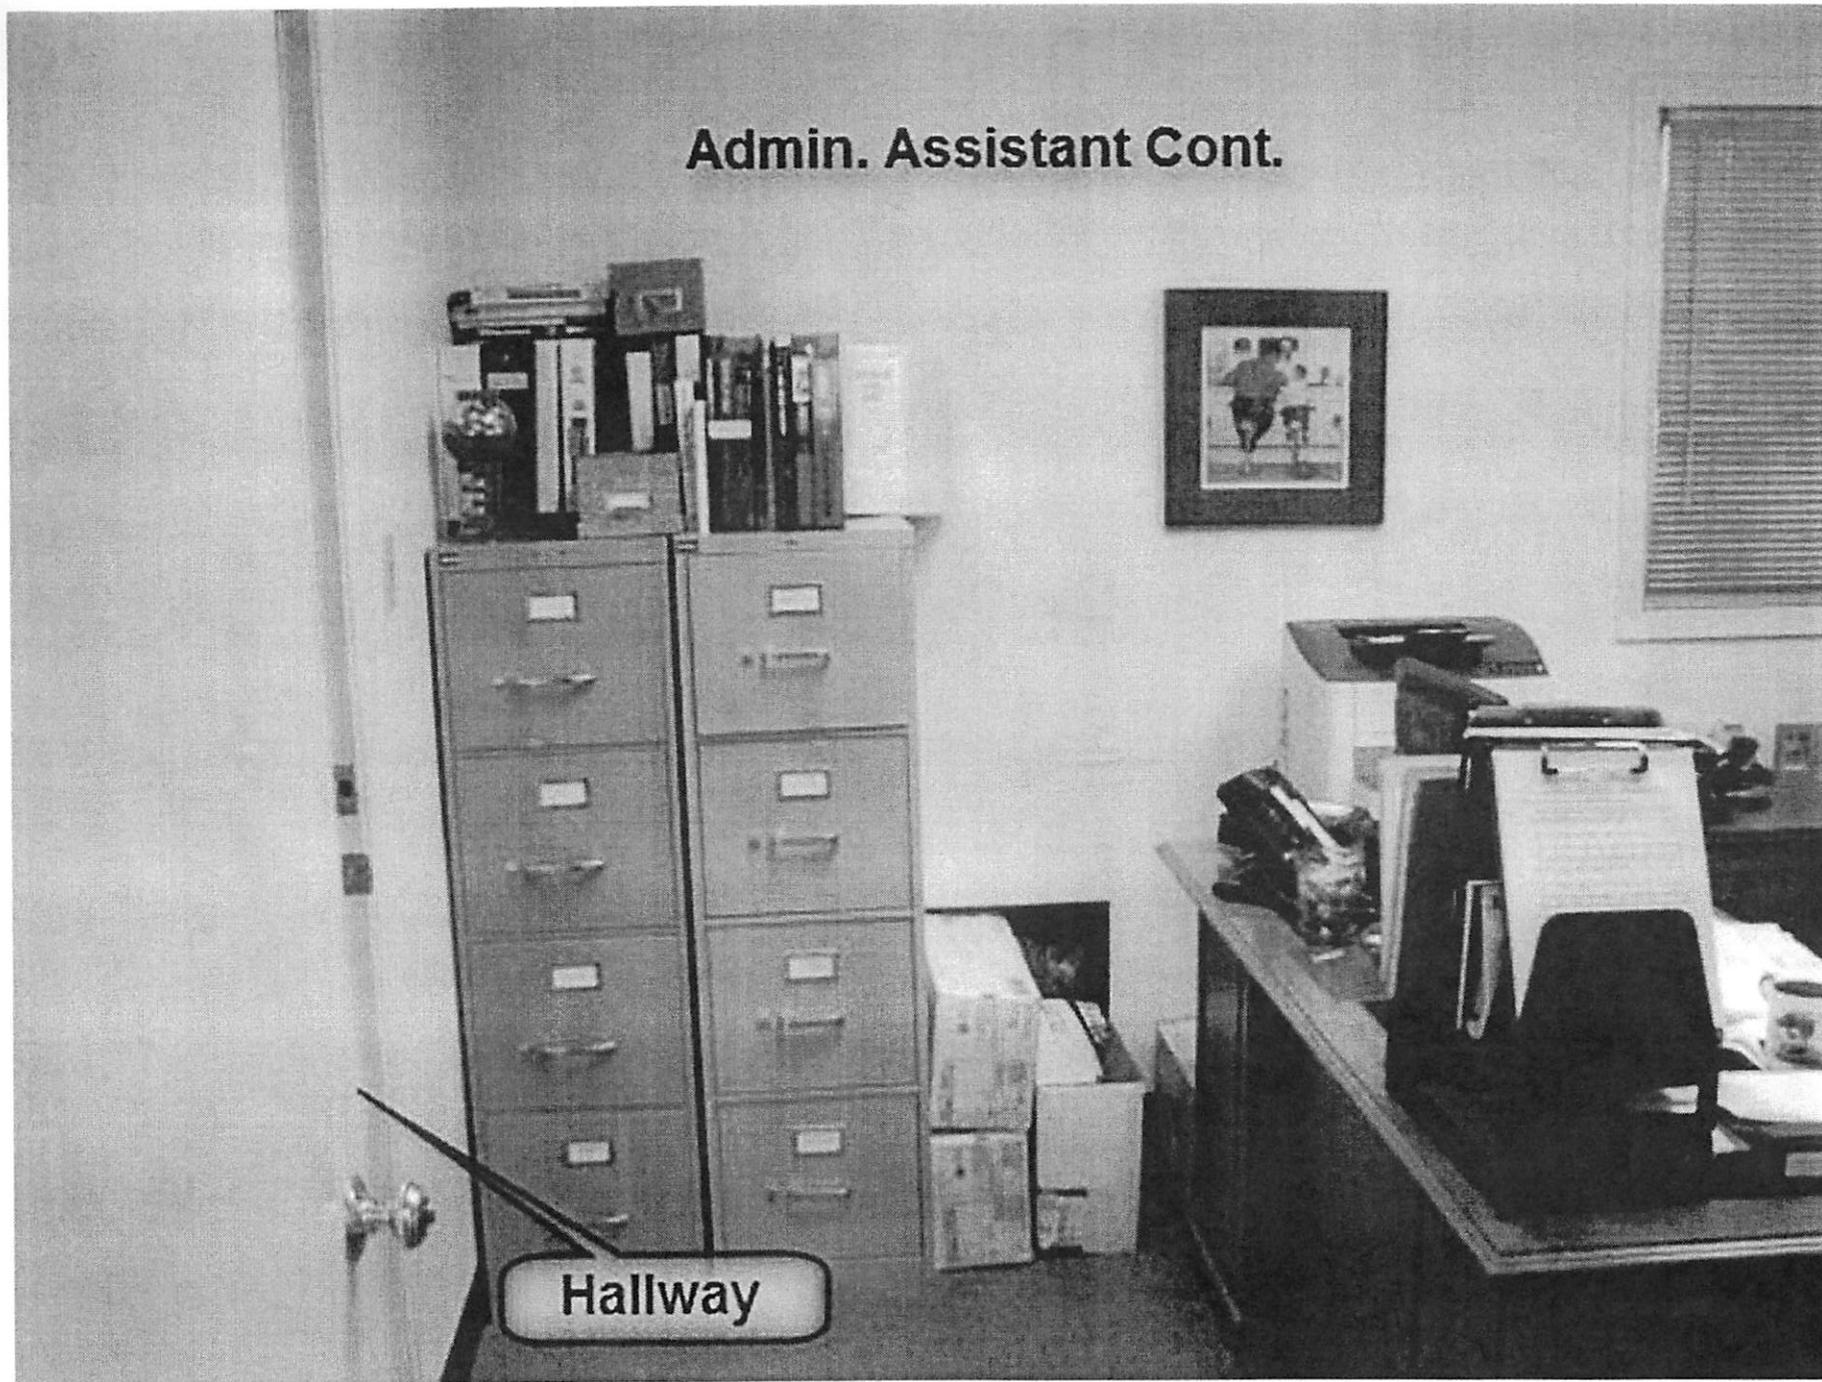
Admin. Assistant Office

- The administrative assistant's office is also too small. The administrative assistant needs room to lay out paperwork, work on projects, and more room for filing cabinets. The administrative assistant also serves as the Chief's secretary and is responsible for UCR reporting, personal files, and all necessary paper work and projects directed by the Chief of Police.

10.5' X 12'
